HOME INSPECTION REPORT

1234 Main St.
Boone, NC 28607

03/02/2020 9:00AM

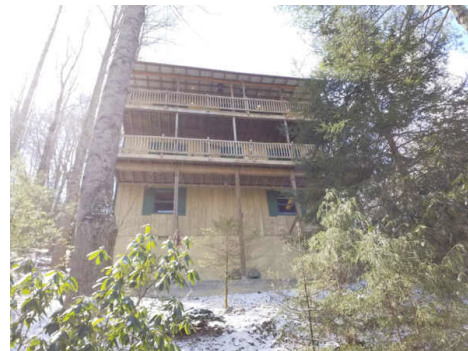
General
MULTI-LEVEL DECK

This home has an attached multi-level deck. This structure is beyond the scope of a home inspection as it requires extensive engineering for construction. While it is inspected for common defects, you may wish to have a structural engineer evaluate the structure before closing.

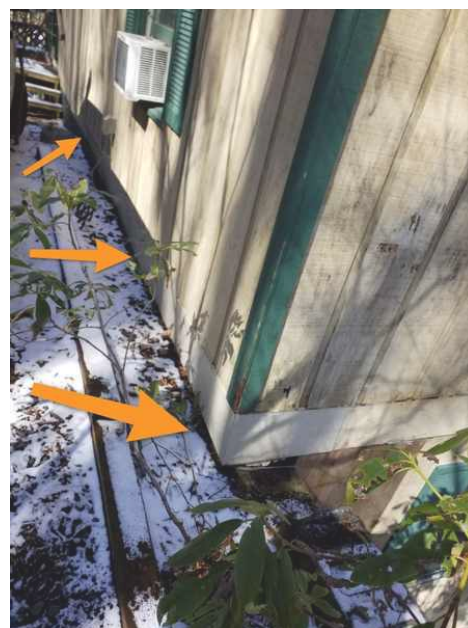
Grading is sloping towards the home in some areas. This could lead to water intrusion and foundation issues. Recommend qualified landscaper or foundation contractor evaluate to ensure that water flows away from home or is otherwise controlled.

Contact a qualified grading contractor.

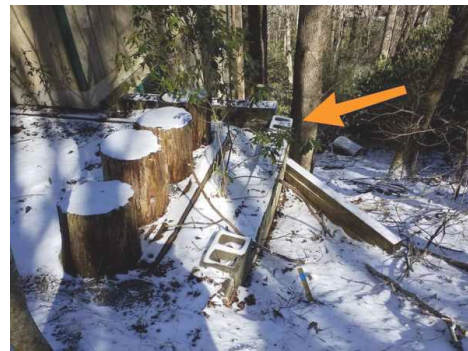
Retaining wall appears to be leaning and showing signs of deterioration. This is an indication of inadequate construction, deteriorating from age or overwhelming pressure on the wall. Over time, the wall may continue to lean and potentially fail. A landscaping professional is recommended to evaluate further.

Contact a qualified landscaping contractor

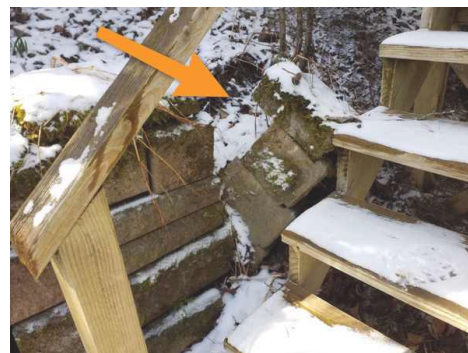
FAILED RETAINING WALL

The retaining wall has failed and no longer functions as originally intended. A general contractor is recommended to repair/replace as needed to ensure adequate drainage and prevent potential safety hazards.

Contact a qualified general contractor.

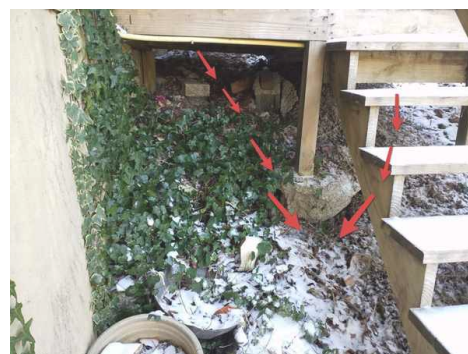
IMPROPER DRAINAGE/WASH OUT

There appears to be one or more areas of inadequate drainage indicated by wash out next to exterior walls and/or around deck footings. A grading professional is recommended to evaluate further to repair/replace wash out areas and improve drainage around the home.

Contact a qualified grading contractor.

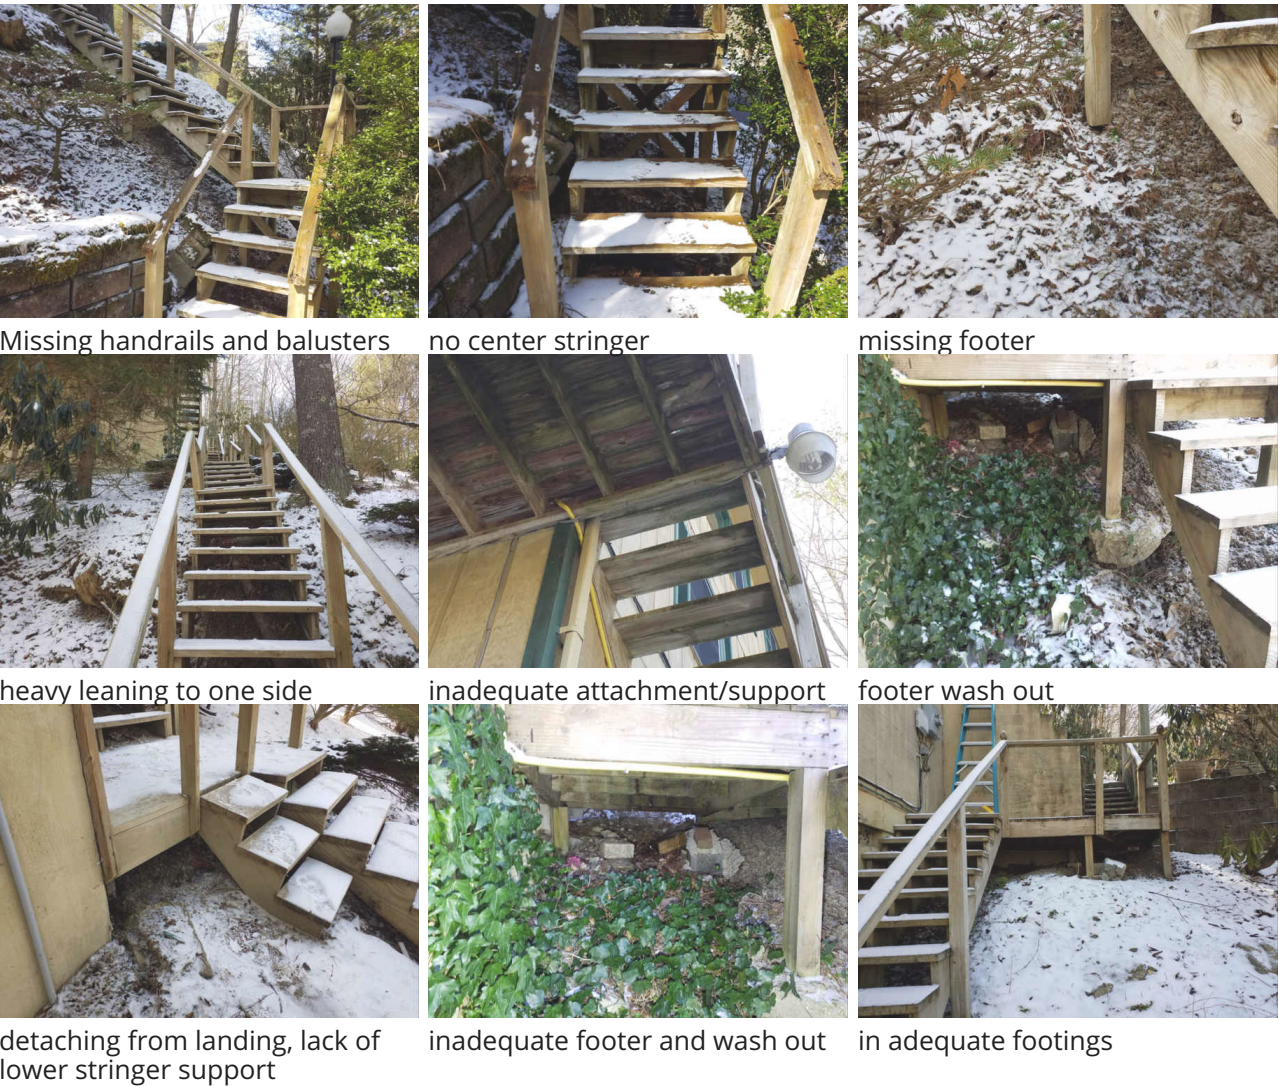
The exterior stair structures have serious areas of concern, including but not limited to:

- Missing handrail and balusters,
- no center stringer,
- Missing footers,
- Heavy leaning to one side,
- inadequate attachment and support structure,
- exposed footers from wash out,
- Stairs detaching from landing with no bottom stringer support,
- missing, damaged and overall inadequate footings,

These items are serious structural and safety concerns which could lead to trip hazards and structural failure. A structural engineer is recommended to evaluate further and provide a course of action for repair/replacement/modification as needed.

Recommendation
Contact a qualified professional.

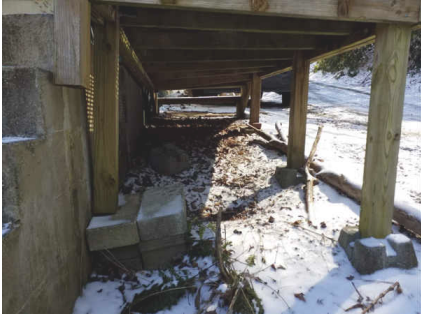
The front stoop has detached from the house and has overall inadequate/improper construction. This is a serious safety and structural concern. Replacement by a qualified contractor is recommended.

Contact a qualified general contractor.

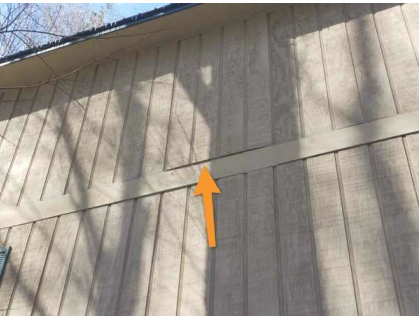
The exterior wood siding, trim and flashing has several areas of deterioration evident. Over time, these areas will continue to deteriorate and allow further damage, organic growth, and/or water entry. A siding professional is recommended to evaluate and repair/replace as needed. Hidden damage may be present.

South wall, detached/loose siding.

Recommendation
Contact a qualified siding specialist.

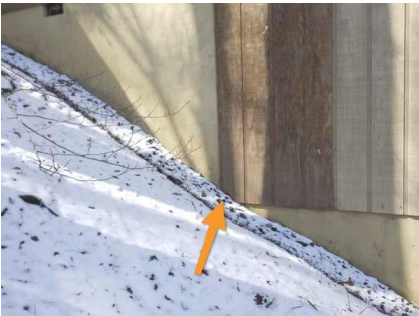
South wall, improper siding to ground clearance

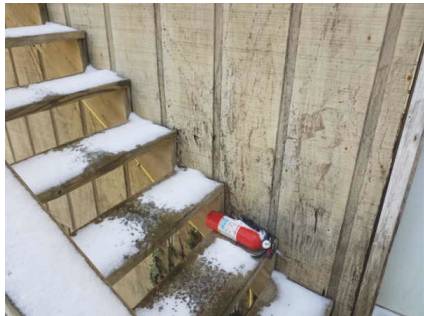
North Wall, Damage from failed gutter and growing vines

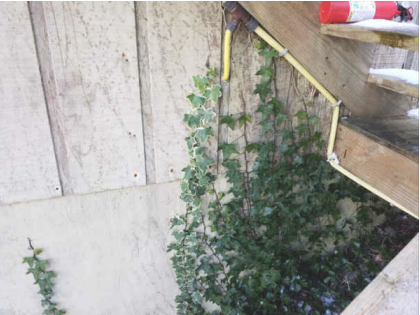
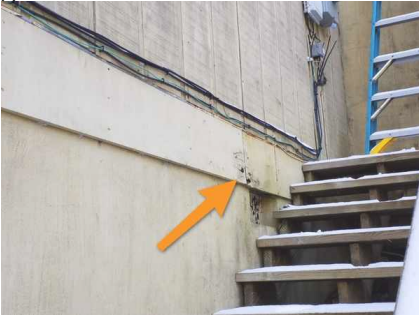
Water damage, North Wall

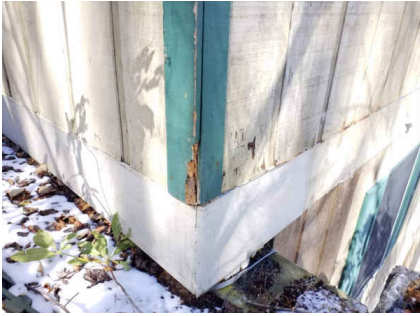
Deteriorating siding and trim, SW corner

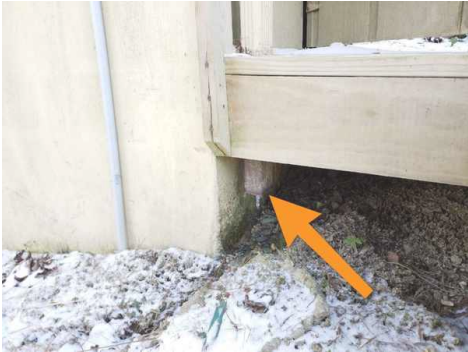
One or more downspouts drain too close to the home's foundation and/or deck support footings. This can result in excessive moisture in the soil at the foundation, which can lead to foundation/structural movement and water entry. Recommend a qualified professional adjust downspout extensions to drain at least 6 feet from the foundation.

Contact a qualified professional.

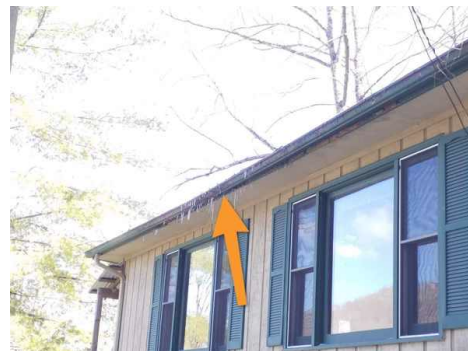
GUTTER DAMAGED

Gutters were damaged/dented/sagging. This can result in overflow and excessive moisture in the soil at the foundation, which can lead to water intrusion foundation/structural movement. It can also damage wood components below and promote water entry. Recommend a gutter contractor evaluate and repair.

Contact a qualified gutter contractor

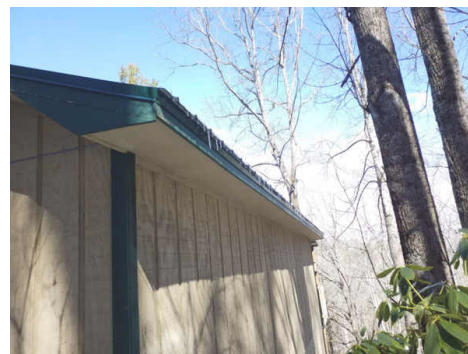
GUTTERS MISSING

There are no gutters present in one or more areas on the structure. Gutters are recommended because they collect rain water from the roof and direct it away from the building. With no gutters in place, rainwater can fall at the soil directly below deck support footers and foundation walls. This can soften the soil and cause potential structural concerns or water entry. A gutter professional is recommended to install gutters.

Contact a qualified gutter contractor

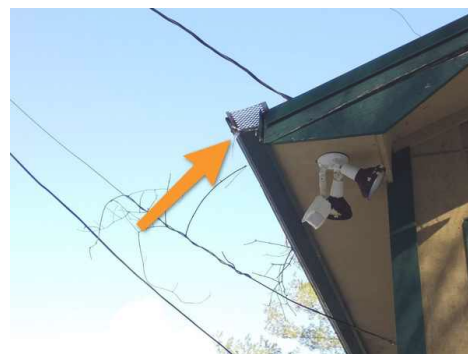
GUTTER MISSING END CAP

The gutter has a missing end cap. A gutter professional is recommended to properly install the end cap to ensure adequate water control.

Contact a qualified gutter contractor

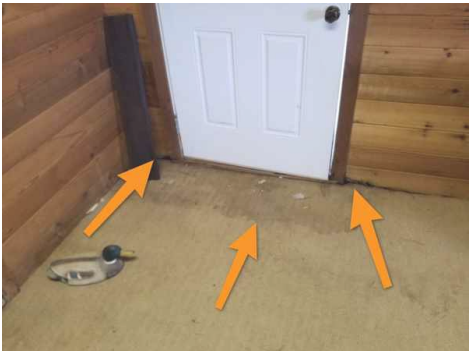
Heavy water entry is evident at the base of the lowest level exterior door. This is likely the result of the failed gutter and deteriorating exterior. A general contractor is recommended to evaluate further, determine cause and extent of the damage and repair/replace as needed.

Contact a qualified general contractor.

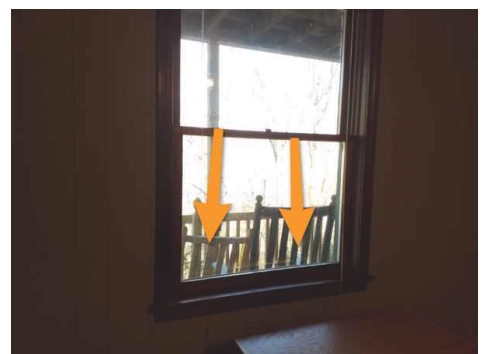
One or more windows will not stay open when lifted. This is an indication of failed hardware. A window repair specialist is recommended to evaluate further to ensure proper operation.

Contact a qualified window repair/installation contractor.

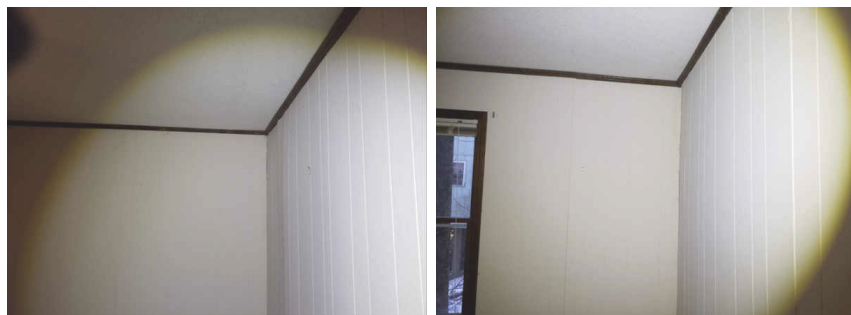
BOWING WALL PANELS

The lower level bedroom walls have bowing wall panels. This is an indication of heavy ambient air moisture or water entry from the below grade wall. A general contractor is recommended to evaluate further and determine the cause of the bowing wall panels, remedy and moisture/water issues and repair replace damaged panels. Hidden damage and organic growth may be present behind the walls.

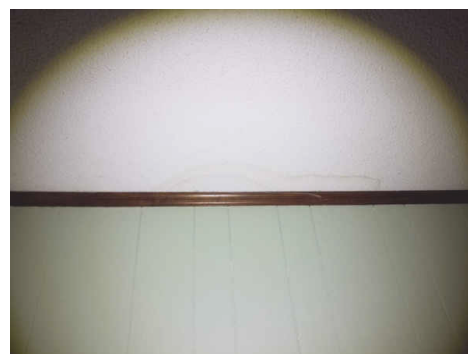
STAIN(S) ON CEILING

Moisture staining was observed on the ceiling. The stain was inactive when tested with a moisture meter. Verify with the seller that the issue has been resolved. Monitor the area for further evidence of water intrusion. If additional leaking is evident, a qualified professional is recommended to evaluate further.

Contact the seller for more info

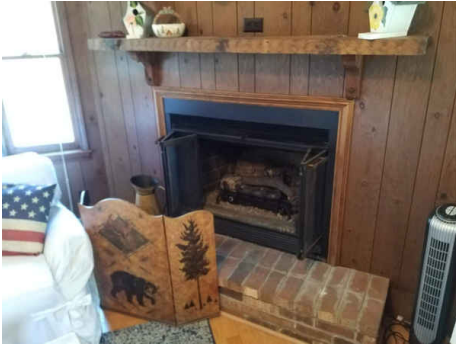
Type

Gas, Prefabricated, Ventless

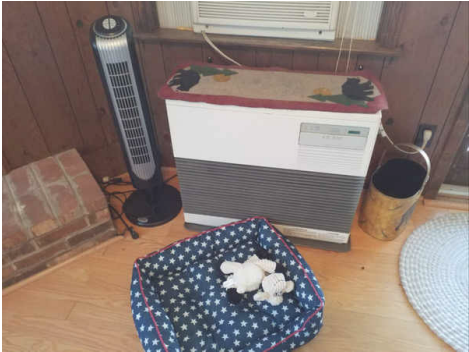
MONITOR HEAT

One or more heating systems in the home were shut down or otherwise did not respond with normal controls. You may wish to have a system technician evaluate before closing.

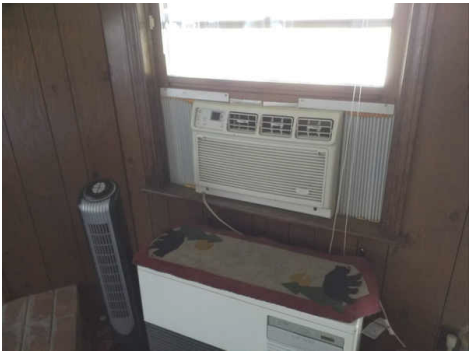
WINDOW AC UNIT

This home is equipped with a window AC unit. This system is beyond the scope of a home inspection and was not inspected.

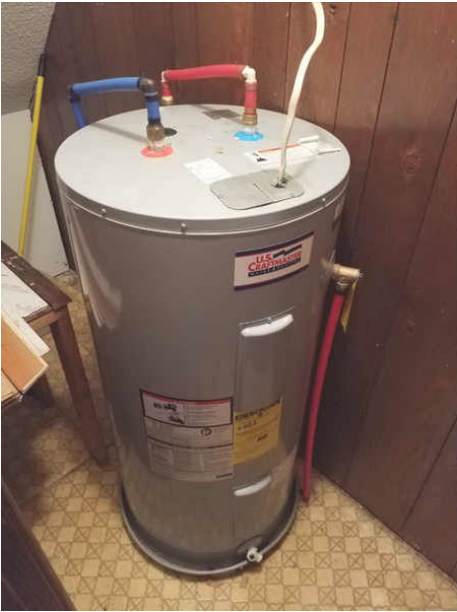
Hot Water Systems, Controls, Flues & Vents: Capacity 50 gallons	Hot Water Systems, Controls, Flues & Vents: Model NE3F50RD 110	Hot Water Systems, Controls, Flues & Vents: Serial 1814109862457
Hot Water Systems, Controls, Flues & Vents: Manufactured year 2018

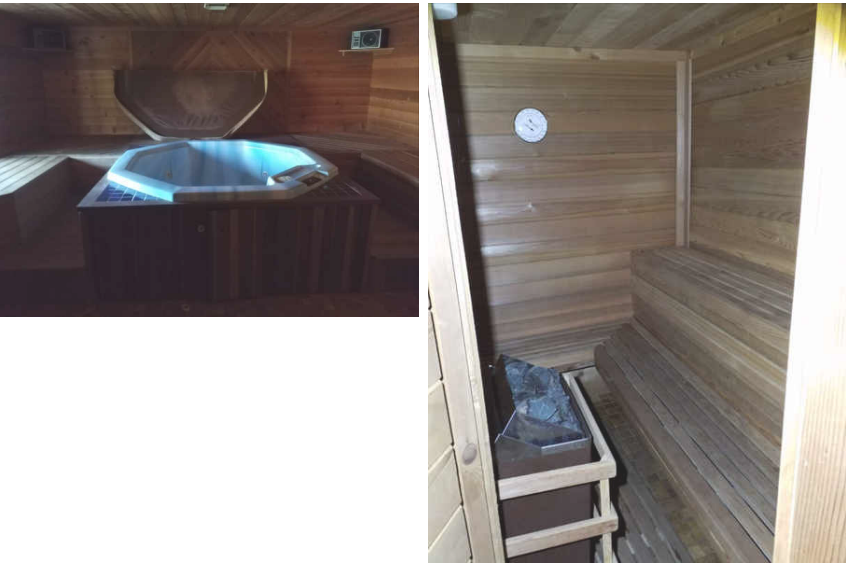
HOT TUB/SAUNA

This home is equipped with am indoor hot tub and sauna. These systems along with support structures, plumbing, and electrical connections are outside the scope of a home inspection. A system professional is strongly advised to fully evaluate before closing.

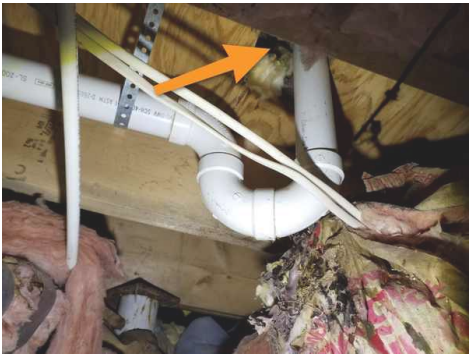
A DWV pipe showed signs of a leak. Recommend a qualified plumber evaluate and repair to prevent additional leaking and potential water damage.

Recommendation
Contact a qualified plumbing contractor.

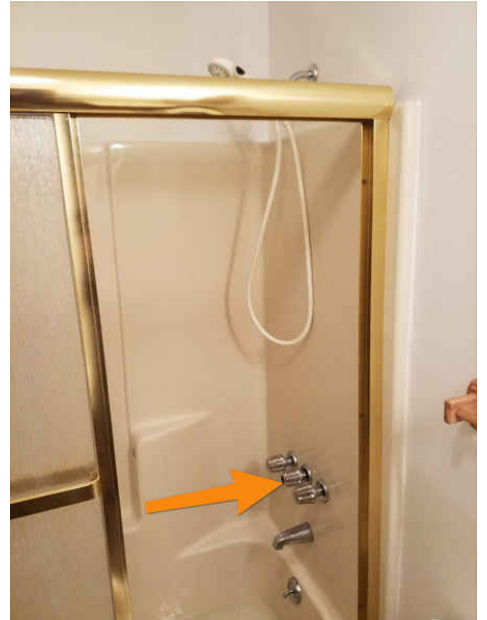
Repair/replacement is recommended to ensure proper operation and ease-of-use

Contact a qualified professional.

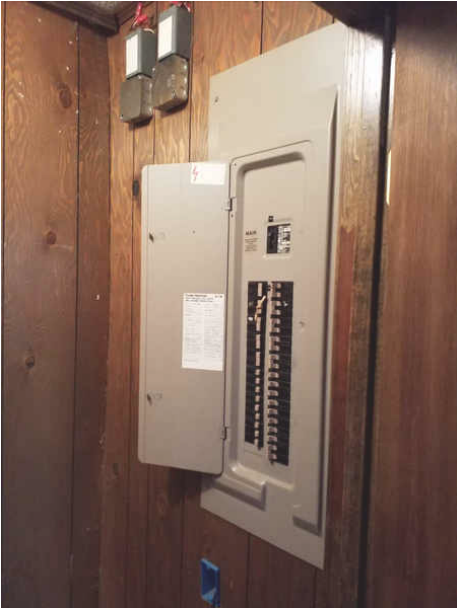
Main & Subpanels, Service &
Grounding, Main Overcurrent
Device: Main Panel Location

Lower Level, Closet

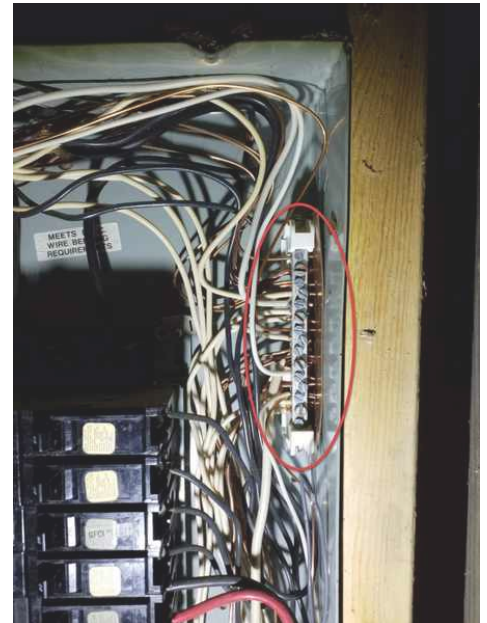
The sub panel is improperly wired. The grounds and neutrals are not separated/isolated. This is a potential safety hazard if there is ever an over current event such as a lightning strike. A licensed electrician is recommended to evaluate further.

Contact a qualified electrical contractor.

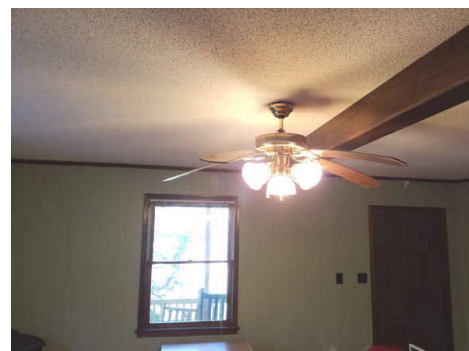
The ceiling fan in the lower level has drooping fan blades. This is an indication of heavy moisture in this level and can cause the fan to malfunction. A qualified professional is recommended to repair/replace as needed.

Contact a qualified professional.

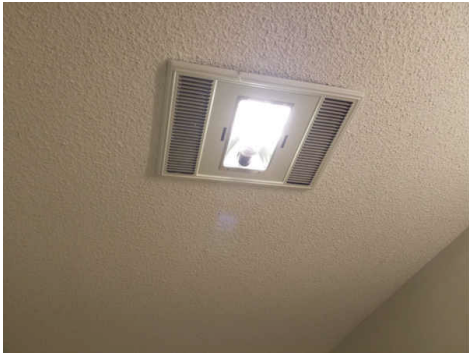
The bathroom vent fan did not function properly when tested. A licensed electrician is recommended to evaluate further and repair/replace as needed to ensure proper operation and alleviate potential safety concerns.

Contact a qualified electrical contractor.

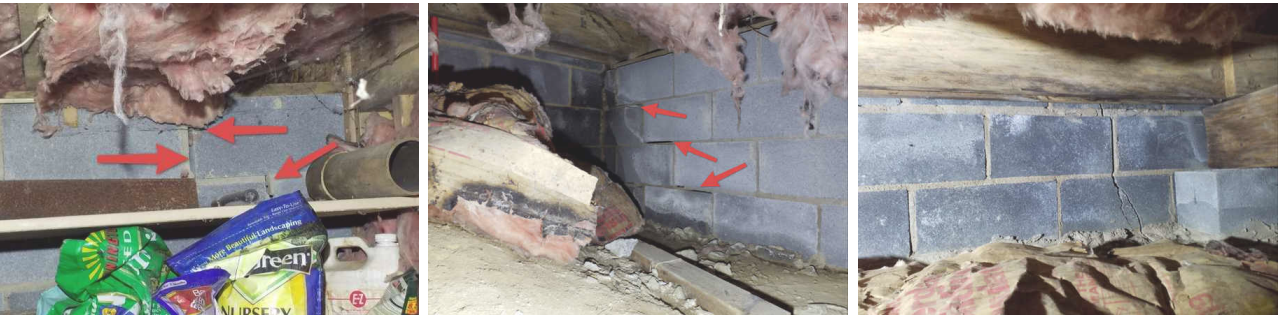
North Wall, left of lowest level entry.

NW Corner

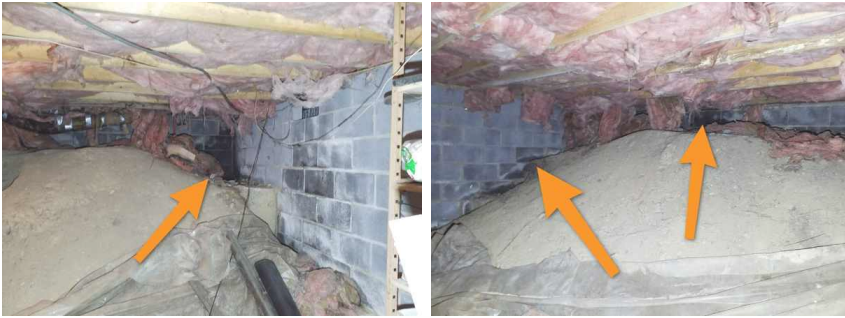
13.1.2 Foundation

FOUNDATION WALL WATER INTRUSION

Water intrusion is evident through the foundation wall with darker stains and efflorescence. This is an indication of inadequate exterior drainage. Moisture in a crawlspace/basement can cause potential organic growth and damage to wood components. A grading or basement professional is recommended to evaluate further.

Contact a qualified grading contractor.

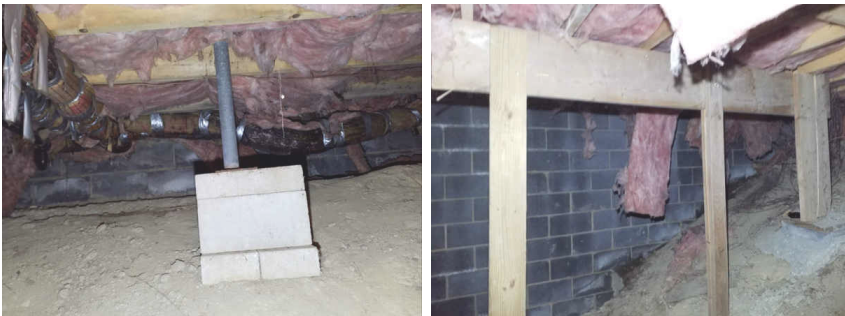
13.2.1 Floor Structure

MODIFIED CONSTRUCTION

The floor structure has areas of modified or added supports. This is an indication of previous structural issues in the home. Verify with the seller what structural issues are present. A general contractor or structural engineer is recommended to evaluate further.

Contact a qualified structural engineer.

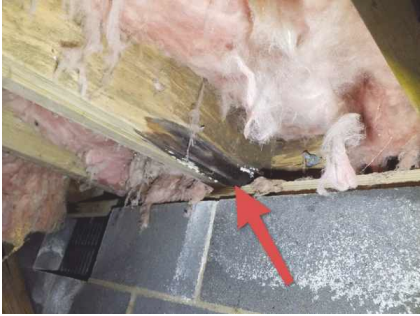
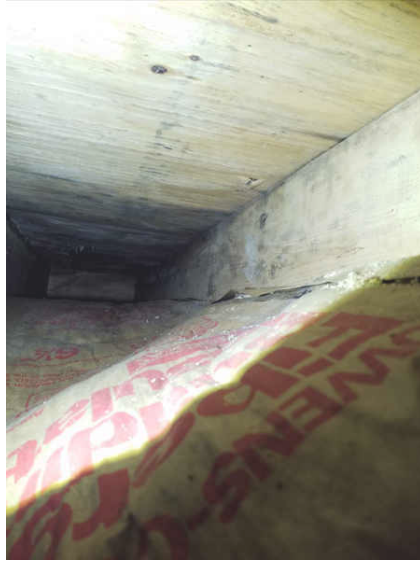
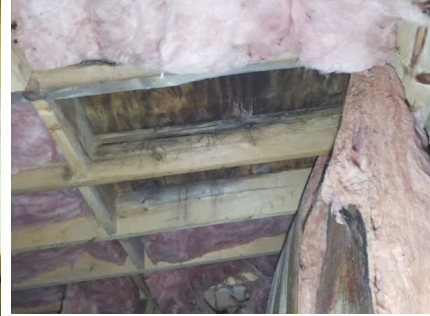
13.2.2 Floor Structure

SUBFLOOR - WATER STAINS/DAMAGE

Contact a qualified general contractor.

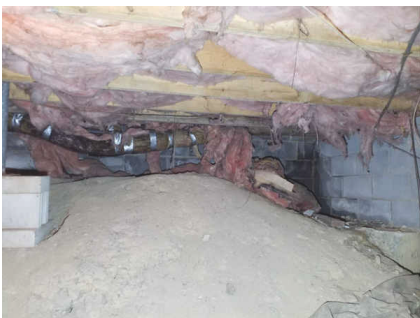
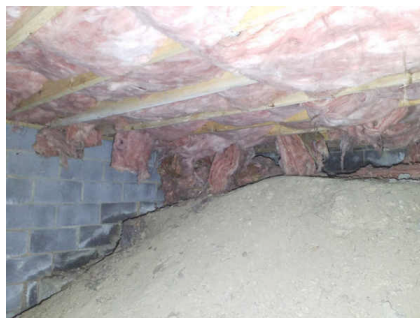
13.3.1 Insulation

FALLING/DAMAGED INSULATION

Contact a qualified insulation contractor.

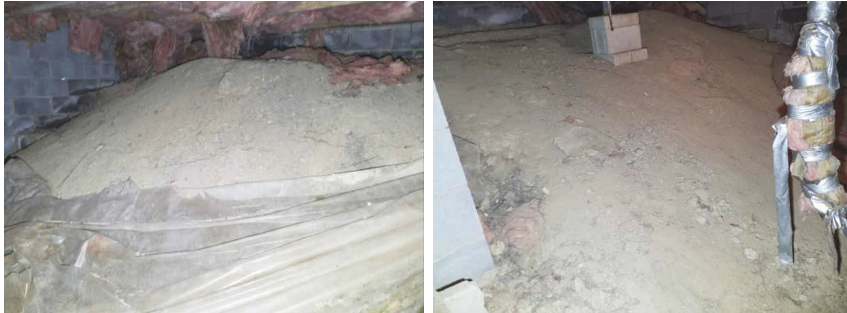
13.5.1 Vapor Retarders (Crawlspace or Basement)

DISPLACED

Contact a qualified insulation contractor.
