# Western States Inspections & Services, Inc.

2523 S. Eastover St. Bennett, CO 80102

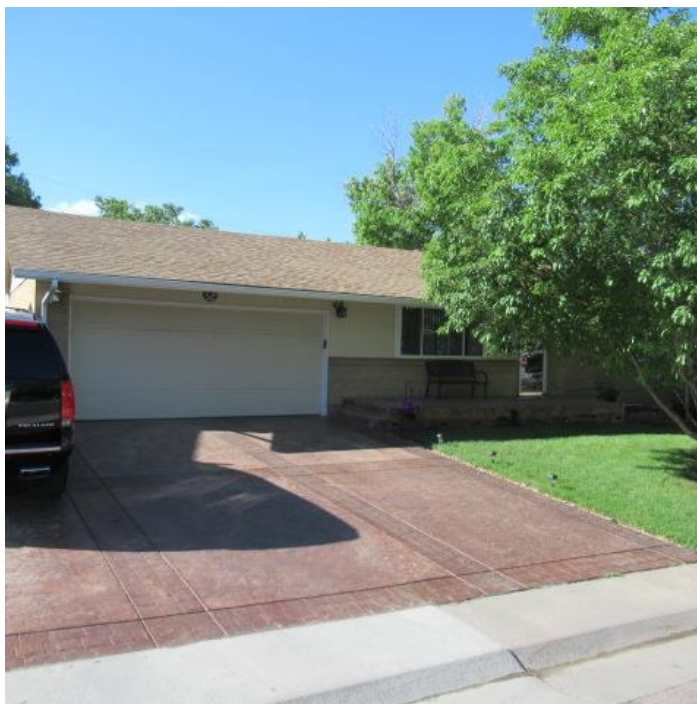
- ☒ Client or representative was not present for entire inspection  
☐ Snow covering some features and limiting inspection ☐ Raining (may limit inspection) ☐ Recent rain  
**Average temps during inspection:** ☐ Cold <32° ☐ Cool 32°- 65° ☒ Warm 65°- 85° ☐ Hot >85°  
**Property type:** ☒ Single family ☐ Condo ☐ Townhome ☐ Attached ☐ Multi-unit ☐ Commercial  
**Status:** ☒ Occupied ☐ Vacant ☒ Furnishings present and limit inspection (furniture, etc. is not moved)

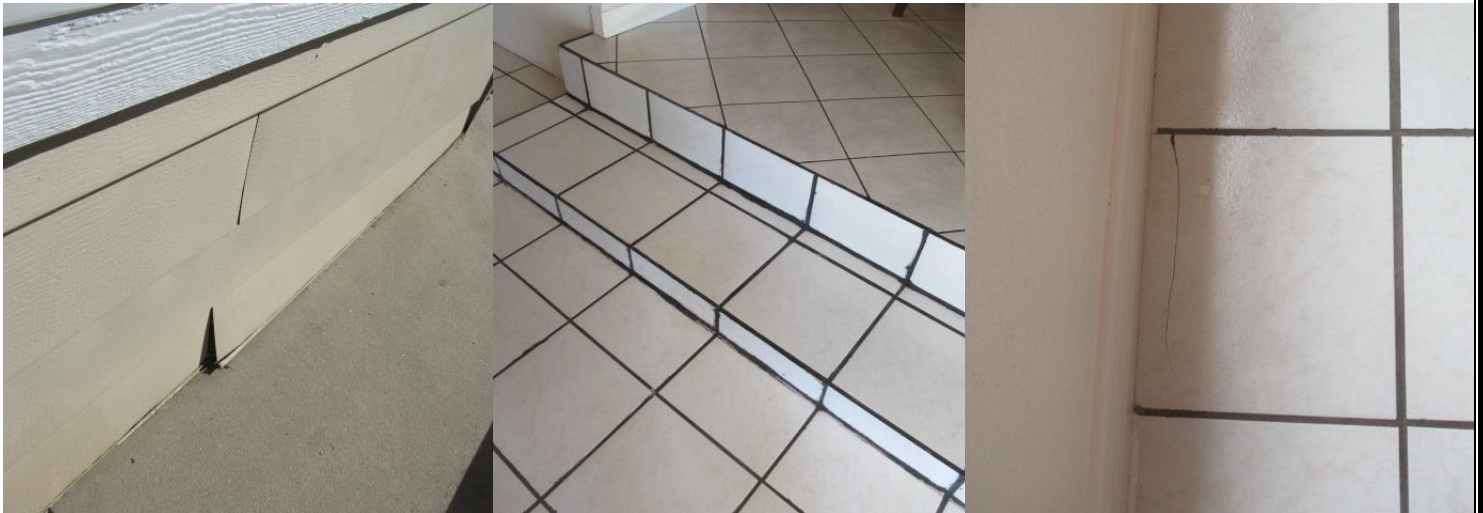
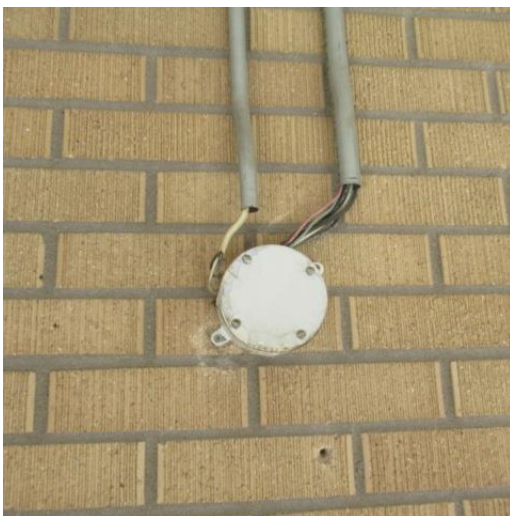
#### 5 PATIO ☒ SW corner of house

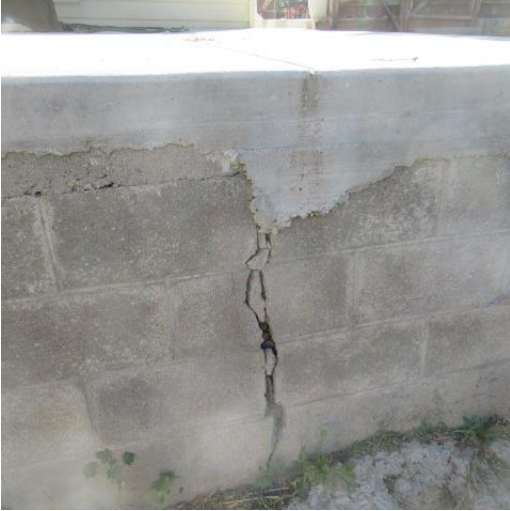
**Block retaining wall has major gapped crack.**

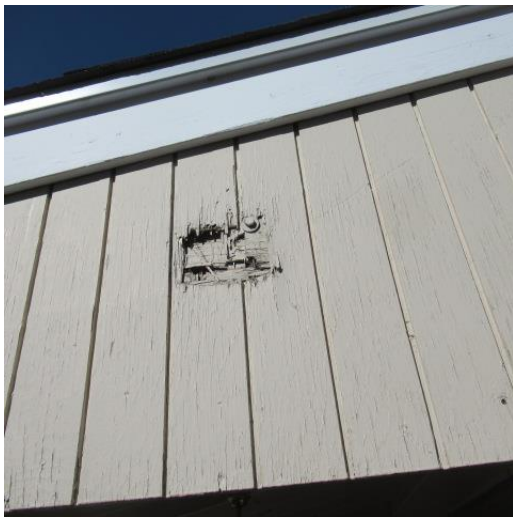
**Masonry veneer (stucco, stone, brick):** ☐ N/A

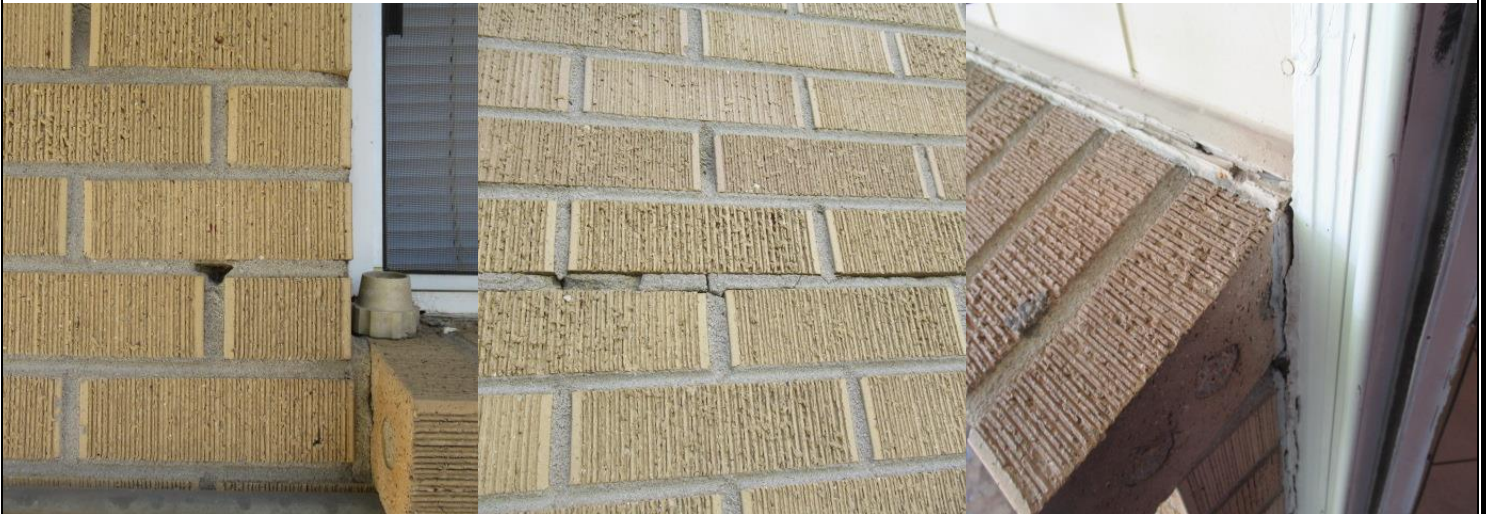
Further evaluations should be conducted by qualified independent experts.  
Paint prior to 1979 may contain lead. Paint is not tested for lead content.

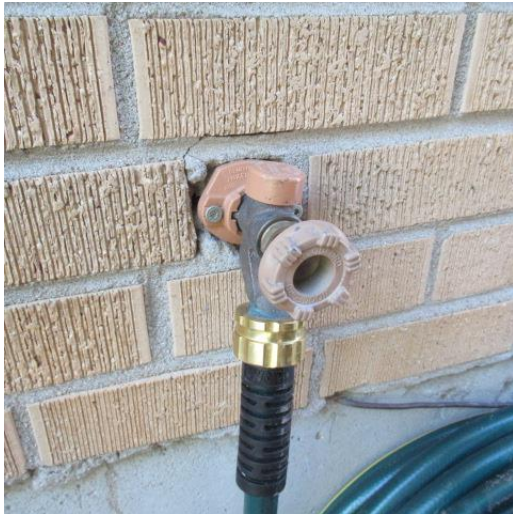
**11 SPRINKLER** ☐ N/A ☐ System is off **Minimal Inspection: Inspector does not operate sprinkler system**  
**Damage to water lines under deck**

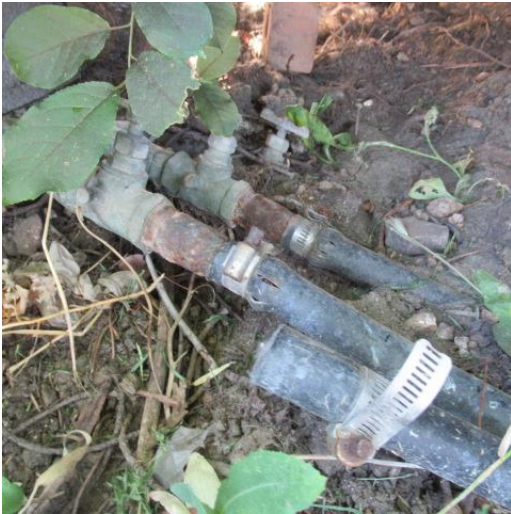
Because most of sprinkler system is hidden and large amounts water must be run to determine function; sprinkler inspection is minimal and buyer should further investigate. Inspector does not inspect valve boxes or spray coverage. If possible, buyer is encouraged to ask the seller or other experts for instructions on use of the system.

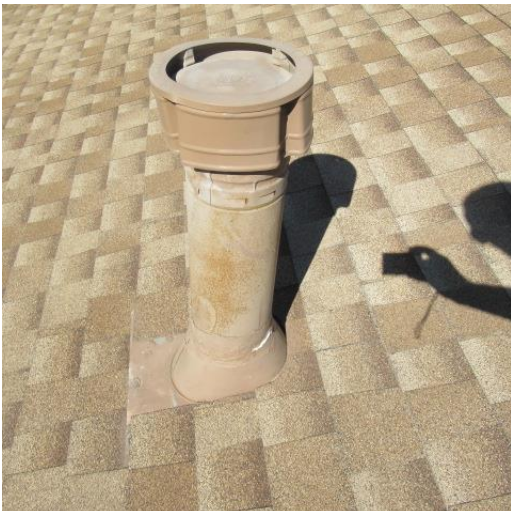
**15 GUTTERS** ☐ N/A ☐ Maintained by HOA (not inspected) ☐ None installed (usually required)

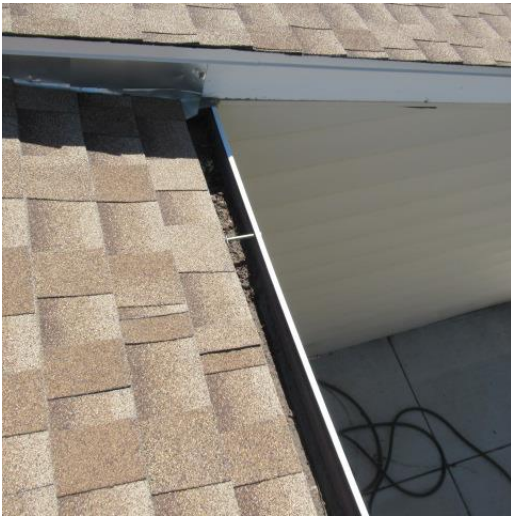
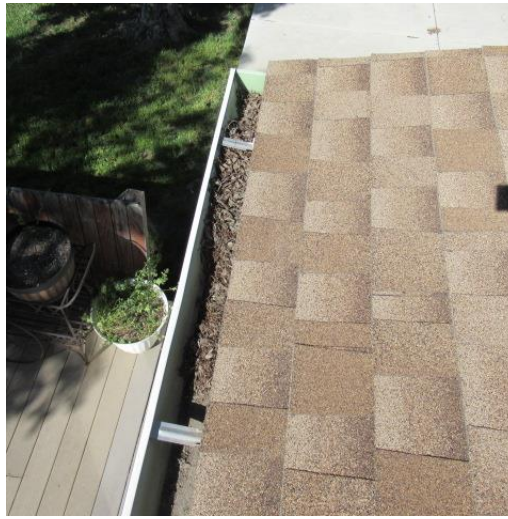
\*When weather and gutters are dry, it is difficult to determine leakage or drainage. In most installations, downspout extensions should divert water at least five feet from foundation. Inspector does not determine the effectiveness of any underground drains.

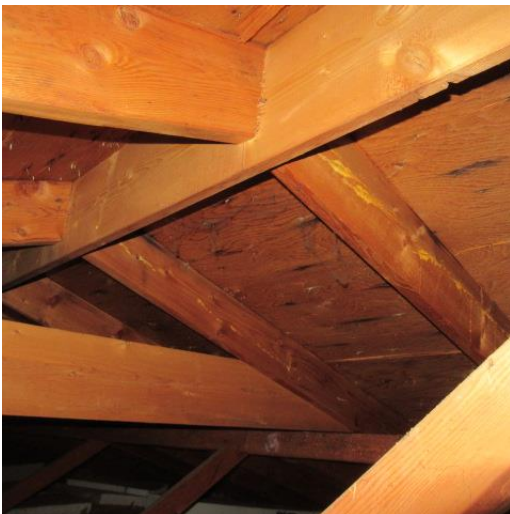
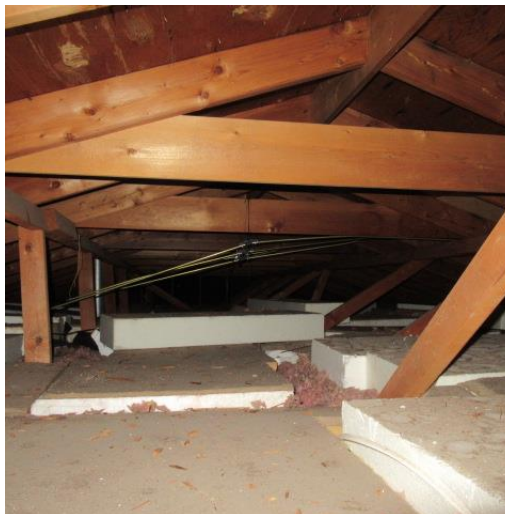
**17 ELECTRICAL SERVICE** ☒ Overhead ☐ Underground (not visible for inspection)

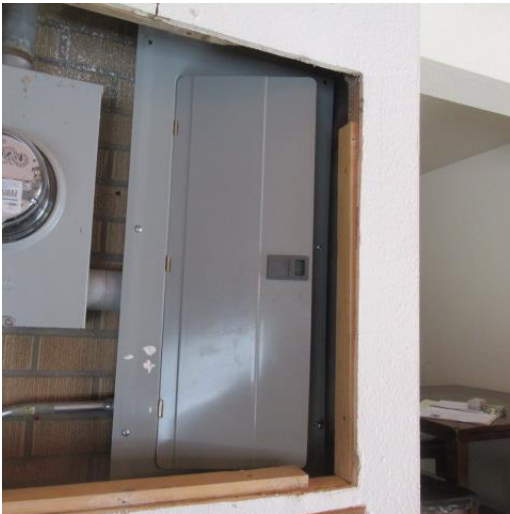
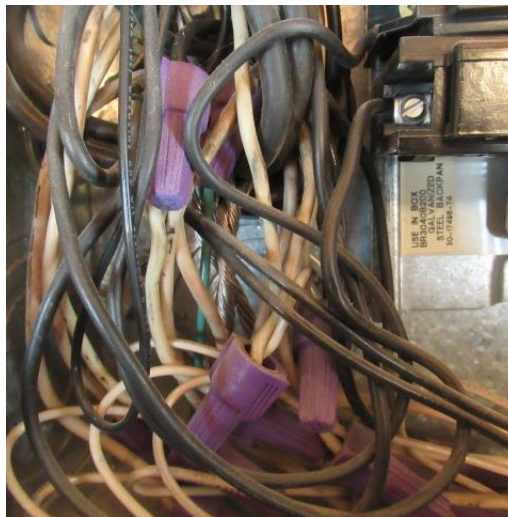
\*Solid aluminum wiring has special concerns and installation instructions. Evaluation by a licensed electrician is recommended.

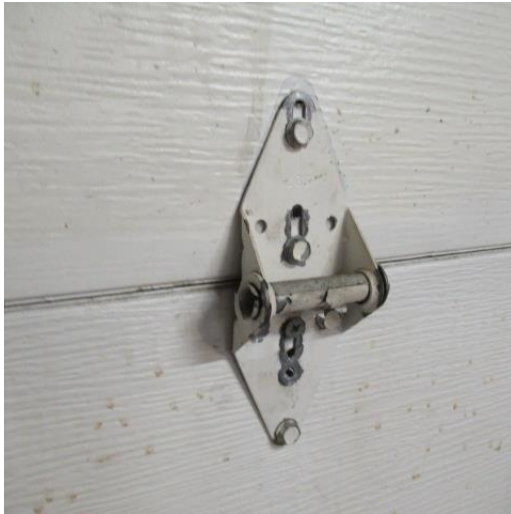
Lags, bolts, and nuts on wood doors need to be snugged annually. Do not over tighten.

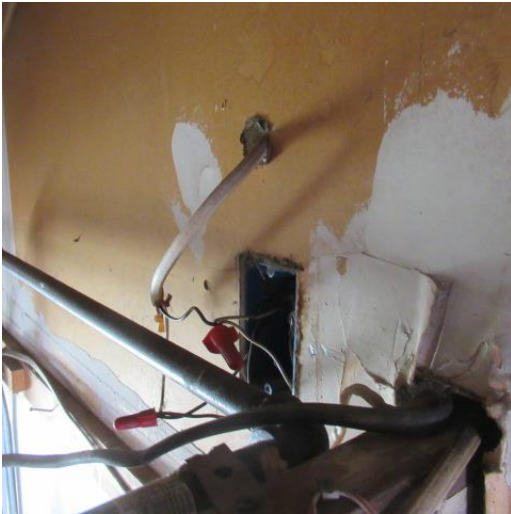
## 19 EXTERIOR DOORS

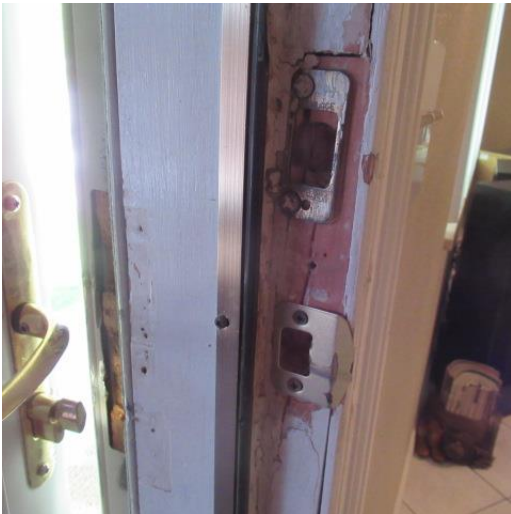
## 20 INTERIOR DOORS

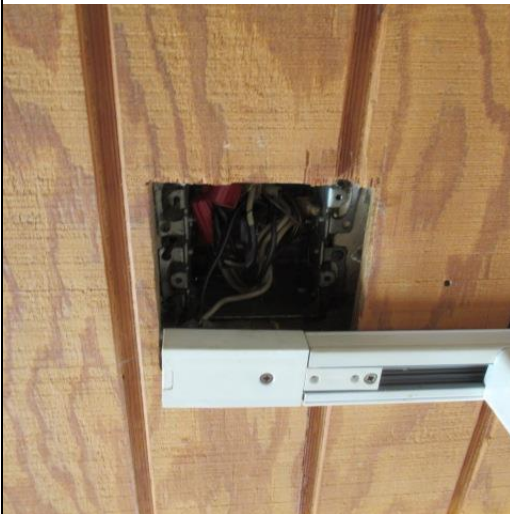
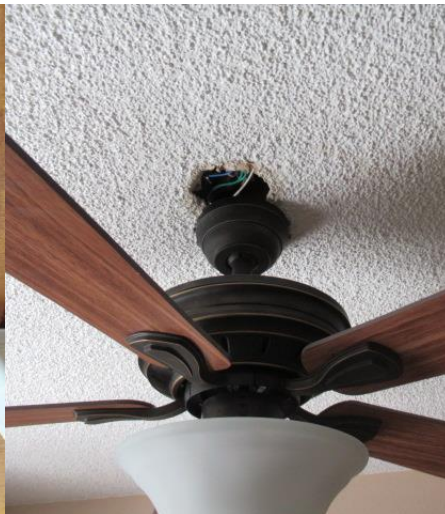
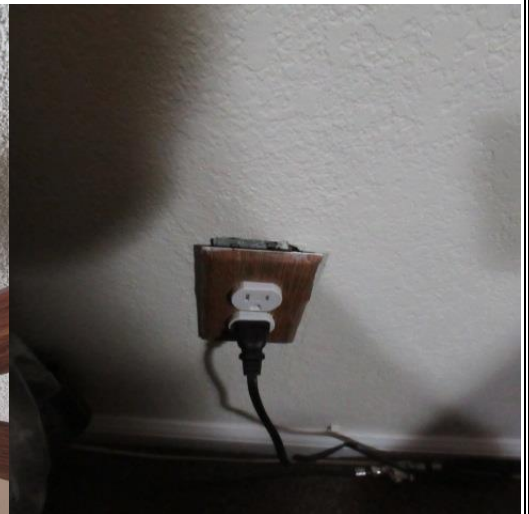
**'GFCI' outlets are a safety device recommended at exterior, garage, bathroom, kitchen, and wet bar locations.** An ungrounded GFCI can provide GFCI protection if wired correctly.

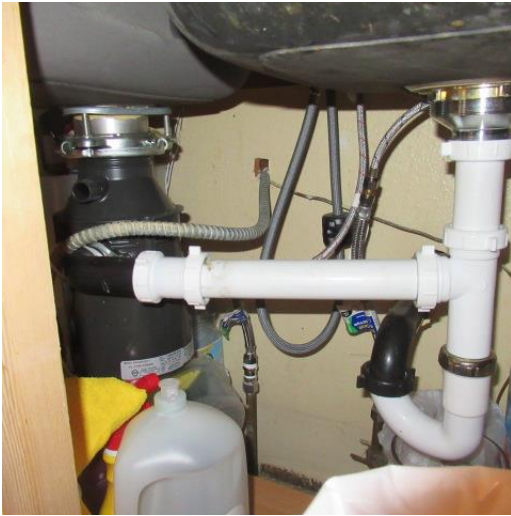
**DISPOSAL** ☐ N/A ☐ Power off ☐ Not working  
☒ Exposed splices ☐ Loose or missing wire clamp

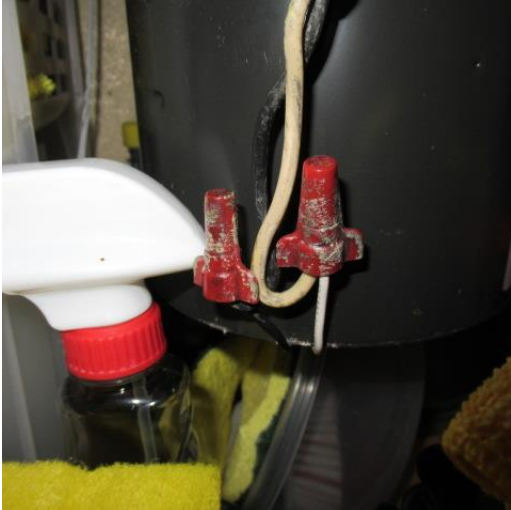
**STOVE/OVEN** ☐ N/A ☐ Power / gas off—no inspection

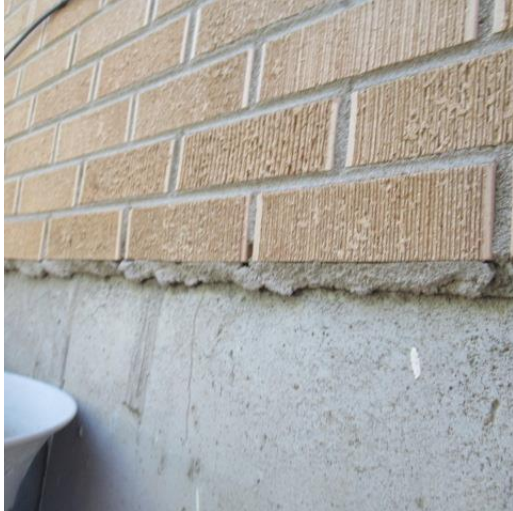
\*Inspector's observations and conclusions are based on observable components.

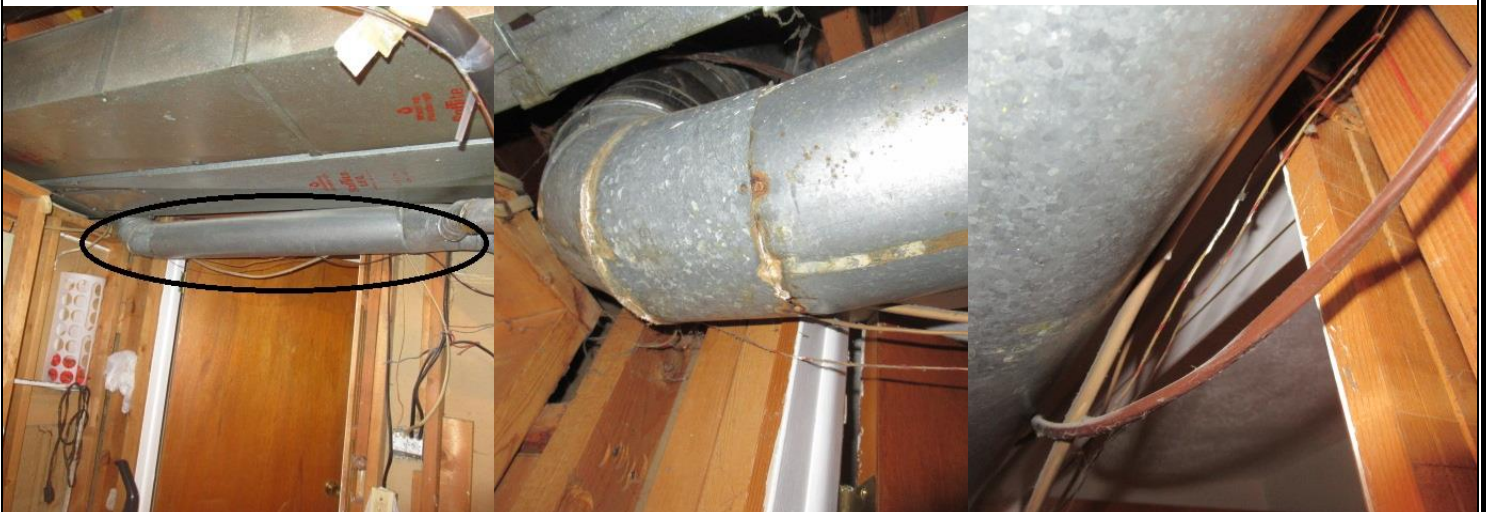
**HEAT EXCHANGER** (Not fully visible) Air or water flows over the heat exchanger and is warmed for distribution.

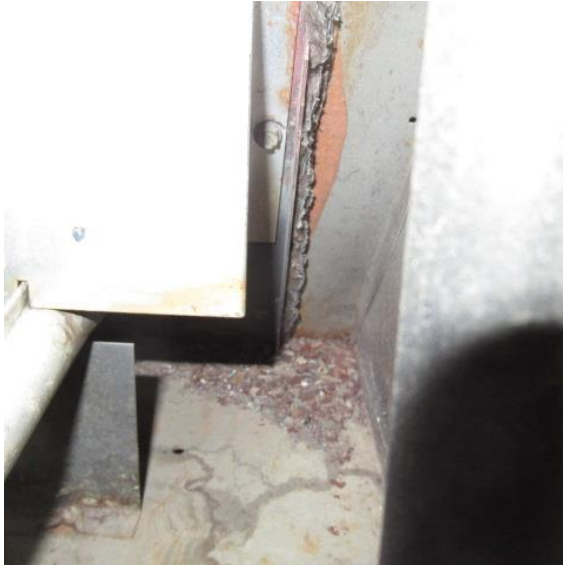
Only a small portion of the heat exchanger is visible. In some units, it is impossible to view any of the heat exchanger. In all cases, it requires the expertise of a licensed HVAC technician to thoroughly evaluate the condition of a heating unit. The inspector makes comments based on what is viewable. The client is always encouraged to have a complete system evaluation done by a licensed HVAC technician. CO test is not definitive.

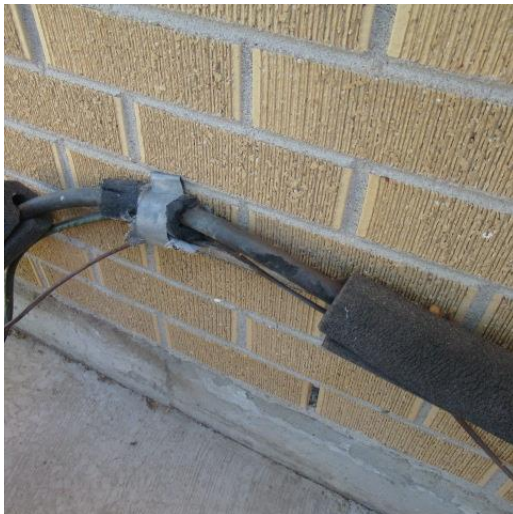
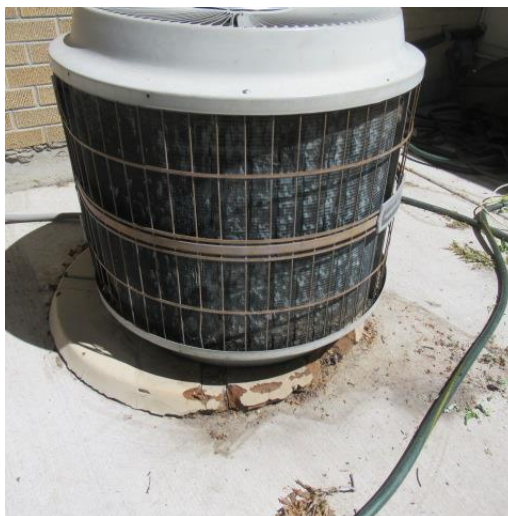
Many factors are involved in determining the adequacy and effectiveness of a cooling system. Home inspector only evaluates the condition of existing components.

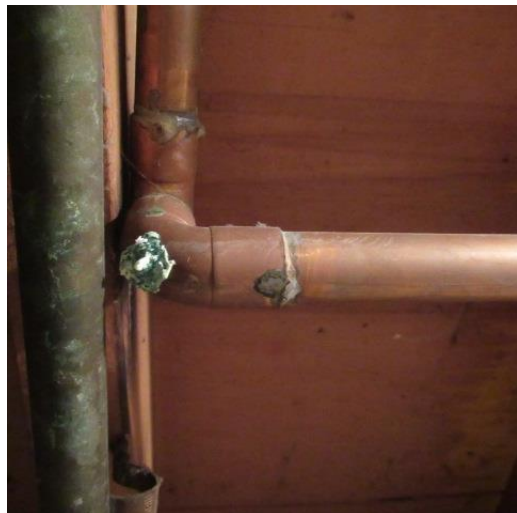
☒ **Corrosion/blisters** **above water heater**

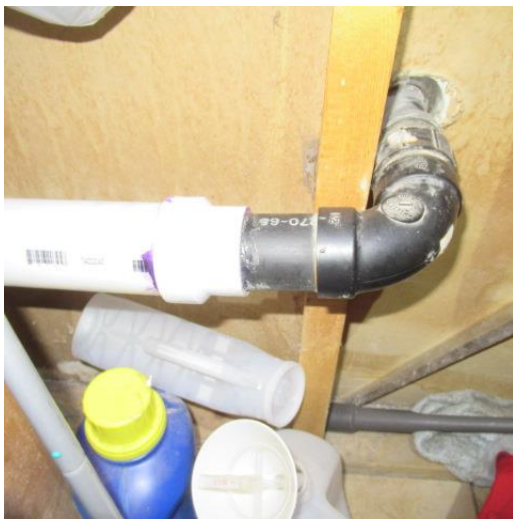
Some 'ABS' black plastic piping made between 1984 to 1990 have documented problems. It is recommended to replace lead DWV lines, but not required. **Some leaks and other drainage problems require much more water to be run than can be done during this inspection, to reveal hidden problems.**

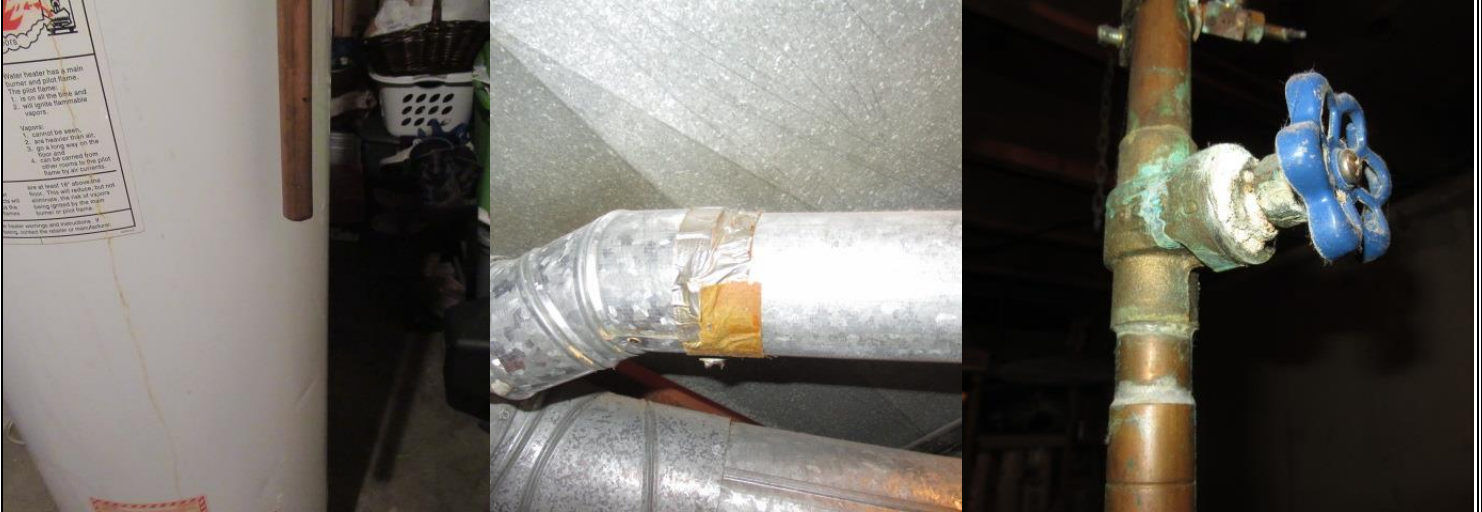
Any estimate of the remaining life of a water heater doesn't constitute any kind of warranty or guarantee. Estimating average normal life is based on inspector's experience. Average normal life is estimated at 15 years. This average means that some water heaters may fail sooner and others may continue to operate for longer.

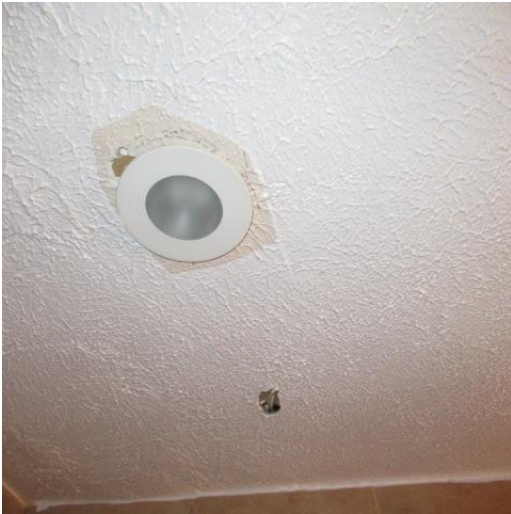
**VENTILATION** ☐ Fan only ☐ Window only ☒ Fan and window

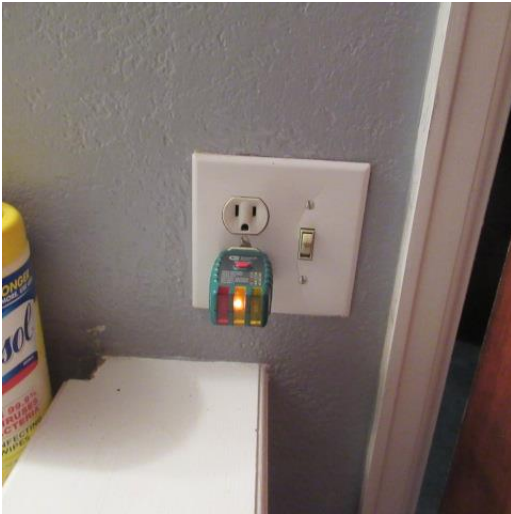
\* Ungrounded GFCI outlet is an approved option on a pre-1960 ungrounded electrical system. Outlets may be protected by a GFCI outlet in another bath or area.

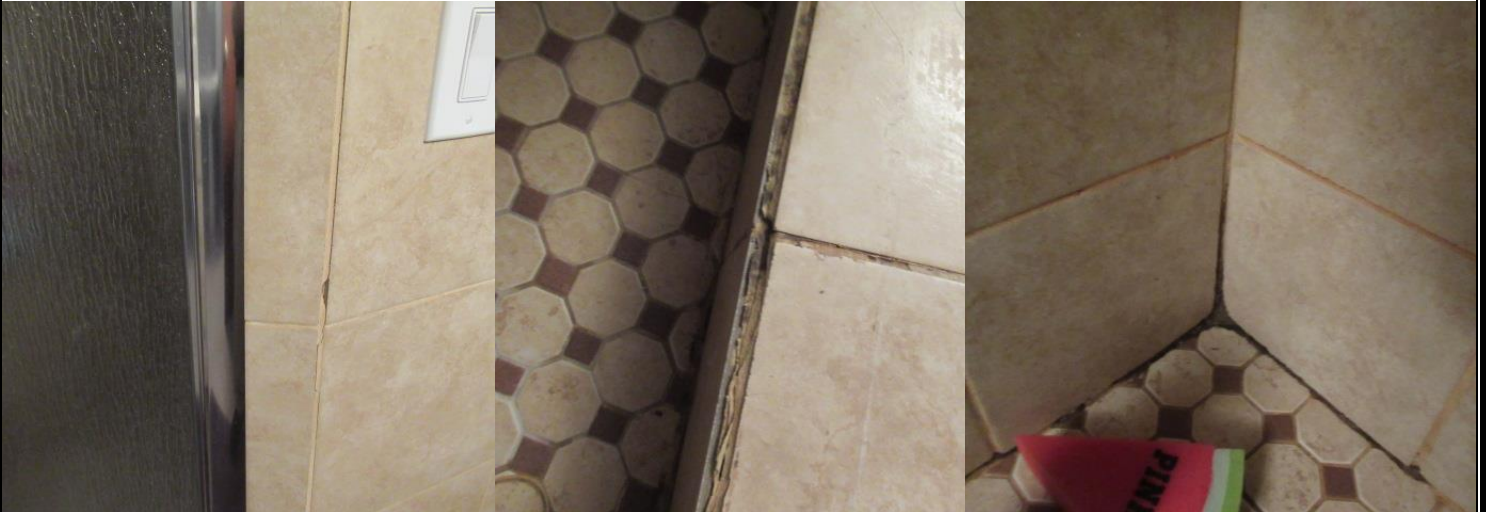
Identifying mold or type or toxicity of mold is not within the scope of this inspection. "Mold-like substance" or "moldy" means that observed substance has the appearance of mold. Damaged/wet wall may have hidden mold/rot inside.

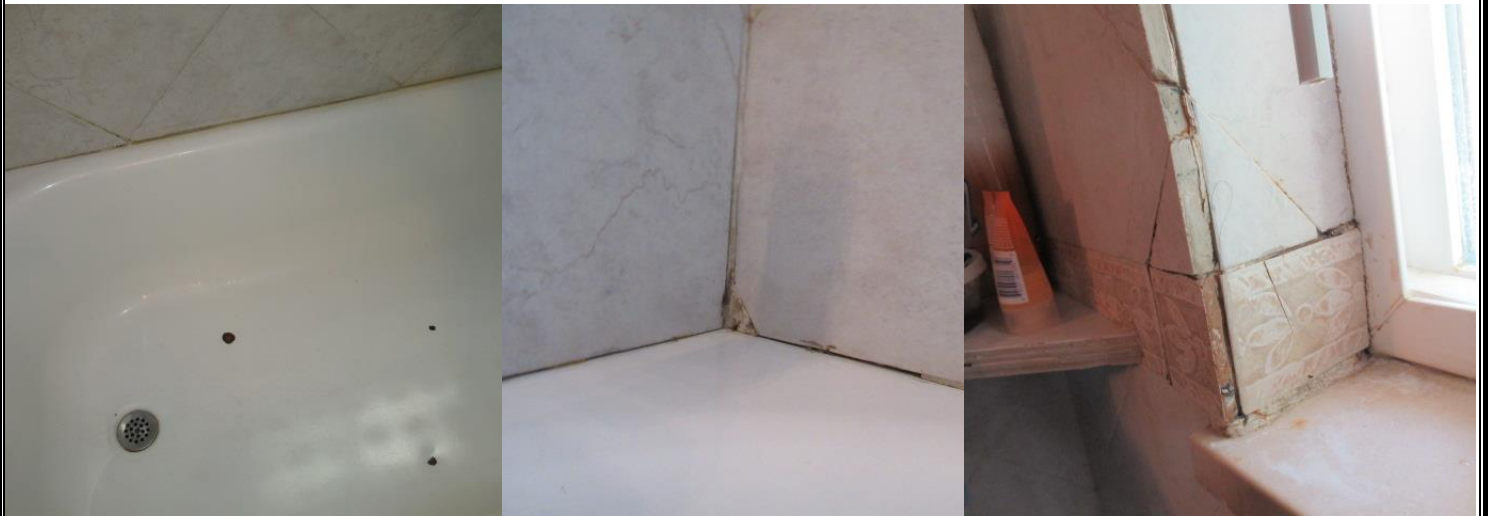
Identifying mold or type or toxicity of mold is not within the scope of this inspection. "Mold-like substance" or "moldy" means that observed substance has the appearance of mold. Damaged/wet wall may have hidden mold/rot inside.
