TF HOME INSPECTION
9084633423
tfhomeinspectionllc@gmail.com
<https://www.tfhomeinspection.com>

TFHI RESIDENTIAL REPORT

1234 Main St. Union NJ 07083

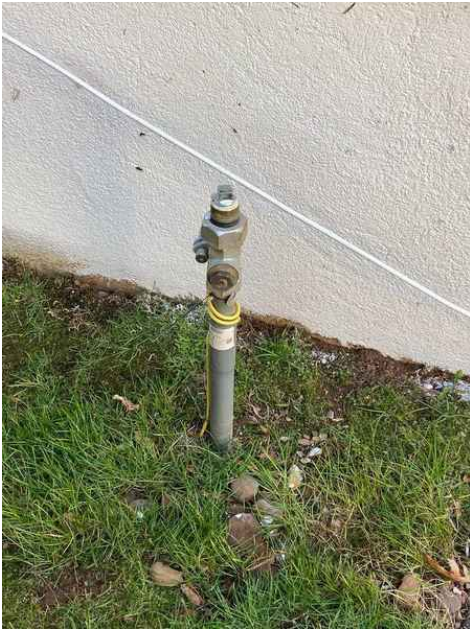
GAS METER NOT INSTALLED

All gas appliances, systems and features were unable to be used or inspected at the time of inspection.

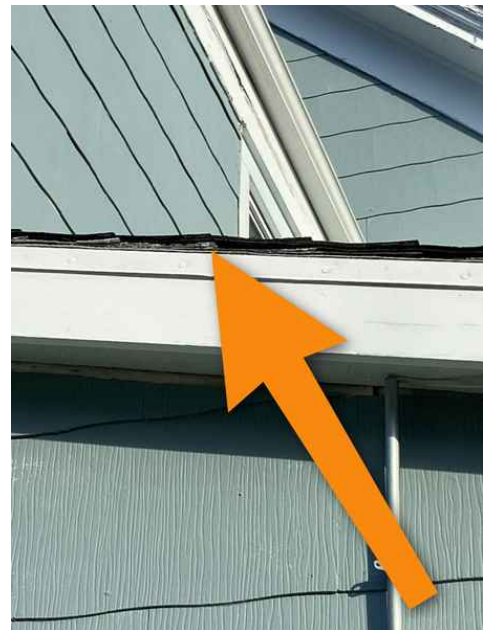
While it is common and permitted to have two layers of roofing, multiple layers of roofing can accelerate deterioration of the roofing materials, as well as add excess weight to the structure. The expected life expectancy for a roof is commonly 25 years, and a second layer can expect a 15-20 year additional life expectancy. The roof should be monitored

Evaluate or Monitor

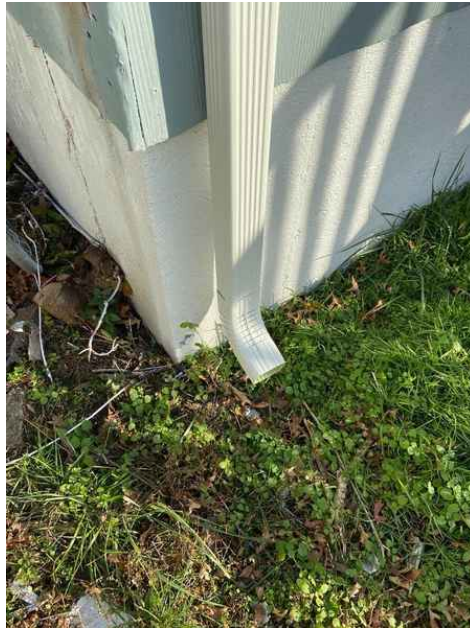
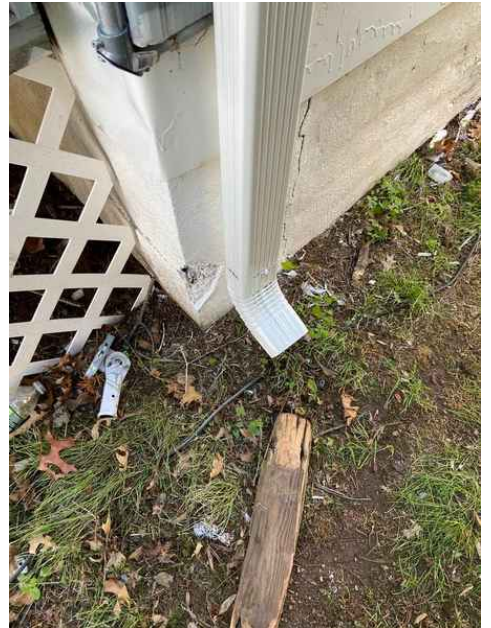
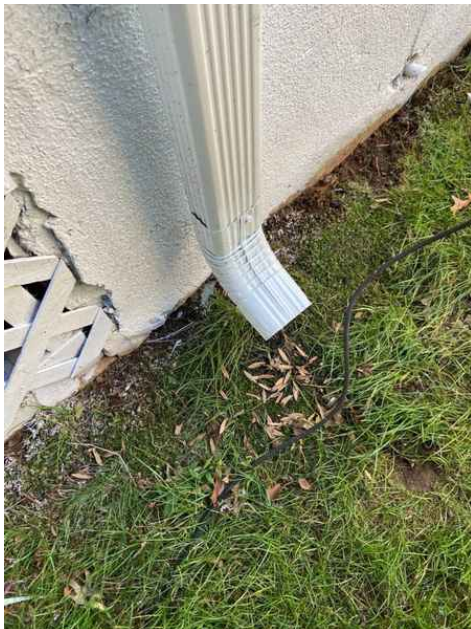
The downspouts need an extension and or a buried drain line to carry water away from the home at the front, rear and sides of home. Having the downspouts terminate at such a short distance can allow for water to penetrate the basement during heavy rain. This can cause damage to the interior finishes of the basement and the foundation. I recommend a qualified licensed contractor repair or replace as needed.

Contact a qualified gutter contractor

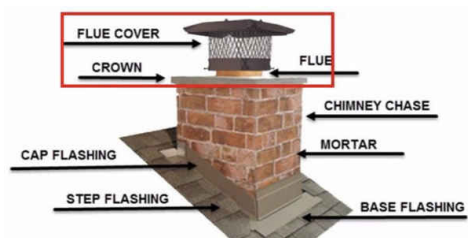
CHIMNEY RAIN CAP MISSING

A chimney rain cap is missing on the chimney. A rain cover on top of a chimney flue is designed to keep out rain (which can damage the flue or appliances it vents) and intended to reduce downdrafts in the chimney in windy conditions. A qualified licensed contractor should repair and replace as needed.

Contact a qualified chimney contractor.

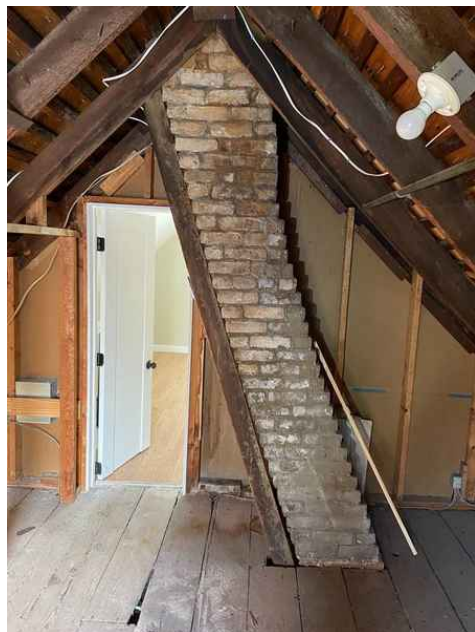
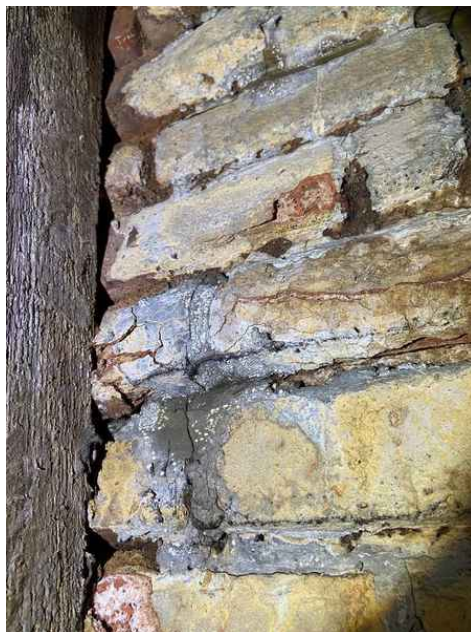
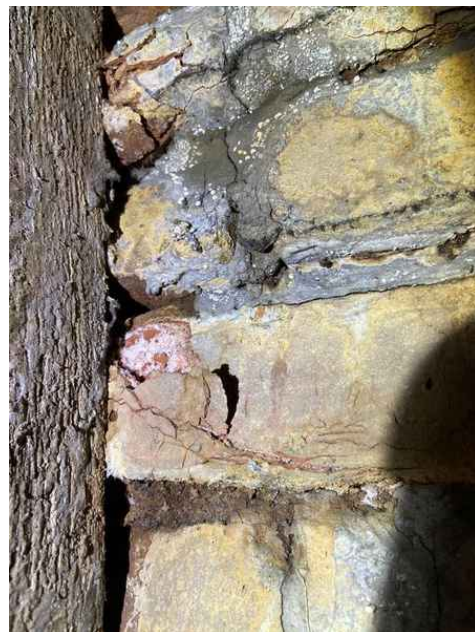
2.4.2 Skylights, Chimneys & Other Roof Penetrations

CHIMNEY REPOINT NEEDED

Joints in the masonry have deteriorated and should be repointed. Repointing is the restoration of the mortar joints in the masonry. A qualified licensed contractor should repair and replace as necessary.

Repair and Replace

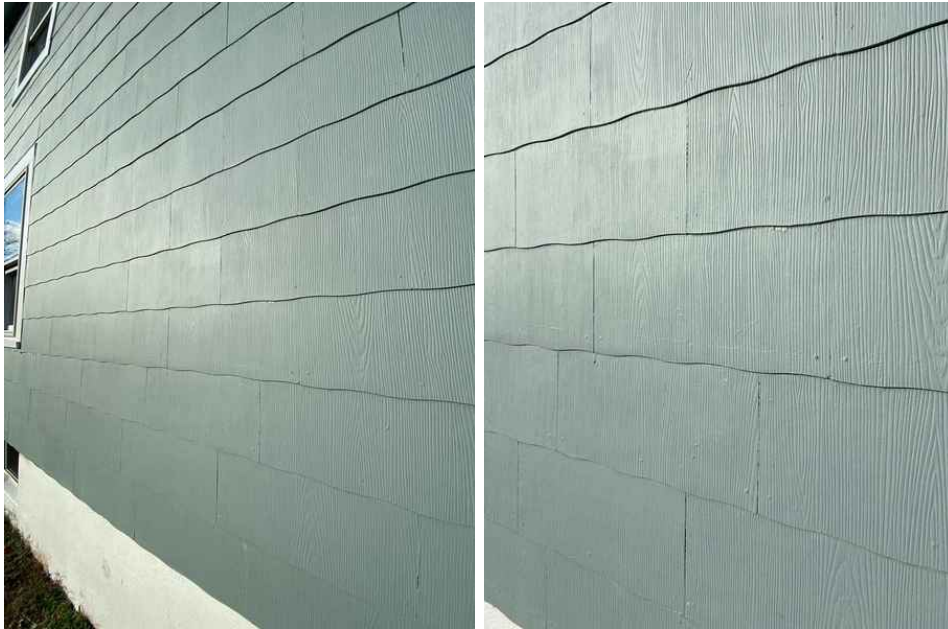
The wall covering of the home appeared to be an older material that could potentially contain asbestos. Asbestos, when disturbed, is a health hazard to breath. A qualified licensed asbestos testing company should assess and test as necessary, before any work is performed as fas as removal or disturbance of the material.

Contact a qualified professional.

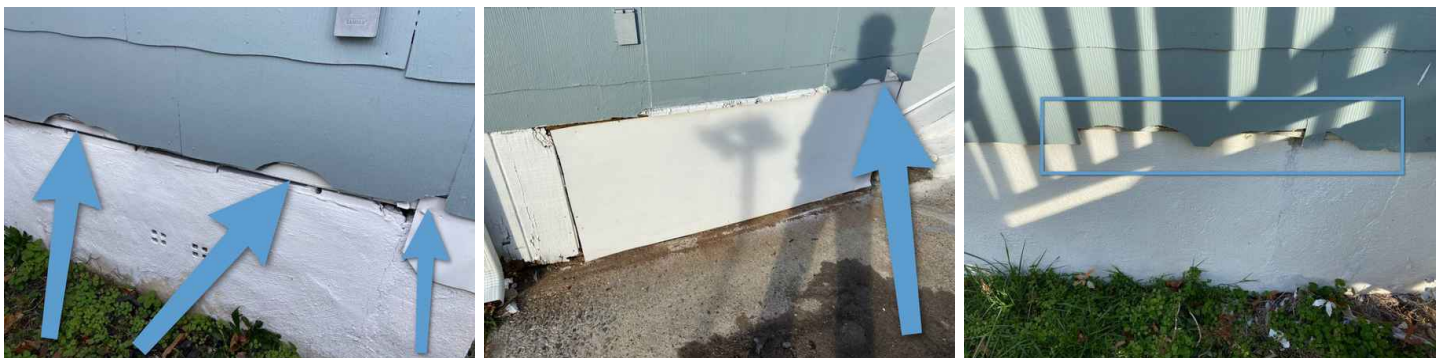
3.1.2 Wall Covering, Flashing & Trim

DAMAGE

Damage to the wall covering was observed at the time of inspection. This is unsightly, and also can allow moisture to penetrate the covering and damage interior finishes of the home. A qualified licensed professional should repair and replace and seal all areas as necessary.

Contact a qualified siding specialist.

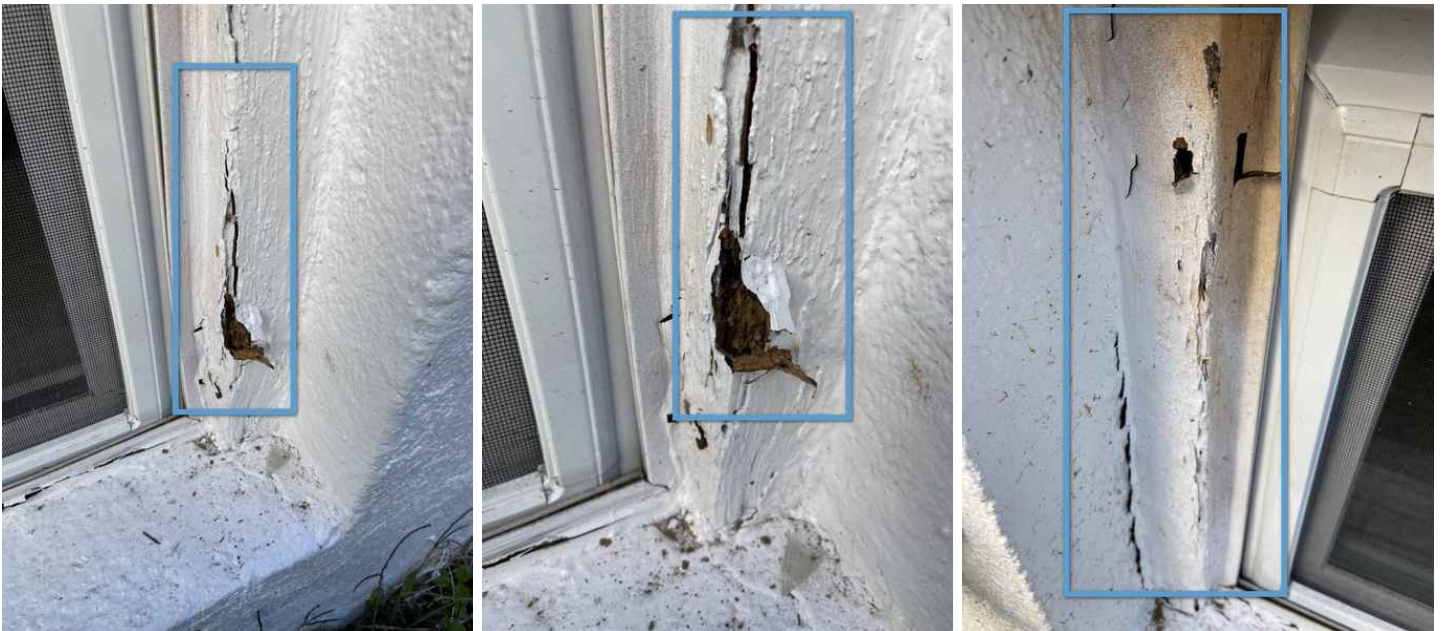
3.3.1 Exterior Windows

WINDOW TRIM TERMITE DAMAGE

The basement window trim was observed to show signs of termite damage. A qualified licensed pest control company should evaluate and advise as necessary for treatment.

Contact a qualified pest control specialist.

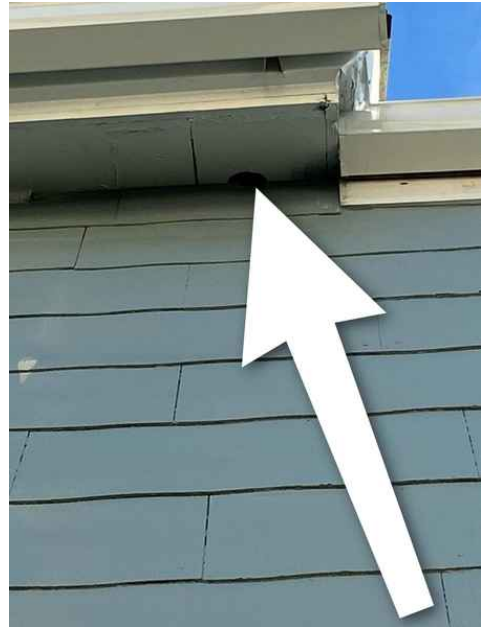
3.5.1 Eaves, Soffits & Fascia

SOFFIT - DAMAGED

One or more sections of the soffit are damaged. This can allow moisture or pest penetration into the home. A qualified licensed contractor should repair and replace as necessary.

Contact a qualified roofing professional.

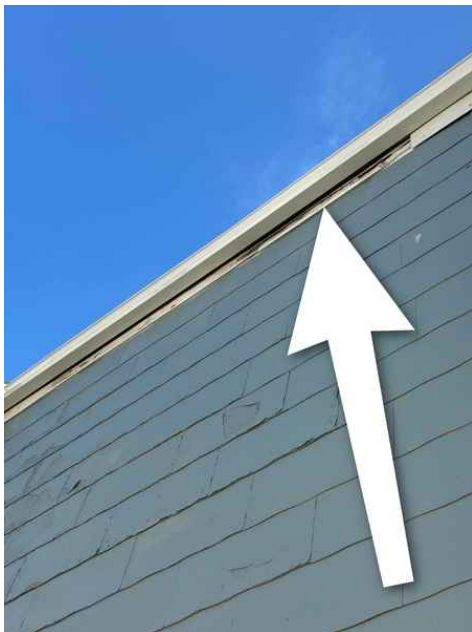
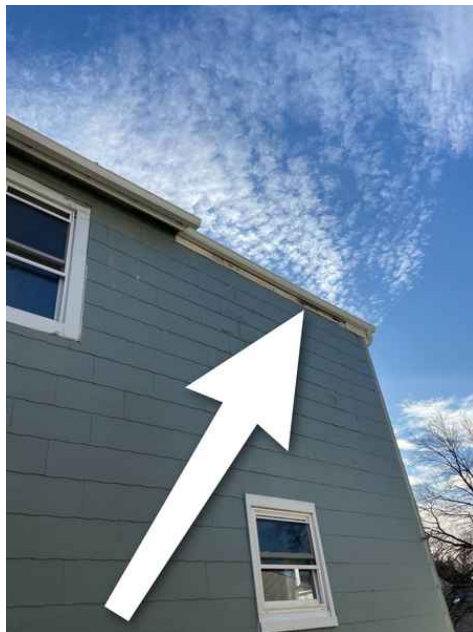
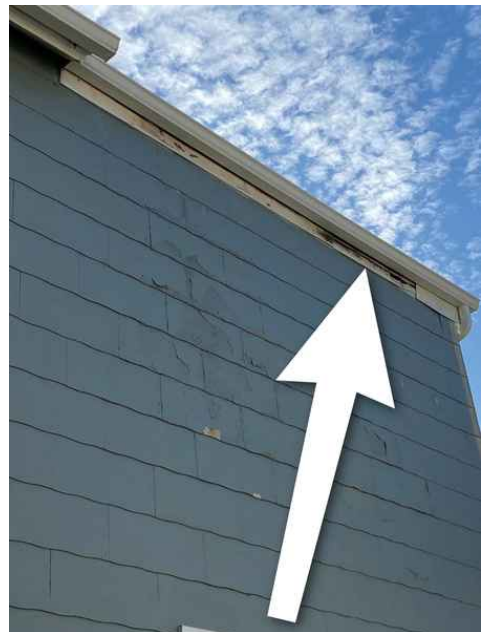
3.5.2 Eaves, Soffits & Fascia

FASCIA FLASHING MISSING

Areas of the aluminum flashing for the fascia are missing. This is a maintenance issue that will prevent water intrusion causing damage and rot. A qualified licensed contractor should repair and replace as necessary.

Contact a qualified professional.

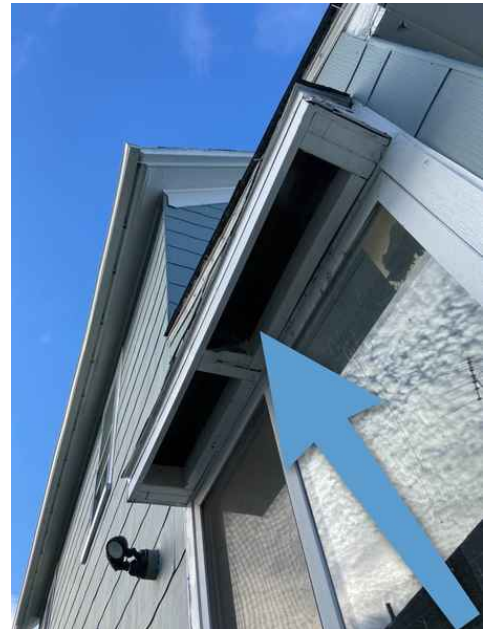
3.5.3 Eaves, Soffits & Fascia

SOFFIT MISSING

One or more sections of the soffit are missing. This can allow pest intrusion into the roof structure of the home and water penetration causing rot and damage. A qualified licensed contractor should repair and replace as necessary.

Contact a qualified roofing professional.

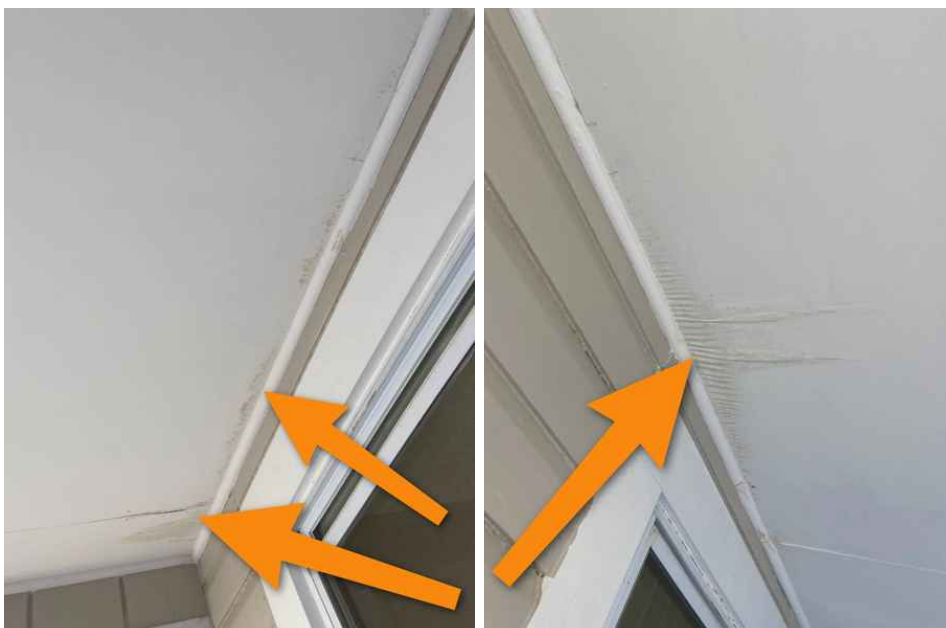
MOISTURE DAMAGE

Stains on the ceiling visible at the time of the inspection appeared to be the result of moisture intrusion. Recommend further examination by a qualified contractor to evaluate if this is an active leak, or the problem has been resolved. Furthermore, a qualified licensed contractor should repair and replace the damaged wall as necessary.

Contact a qualified professional.

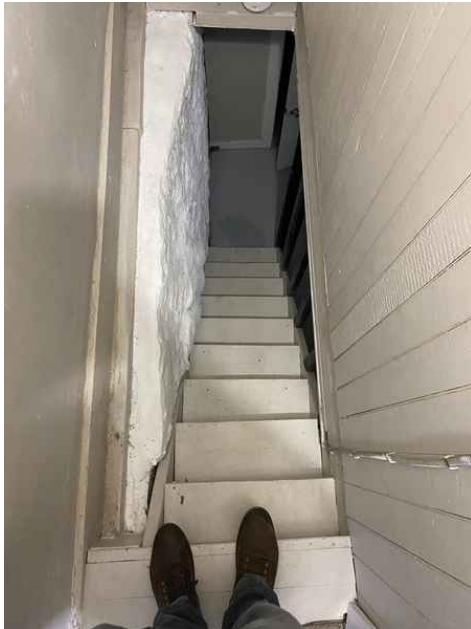
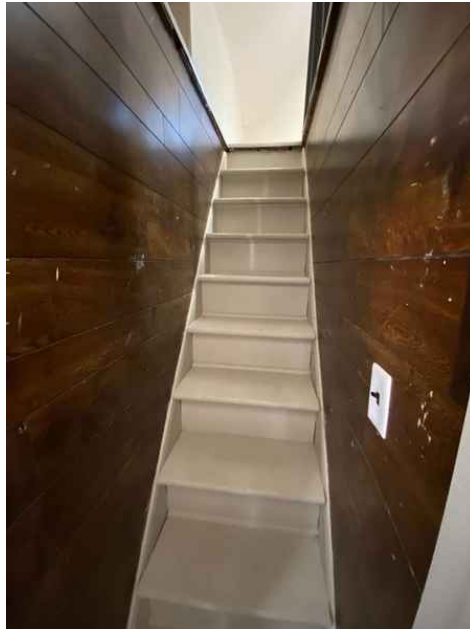
4.4.1 Steps, Stairways & Railings

NO HANDRAIL

Staircases had no handrails. This is a safety hazard. A qualified licensed contractor should evaluate, repair, and replace as necessary.

Contact a qualified carpenter.

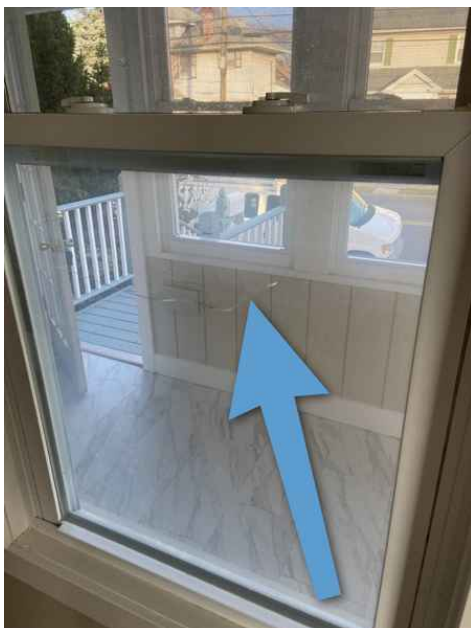
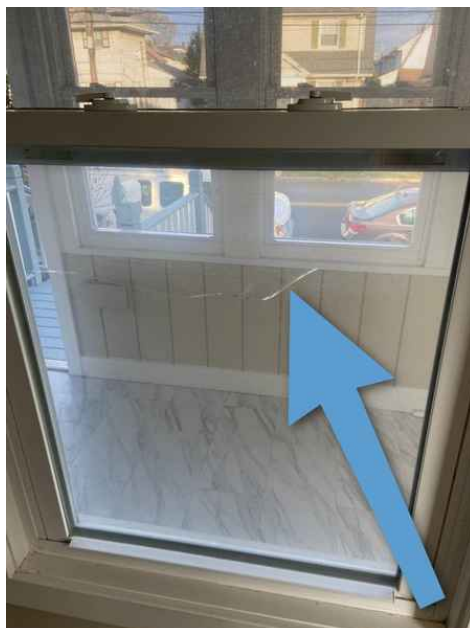
4.5.1 Windows (representative number)

DAMAGED

Window was cracked. A qualified licensed professional should replace as necessary.

Contact a qualified window repair/installation contractor.

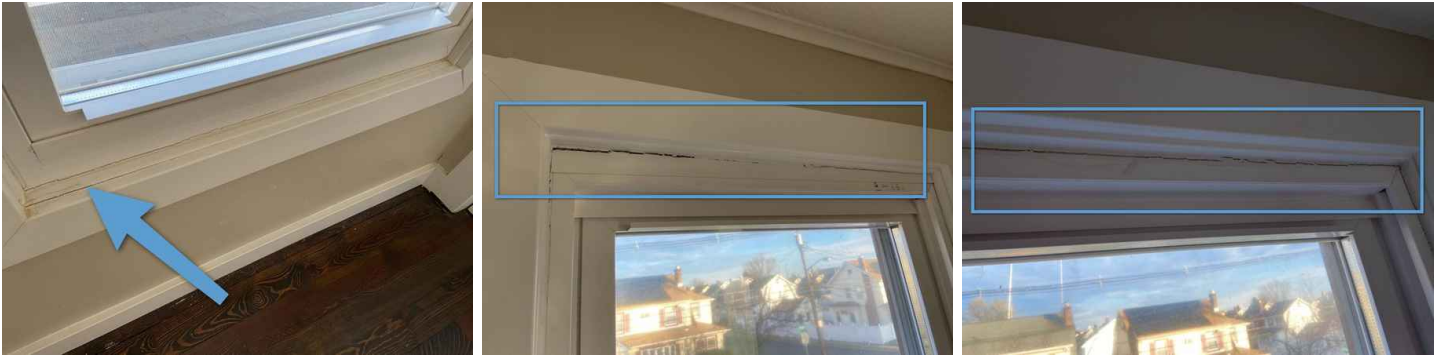
4.5.2 Windows (representative number)

CAULKING/PAINTING

Windows trim was in need of maintenance painting/caulking in areas. This is a maintenance issue. A qualified licensed professional should repair and replace as necessary.

Recommendation
Contact a qualified professional.

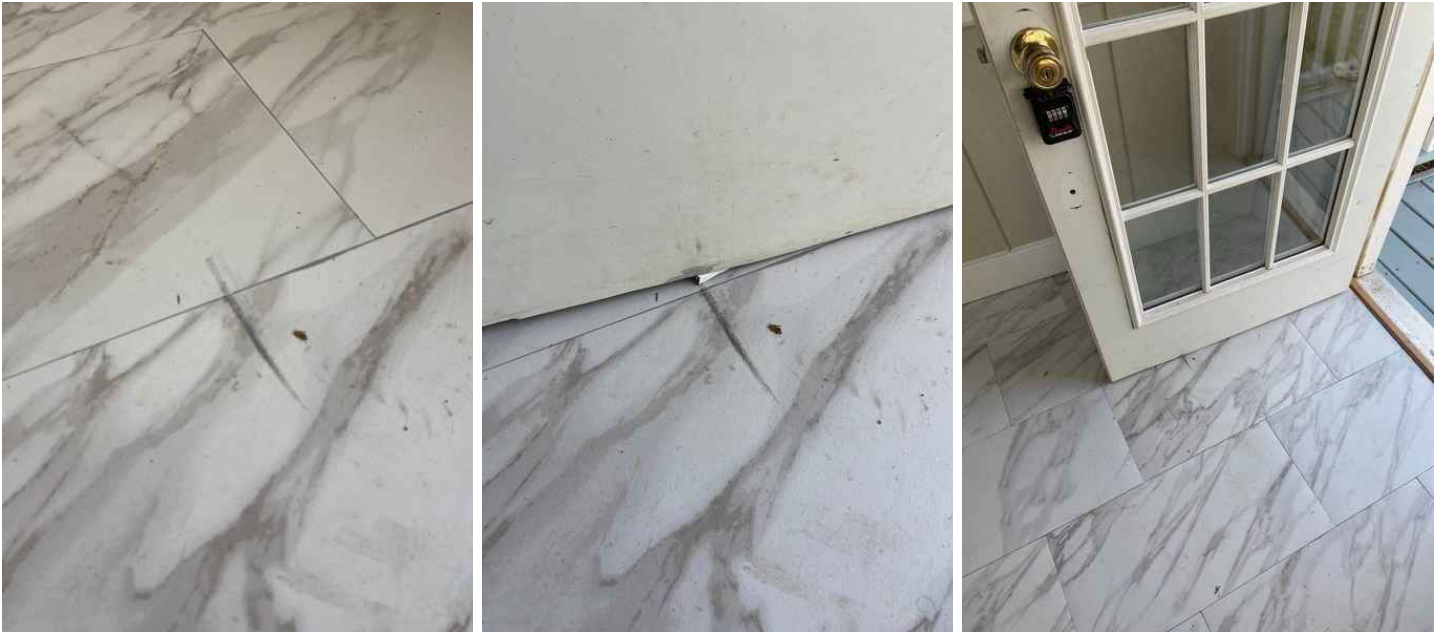
4.6.1 Doors (representative number)

DOOR CONTACTS GROUND

The front entrance door when swung open makes contact with the ground and has damaged the tile/the bottom of the door. This is in need of adjusting. A qualified licensed professional should repair and replace as necessary.

Recommendation
Contact a qualified professional.

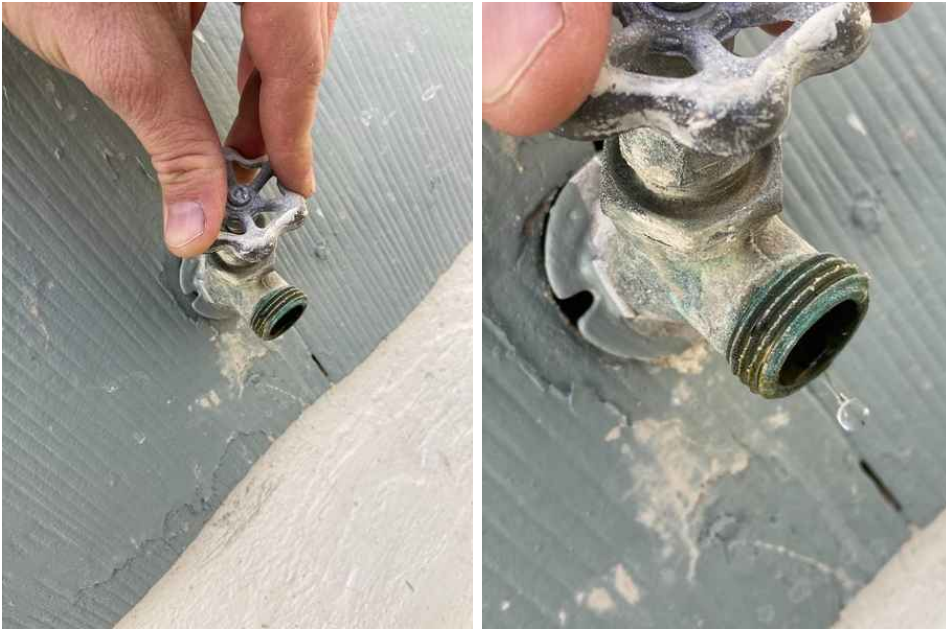
EXTERIOR SPIGOT LEAKING

The exterior spigot was leaking. This will waste water and put excessive water at the foundation exterior. A qualified licensed professional must repair and replace.

Contact a qualified professional.

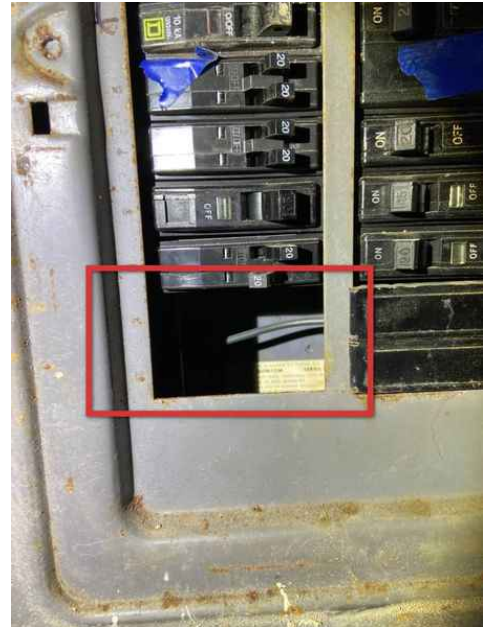
6.2.1 Main & Subpanels, Service & Grounding, Main Overcurrent Device

EMPTY BREAKER COVER MISSING

Contact a qualified electrical contractor.

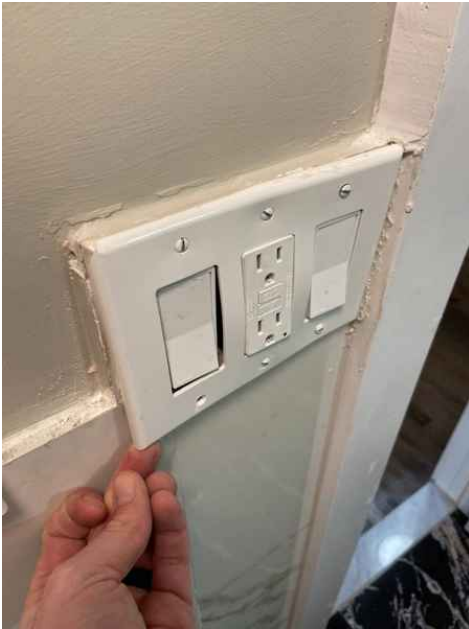
6.3.1 Branch Wiring Circuits, Breakers & Fuses

NEUTRAL DOUBLE TAP

Safety Hazard

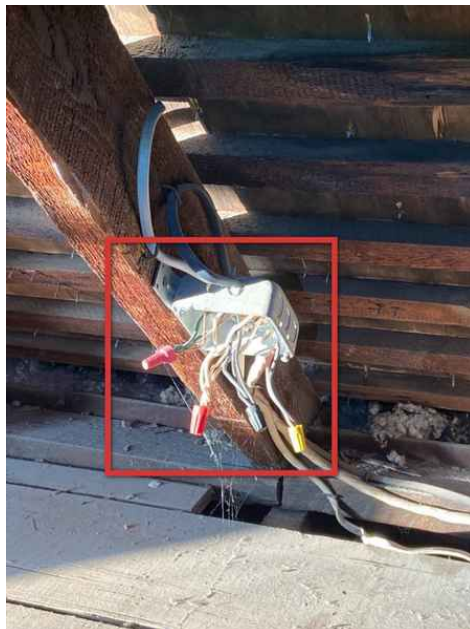
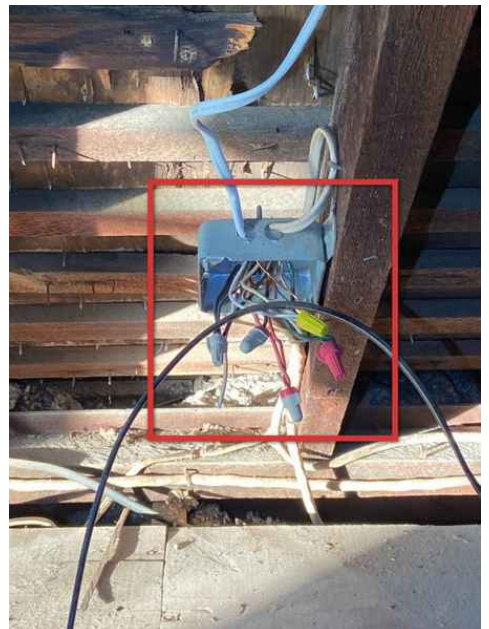
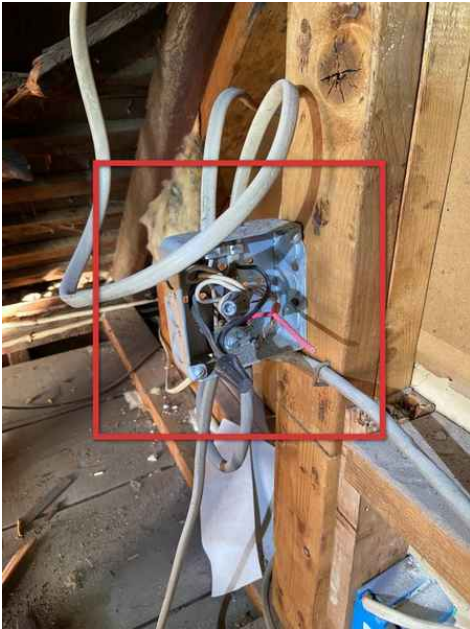
6.4.2 Lighting Fixtures, Switches, Wiring & Receptacles

EXPOSED WIRING CONNECTIONS

Contact a qualified electrical contractor.

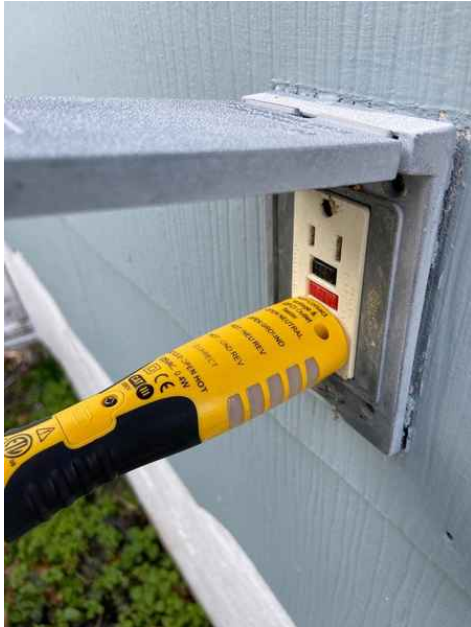
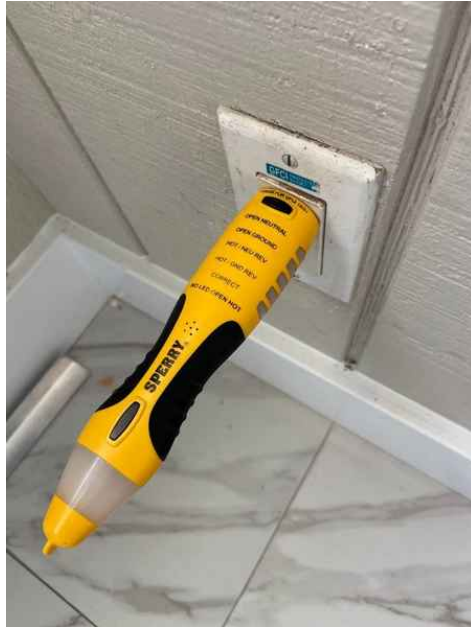
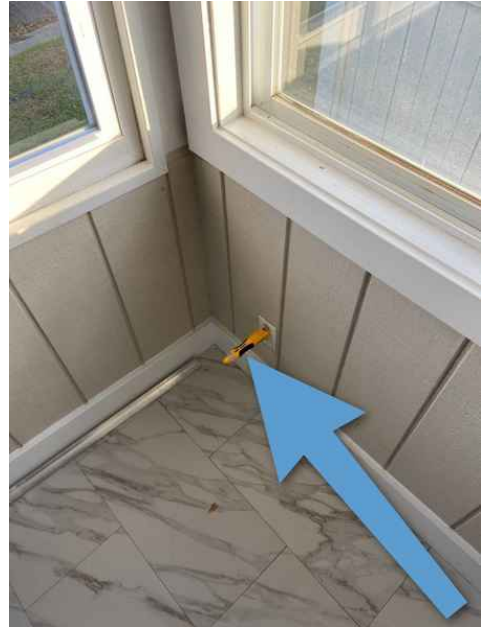
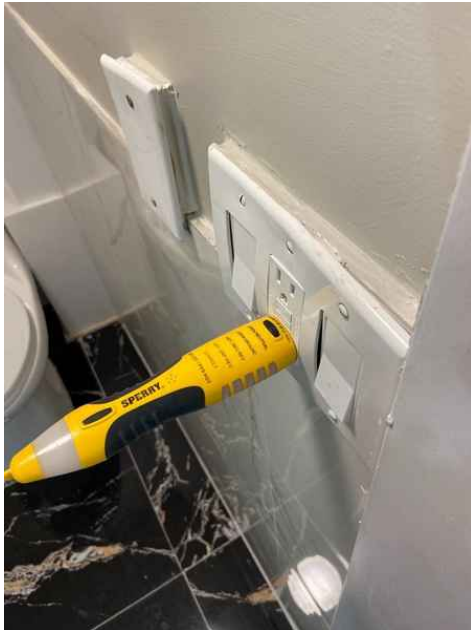
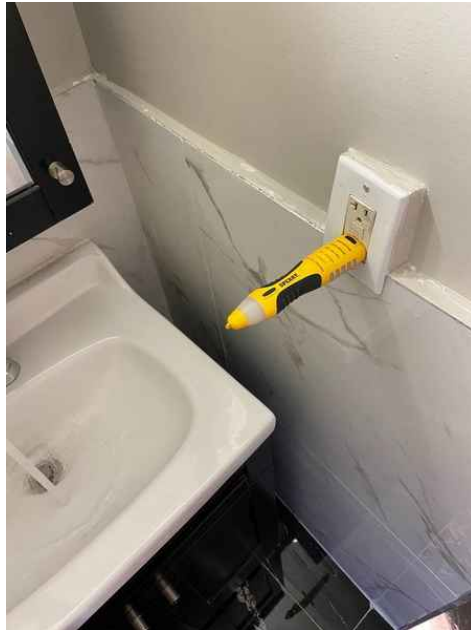
6.4.5 Lighting Fixtures, Switches, Wiring & Receptacles

NO POWER AT RECEPTACLES

Contact a qualified electrical contractor.

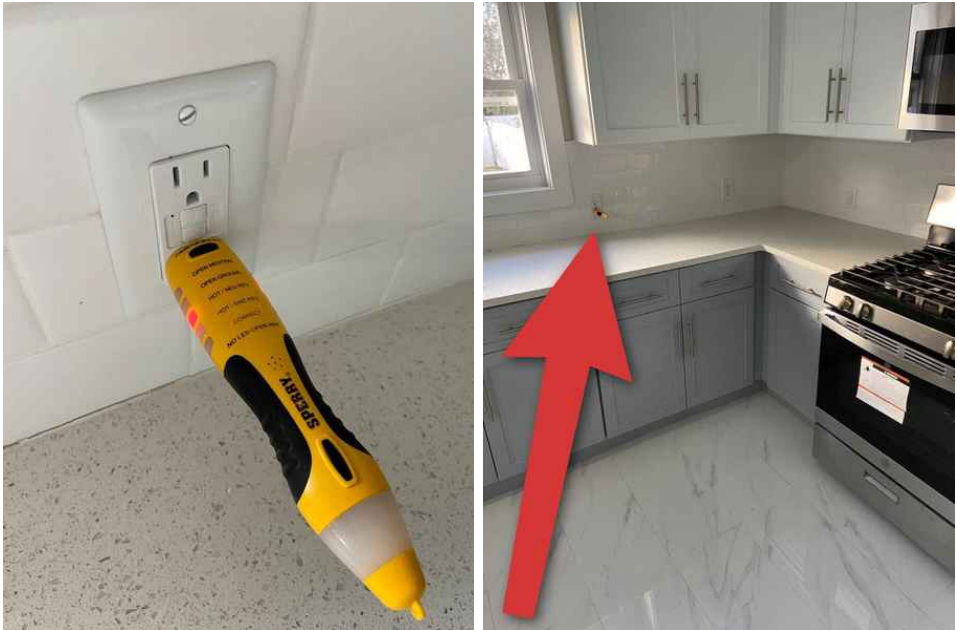
6.5.1 GFCI & AFCI

GFCI IMPROPERLY WIRED

I observed a defect at the GFCI outlet. It was not properly wired. This is a safety hazard. A qualified licensed electrician should evaluate, repair and replace as necessary.

Recommendation
Contact a qualified electrical contractor.

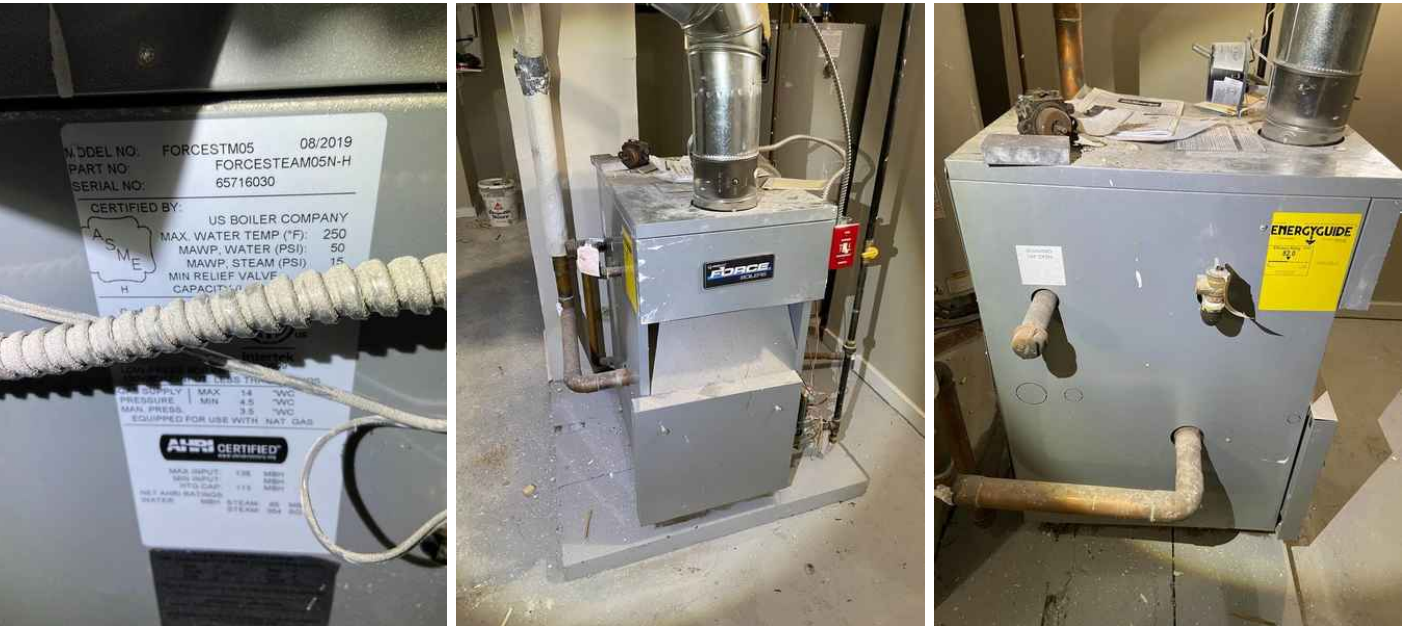
Equipment: Unit
Force

The heating system was manufactured in 2019. The serial number is (Please see image) and model number is (Please see image) and has a 40 year life expectancy.

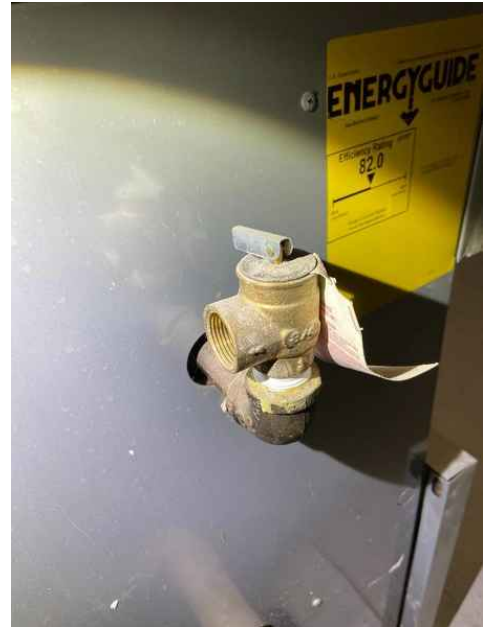
The Pressure Relief valves need to be extended down to at least 6 inches from the ground. This is a safety precaution if the system has a pressure issue and releases extremely hot water. A qualified licensed professional should repair and replace as necessary.

Contact a qualified plumbing contractor.

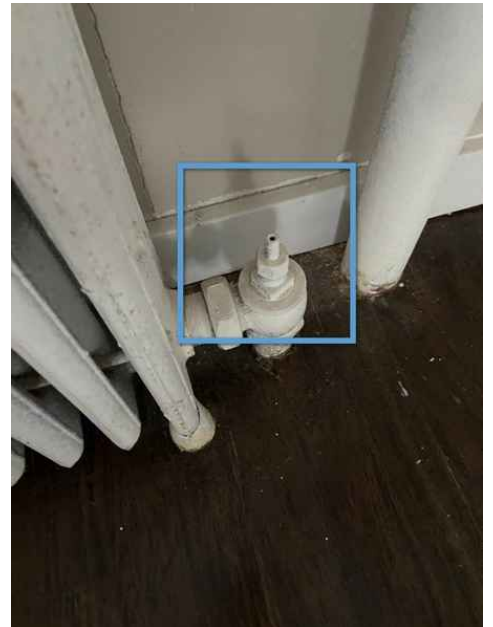
7.5.1 Distribution Systems

VALVE DAMAGED

One or more valves were observed to be damaged. This allows for the radiator to be opened/closed to control the heat distribution. A qualified licensed professional should repair and replace as necessary.

Contact a qualified plumbing contractor.

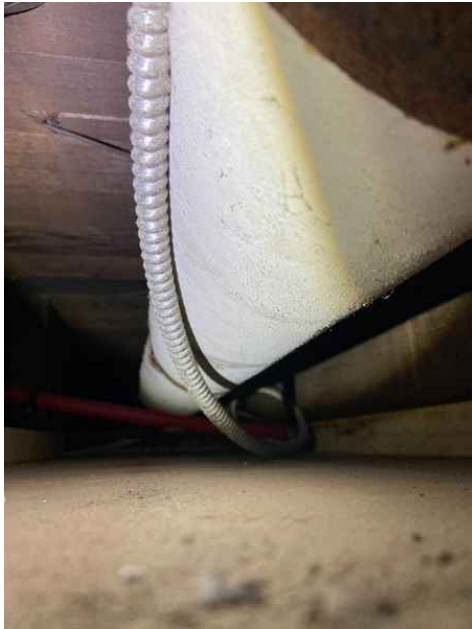
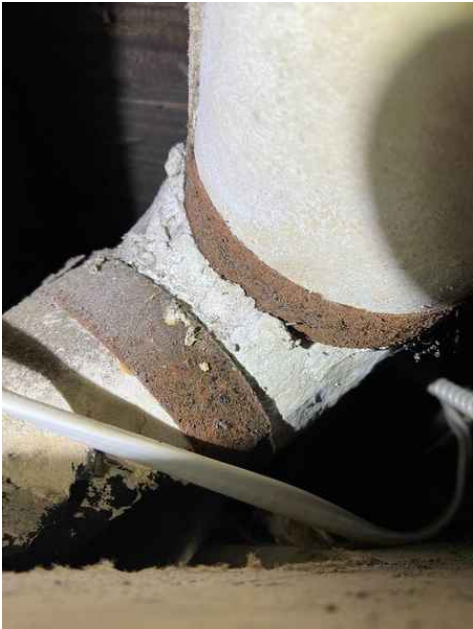
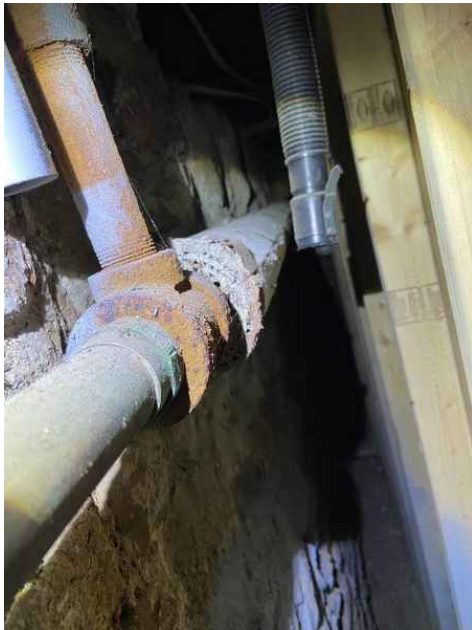
7.5.2 Distribution Systems

POSSIBLE ASBESTOS CONTAINING INSULATION ON PIPING

Insulation of the steam heat supply piping was an older material in areas of the unfinished basement. Material of this type and age, could possibly contain asbestos, and is a health hazard when disturbed. A qualified licensed professional should remove the old insulation, and reinstate with newer modern insulation.

Contact a qualified professional.

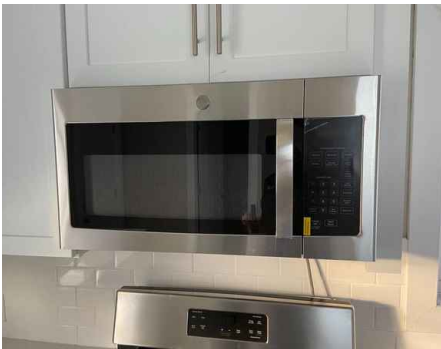
Built-in Microwave: Operational

The microwave was operational at the time of inspection.

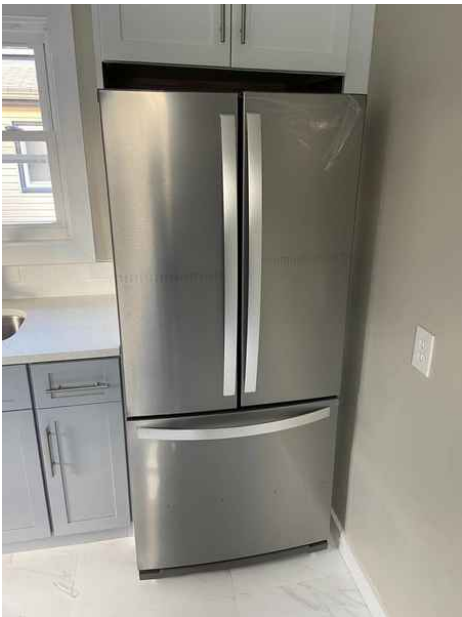
Refrigerator: Operational

The refrigerator was operational at the time of the inspection.

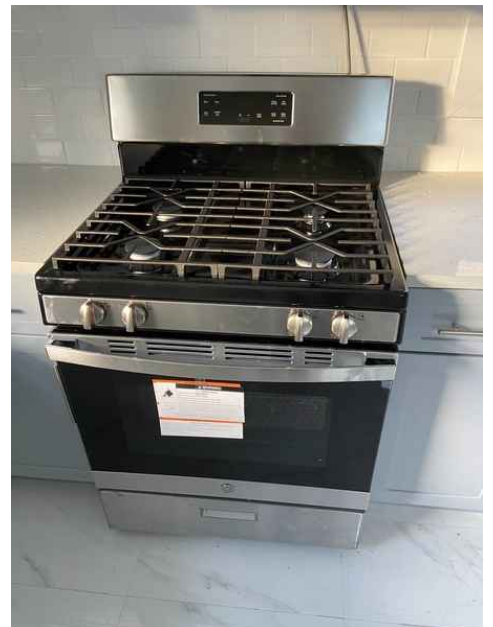
NOT PLUGGED IN AND GAS TURNED OFF AT OVEN

The oven was not plugged in and the gas was turned off

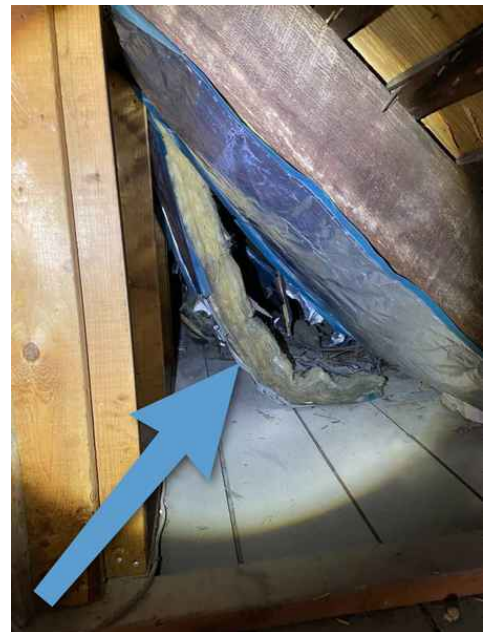
LOOSE INSULATION

Contact a qualified insulation contractor.

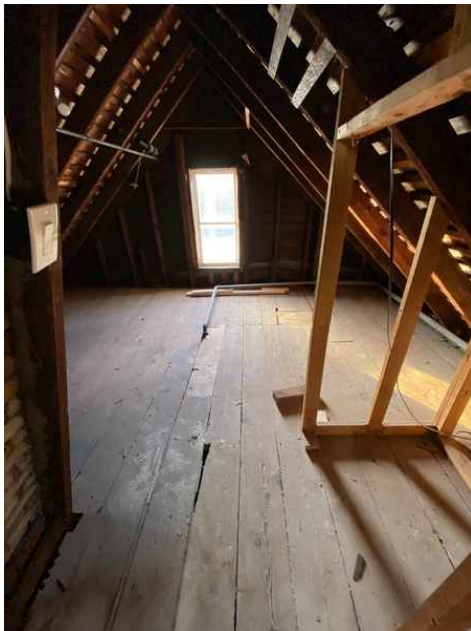
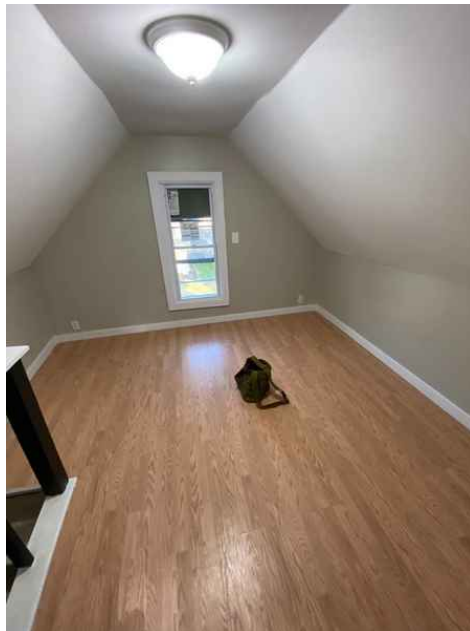
9.6.1 Ventilation (Attic and Foundation Areas)

ATTIC VENTILATION INSUFFICIENT

Contact a qualified insulation contractor.

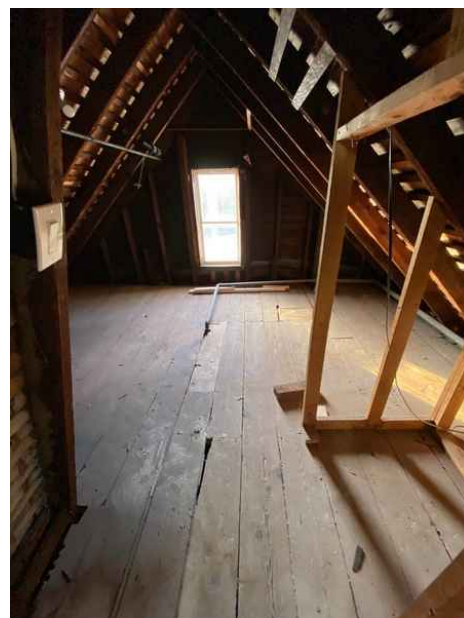
Roof Structure & Attic: Material

Plywood, Wood

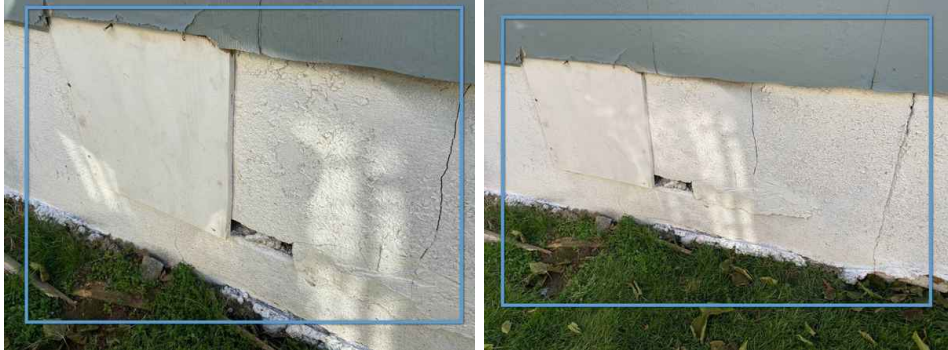
10.1.2 Foundation

TERMITE MUD TUBES

Contact a qualified professional.

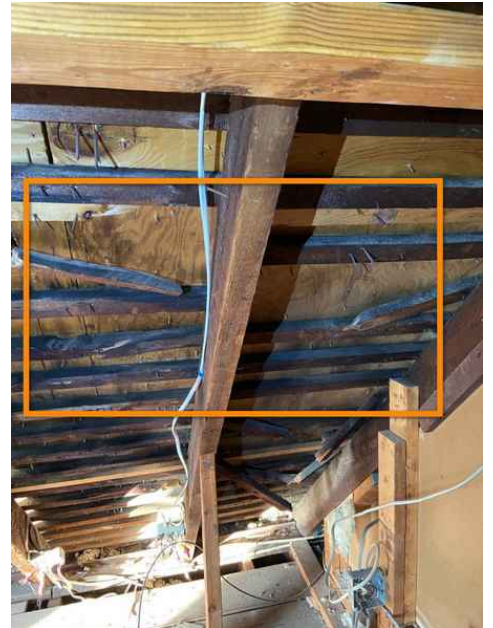
10.7.1 Roof Structure & Attic

DAMAGED NAILING STRIPS

Contact a qualified professional.
