TFHI RESIDENTIAL REPORT

1234 Main St. Union NJ 07083

Buyer Name
12/07/2020 9:00AM

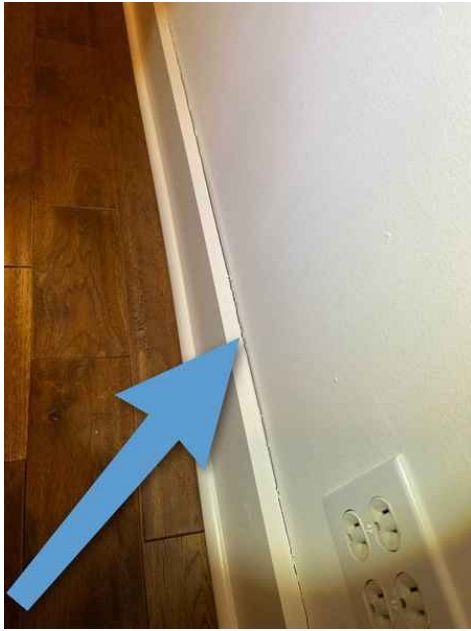
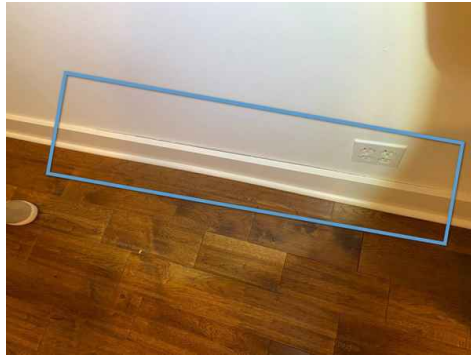
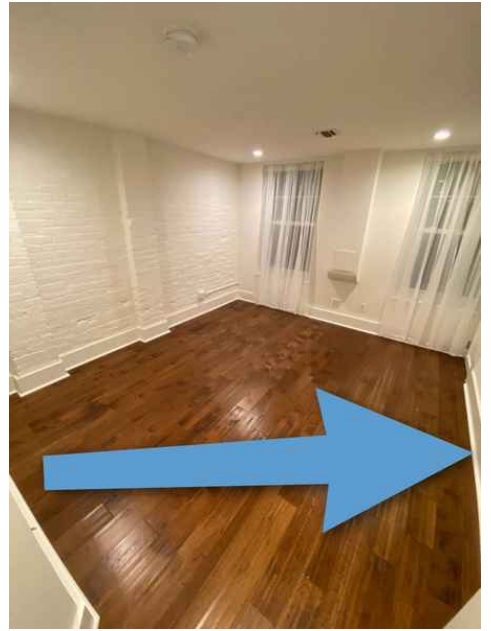
2.2.1 Walls

AREAS IN NEED OF PATCHING/PAINTING

There were areas on the walls noted in the home in need of painting/patching. This is a cosmetic issue. A qualified licensed professional should paint and patch any areas in need and as necessary.

Contact a qualified carpenter.

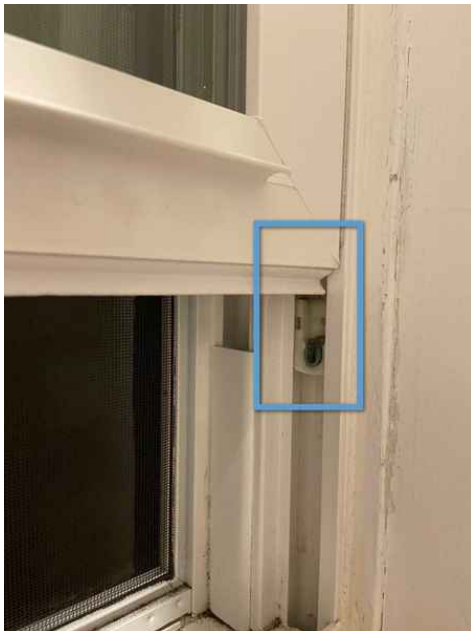
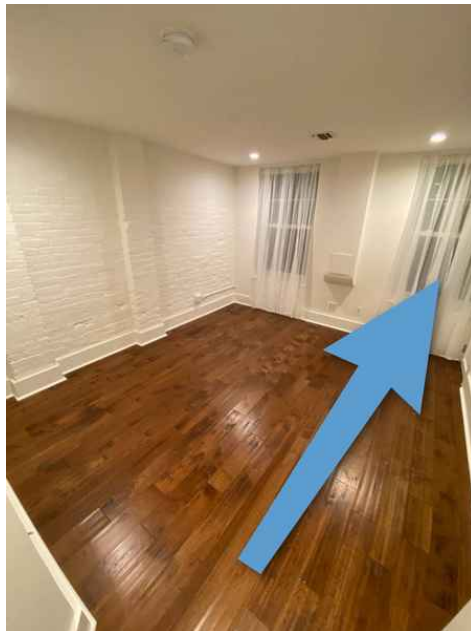
2.5.1 Windows (representative number)

DAMAGED

One or more windows appears to have general damage and an opening component was loose and disconnected. A qualified licensed professional should clean, lubricate & adjust as necessary.

Contact a qualified window repair/installation contractor.

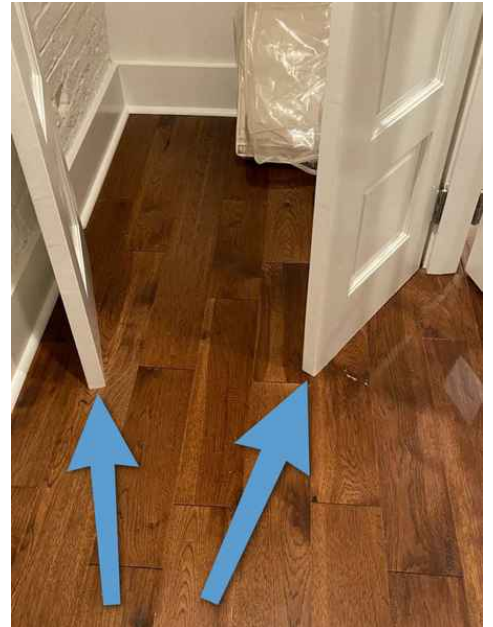
2.6.1 Doors (representative number)

DOOR CONTACTS GROUND

The closet doors when swung open makes contact with the ground. This is in need of adjustment, and has scraped the floor. A qualified licensed professional should repair and replace as necessary.

Contact a qualified carpenter.

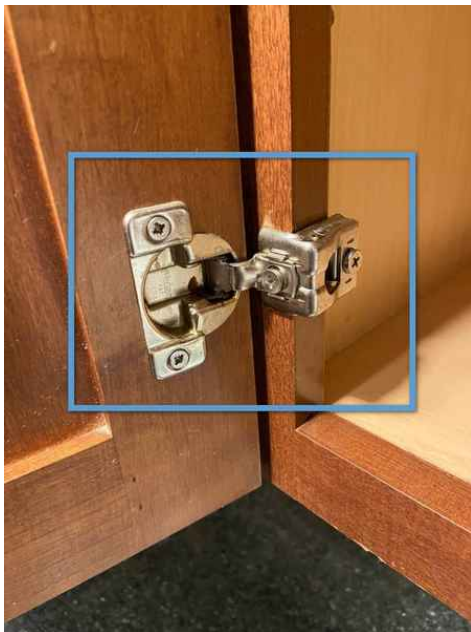
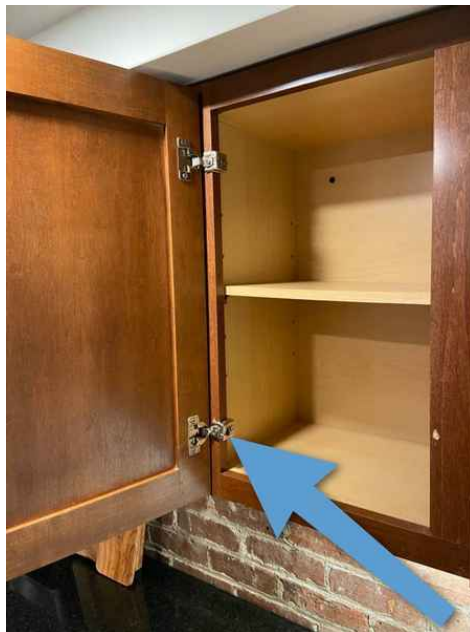
2.8.1 Countertops & Cabinets (representative number)

CABINET HINGE LOOSE

One or more cabinet hinges were loose at the time of the inspection. This is a maintenance issue. A qualified licensed contractor should repair and replace as necessary.

Contact a qualified carpenter.

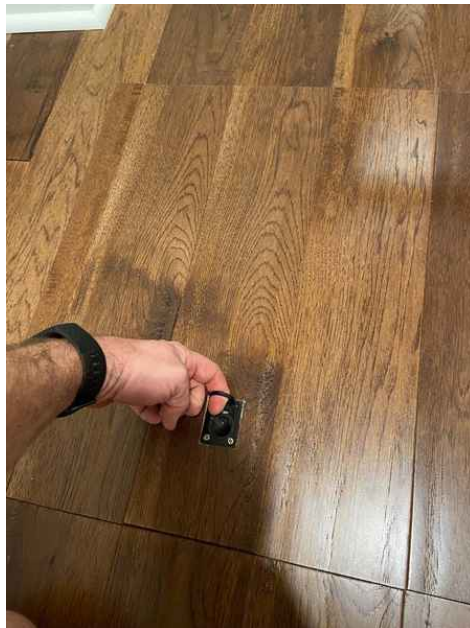
3.8.1 Sump Pump

SUMP PUMP CAP UNABLE TO BE LIFTED

**Safety Hazard**

The cap over the sump pump was stuck and unable to be pulled open. This is also a trip hazard due to the unevenness of how the door sits along the floor. A qualified licensed professional should repair and replace so the door sits flush.

Contact a qualified professional.

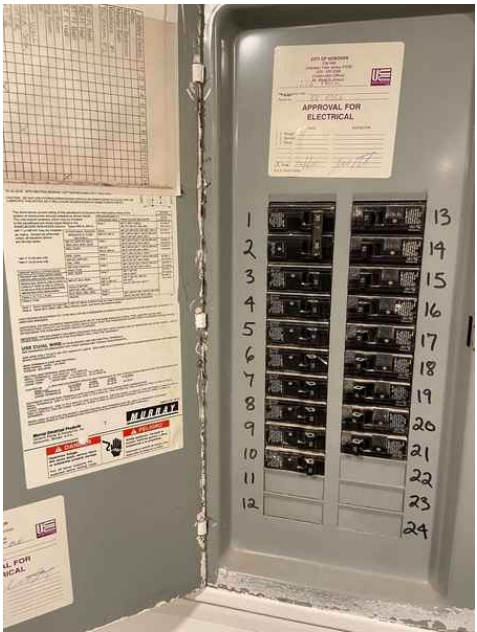
4.2.1 Main & Subpanels, Service & Grounding,
Main Overcurrent Device

MISSING LABELS ON PANEL

At the time of inspection, panel was missing labeling. This is done to identify which breakers are responsible for the homes electrical power sources. A qualified licensed electrician should identify and map out locations on the panel clearly.

Contact a qualified electrical contractor.

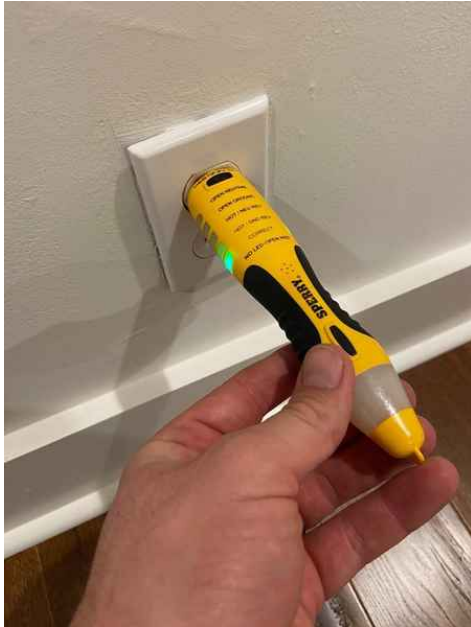
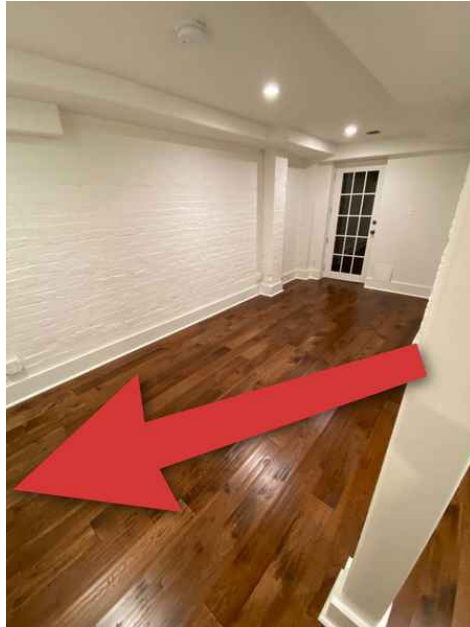
4.4.1 Lighting Fixtures, Switches, Wiring & Receptacles

**LOOSE RECEPTACLE**

A receptacle in the rear left bedroom was observed to be loose and not secured. This is a safety hazard. A qualified licensed electrician should repair and replace as necessary.

Contact a qualified electrical contractor.

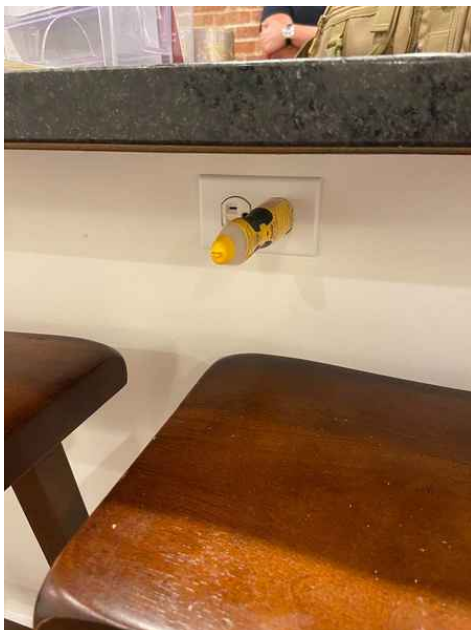
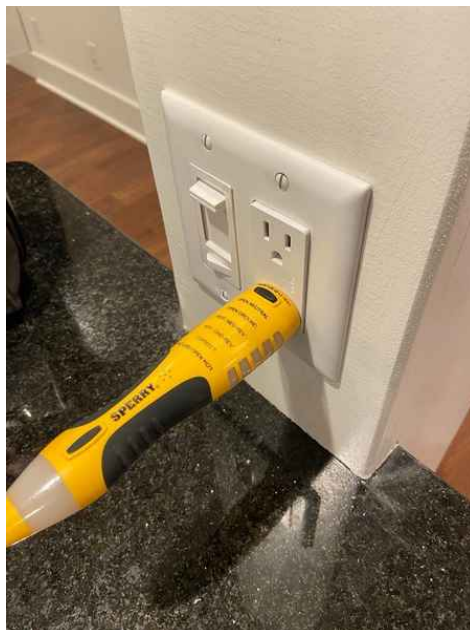
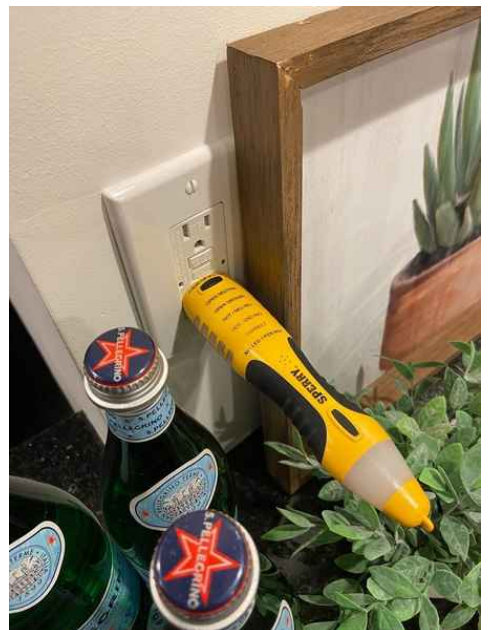
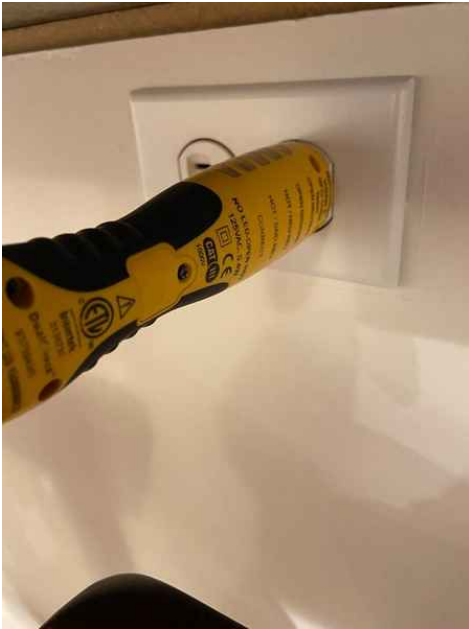
4.4.2 Lighting Fixtures, Switches, Wiring & Receptacles

**NO POWER AT RECEPTACLE**

There was no power noted at all 4 receptacles at the kitchen peninsula. A qualified licensed electrician should repair and replace as necessary.

Contact a qualified electrical contractor.

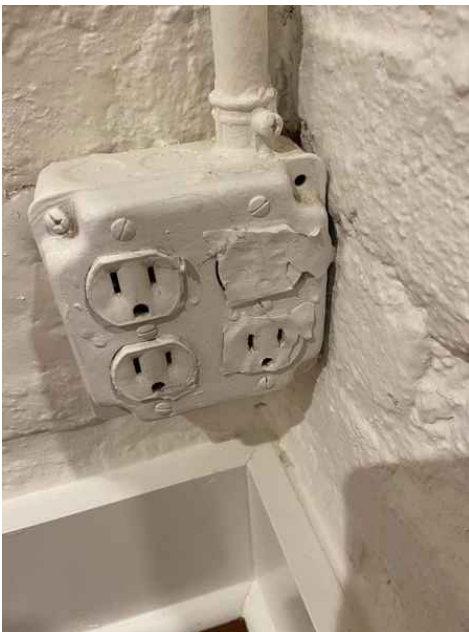
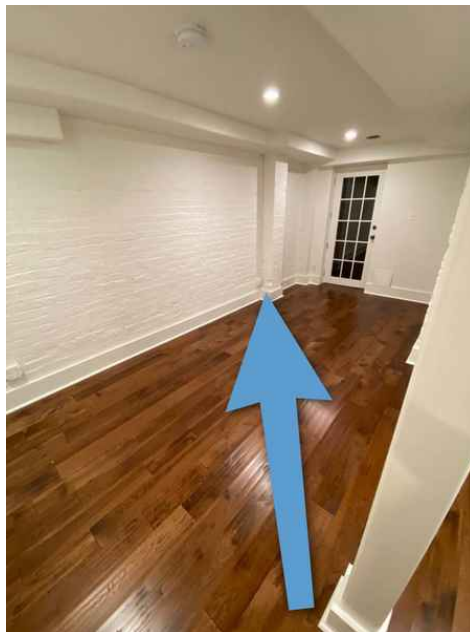
4.4.3 Lighting Fixtures, Switches, Wiring & Receptacles

RECEPTACLES PAINTED OVER

Electrical receptacles are painted over and unable to be tested/used at the time of inspection. This is a maintenance issue. A qualified licensed professional should repair and replace these receptacles as necessary.

Contact a qualified electrical contractor.

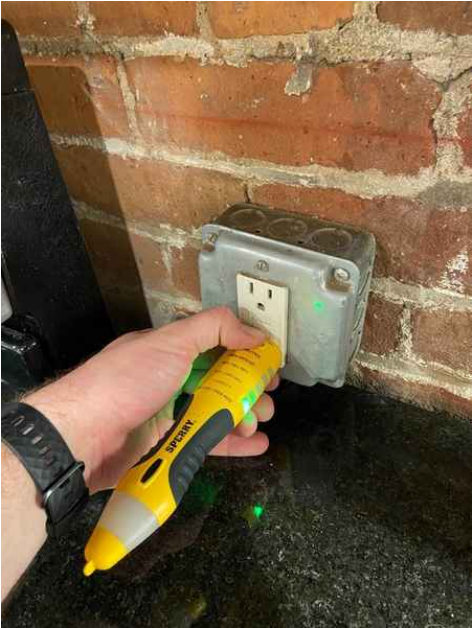
4.5.1 GFCI & AFCI

GFCI NOT TESTING AS FUNCTIONAL

Safety Hazard

KITCHEN

I observed a defect at the GFCI outlet. It was not testing properly. This is a safety hazard. A qualified licensed electrician should evaluate, repair and replace as necessary.

Recommendation
Contact a qualified electrical contractor.

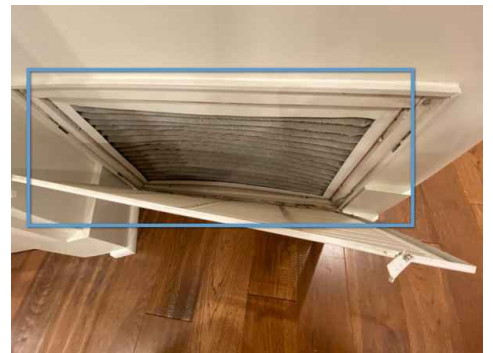
FILTER DAMAGED/DIRTY

The furnace filter was damaged and dirty. Recommend installing a new air filter and changing every 1-3 months. A qualified licensed HVAC professional should also evaluate the system, because running the system without a filter can damage the systems components.

Contact a qualified HVAC professional.

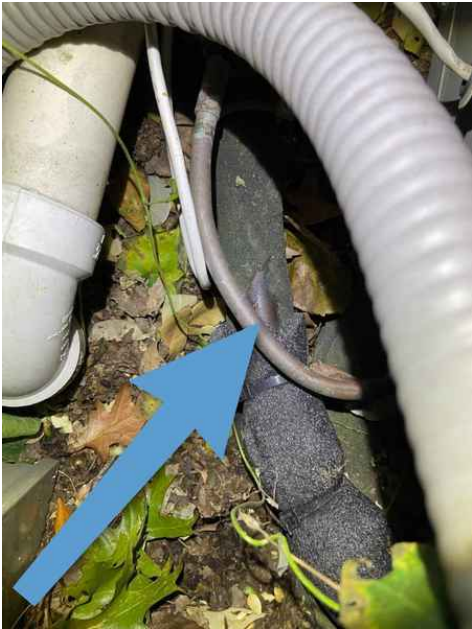
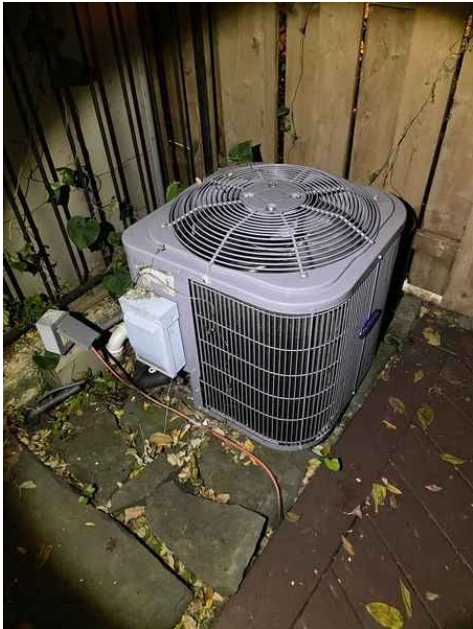
5.2.2 Equipment

INSULATION ON SUCTION LINE DAMAGED/MISSING

The insulation on the suction line was observed to be damaged/missing at the time of inspection.

Insulation on the condensate line helps maintain temperature, as well as prevent condensation. A qualified licensed HVAC professional should evaluate, repair, and replace as necessary.

Contact a qualified HVAC professional.

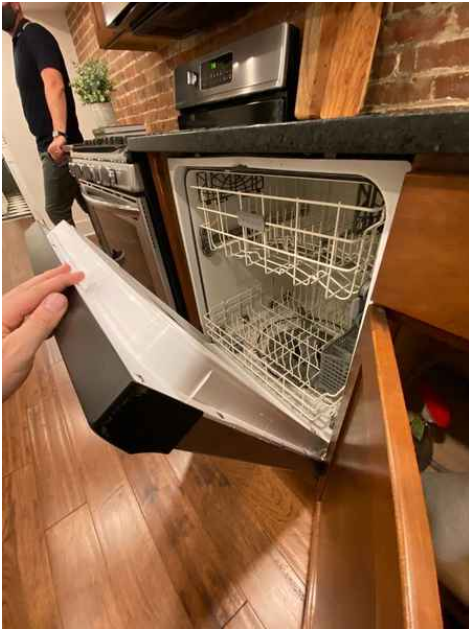
The door on the dishwasher was unable to be fully opened at the time of the inspection. Something was restricting the hinges of the door from fully opening. A qualified licensed professional should evaluate then repair as necessary.

Contact a qualified appliance repair professional.

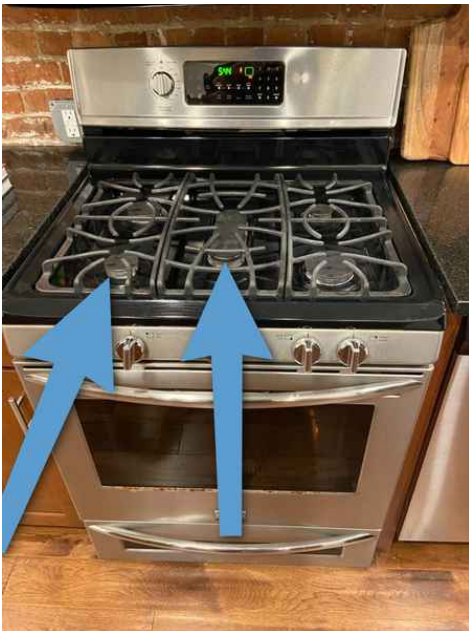
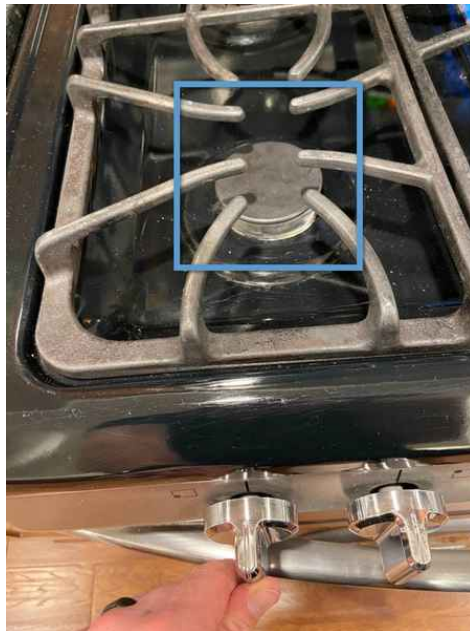
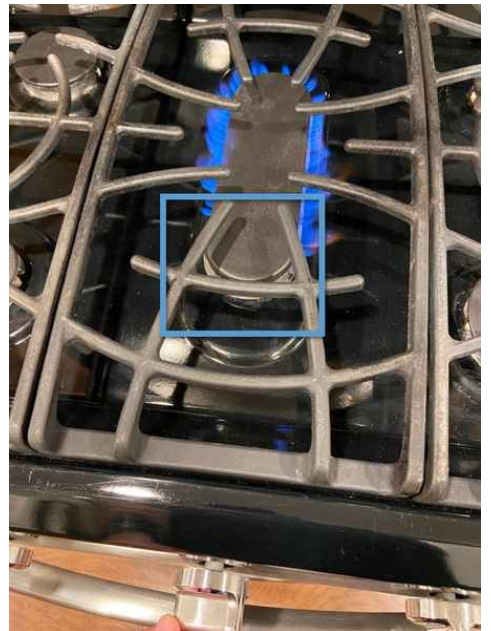
6.3.1 Range/Oven/Cooktop

BURNER NOT LIGHTING

I observed that one or more heating elements did not heat up when turned on. A qualified licensed professional should evaluate, then repair or replacement as necessary.

Contact a qualified appliance repair professional.

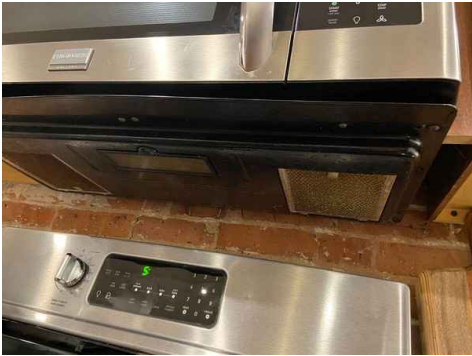
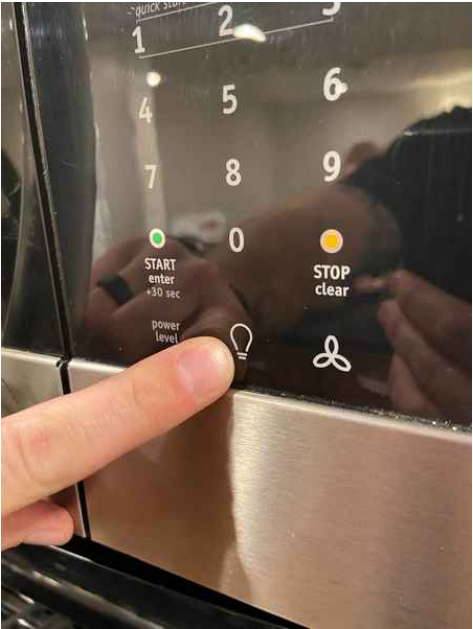
6.4.1 Built-in Microwave

LIGHT INOPERABLE

The light feature on the bottom of the microwave was inoperable. A qualified licensed professional should repair and replace as necessary.

Contact a qualified professional.
