Application of High-Pressure Cold Spray for an Internal Bore Repair of a Navy Valve Actuator

Cold spray is a reduced temperature, supersonic thermal spray process that is increasingly being used to perform repairs on high-value components. In this case, a valve actuator internal bore sealing surface was repaired on an aluminum 6061 hydraulic valve body using high-pressure cold spray. Corrosion damage to non-critical surfaces was also repaired, allowing the part to be returned to service. A high-pressure cold spray system was used to deposit gas-atomized 6061 aluminum powder using helium. The internal bore surfaces were approximately 100 mm in diameter with a depth of nearly 200 mm, and were sprayed using a 45° nozzle 65 mm in length. Modeling predictions validated the approach, and were used to identify a favorable nozzle geometry and process window combination. The minimum required adhesion strength on critical surfaces was 69 MPa. The average adhesion strength was 71.4 MPa, with glue failures on ASTM C633 bond test specimens. The actuator subsequently passed all bench top service related testing, was qualified as an approved repair, and is now in service. This was a first of its

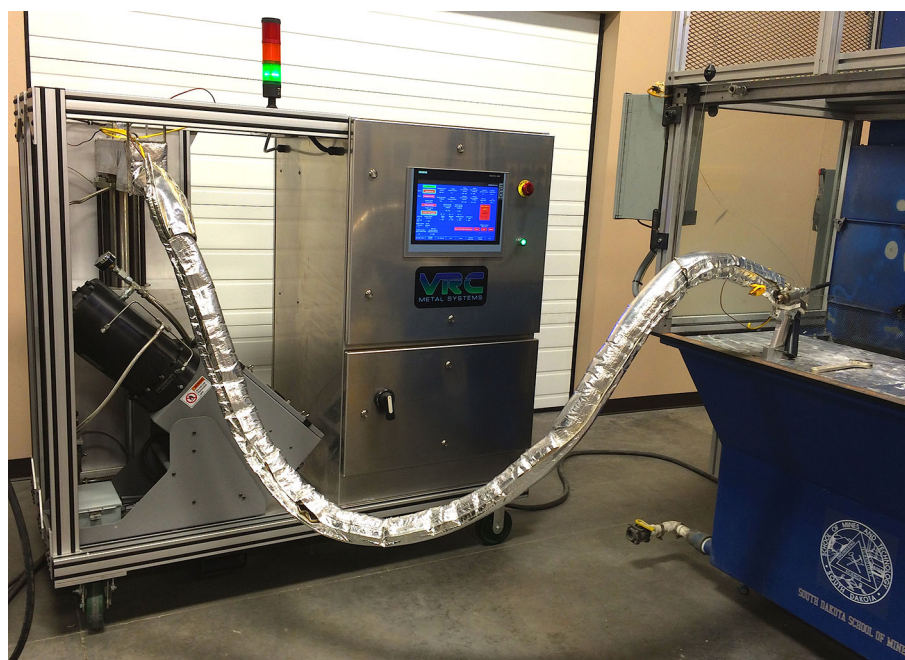
The cold spray system and the actuator repair setup with internal bore nozzle are shown in Fig. 3 and 4, respectively. Helium was used as the process gas to achieve high impact velocities between incident particles for deposition on a 6061 aluminum alloy substrate. Helium has a higher specific heat ratio and a higher specific gas constant than nitrogen. This allows helium to reach higher velocities than nitrogen for any given nozzle that is

Fig. 3 VRC Gen III cold spray system

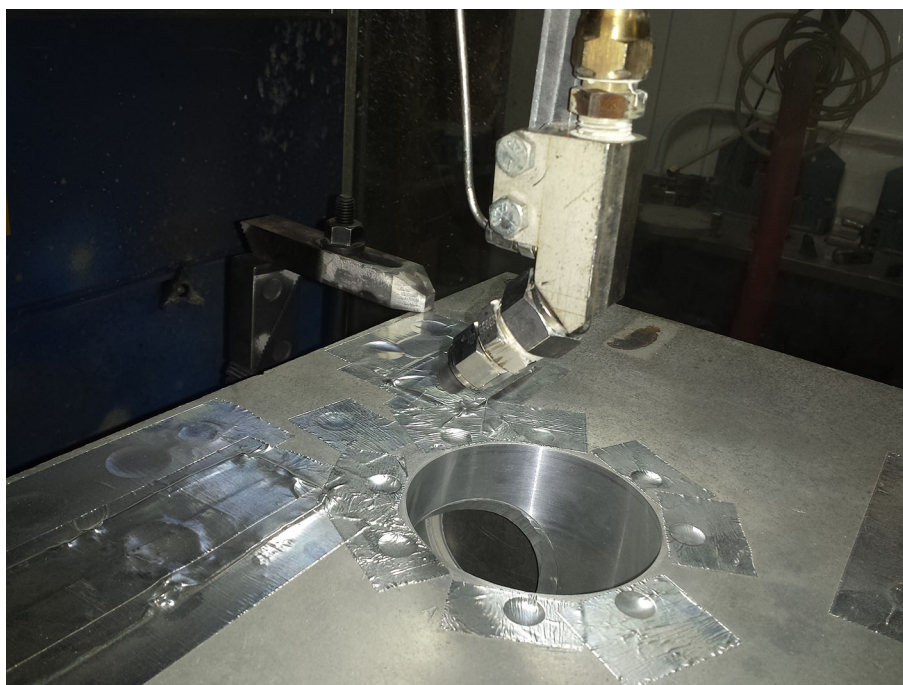
pressure cold spray system (VRC Metal Systems, Rapid City, SD, USA) using a small 45° nozzle developed for internal bore cold spray applications. The nozzle has a throat diameter of 1 mm, an expansion length of 44.5 mm, and a 2 mm exit diameter.

Fig. 4 Experimental setup to repair the valve actuator with internal bore nozzle

Deposition took place using a nozzle stand-off distance of 20 mm, 45° deposition angle, medium powder feed rate of approximately 10 g/min., and a nozzle traveling speed of 250 mm/s. Finally, total deposition thicknesses ranged from 2 to 8 mm.

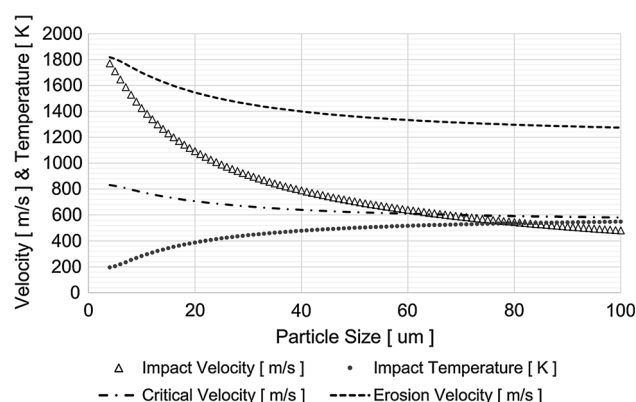
The numerical determination of the bonding criteria of the particle range between 4 μm and 100 μm helps us determine the expected amount of the bonding particles versus the amount of particles impacting the surface, namely the DE (Ref 13). Figure 6 shows the particle impact conditions, and critical and erosion velocities for the spray conditions of the experiment presented here.

Fig. 6 Impact velocity and temperature, critical and erosion velocities for the short nozzle

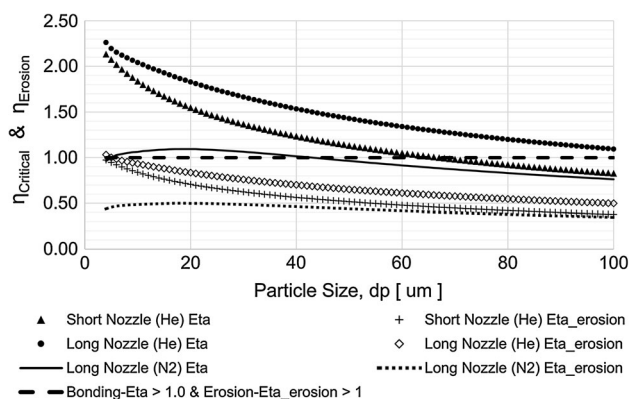
The DE of the particles is calculated as 46% for the calculation with nitrogen, where particles ranging between 5 and 43 μm are estimated to be bonding. The nitrogen gas provides a lower DE, although a higher pressure setting was used for the simulation. Figure 7 shows that with nitrogen, the η value is barely above 1.0, whereas the

helium keeps an average particle (40 μm) at an η value of approximately 1.25. It is expected that values closer to 1.5 provide a better bonding condition. Figure 7 also shows that a shorter nozzle returns lower η values than the longer nozzle. On the other hand, the losses with the shorter nozzle can be compensated through the use of helium over nitrogen and adjusting the spray parameters through predictive numerical methods. Erosion was not found to be an issue for the vast majority of particle sizes that were tested among the three spray conditions (Fig. 7).

Fig. 7 Plot of η and η_{erosion} plotted against the particle size range

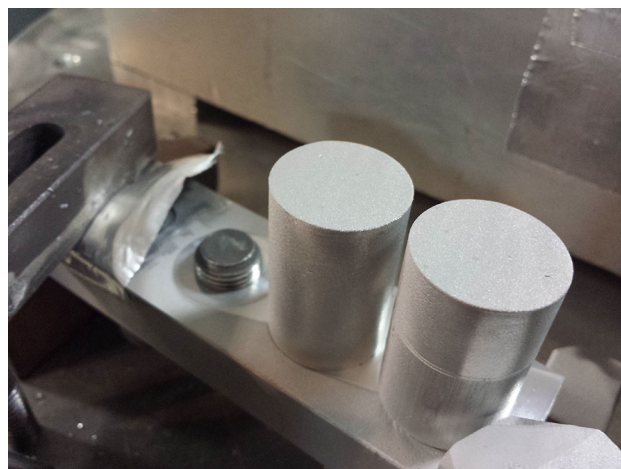
ASTM C633 bond testing was the final cold spray development requirement for approval to repair the aluminum actuator. The incident angle between the cold spray gun and the substrate had to be the same as the incident angle during deposition on the critical surfaces. Table 3 shows the results from the ASTM C633 bond testing. Figure 11 is an image of the cold spray depositions made for testing. The actual bond strength of the Al-6061 coating was higher than the reported average as all of the

Fig. 11 Photo of the ASTM C633 bond test specimens deposited for proof of concept testing to support approval to proceed with actuator repair

failures occurred as glue failures, as opposed to adhesive or cohesive failures of the coating, i.e., the CS layer exceeded the strength of the epoxy. From the results, it can be seen that the cold spray depositions were able to meet the requirements for approval to repair the aluminum actuator.

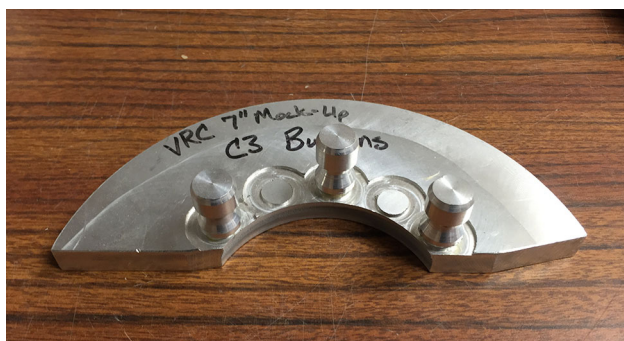
To provide additional confidence that the cold spray process was achieving the same properties in the mockup as seen for the bond coupons, a series of bond tests were performed on the deposited mockup. Figure 12 shows the setup used to perform bond testing of the deposited mockup. From the image, it can be seen that the mockup was sectioned and areas of the cold spray deposit were prepared for ASTM C633 type bond button testing using a reduced size bond button and a Positest® AT-M adhesion tester (DeFelsko Corp., Ogdensburg, NY, USA). Table 4 shows the results of the bond button testing, which all reached the test system maximum load of 68.9 MPa without failure. The results show that the cold spray depositions were able to meet the requirements for approval to repair the aluminum actuator.

Fig. 12 Photo of the modified C633 bond testing which was performed on flat portion the mockup internal bore bottom lip

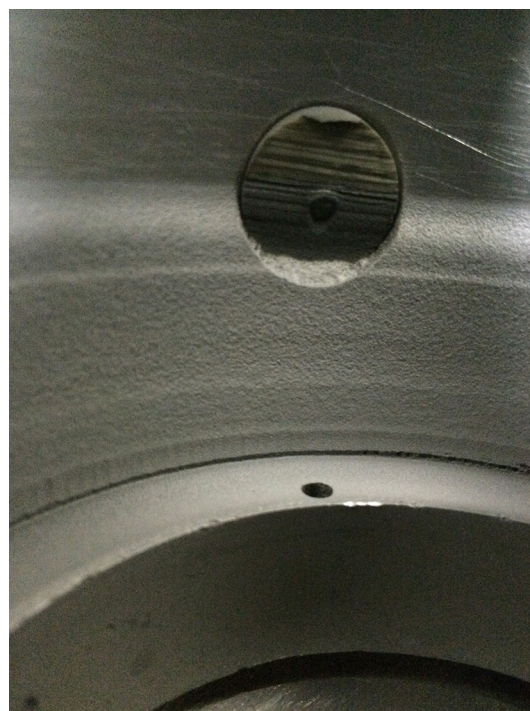
Unfortunately, the first actuator repair attempt failed due to poor bonding in the inside corner region near the bottom of the internal bore (i.e., in the general area shown in Fig. 8). The cold spray material was then machined off, and based on the lessons learned during the first failed repair attempt, a stringent process control document was prepared and followed during the next deposition process, which led to a successful repair on the second attempt. During the repair operation, it was noted that the sharp corner had the propensity to build up first on both sides of the corner before the corner itself could be build up to join the sides. This is a natural geometric challenge, as the

Fig. 17 Photo of bottom inside corner of the internal bore showing the lack of fill in the bottom corner during the initial deposition trials

point of the corner does not present an ideal surface for deposition. We learned, however, that if we sprayed the equivalent of a fillet joint into the bottom corner first, followed by deposition on the walls and bottom shelf of the bore, that we achieved reliable deposition on all surfaces. An image of the as-received aluminum actuator after re-machining in preparation for the repair is shown in Fig. 15.
