The Third Edition of the
Final Report of
The Guardian Wing Corps' Aircraft
3W-CHT (Pltanago Asiatica)'s
Accident over Gomag
on November 25th, 438

Released in July 440

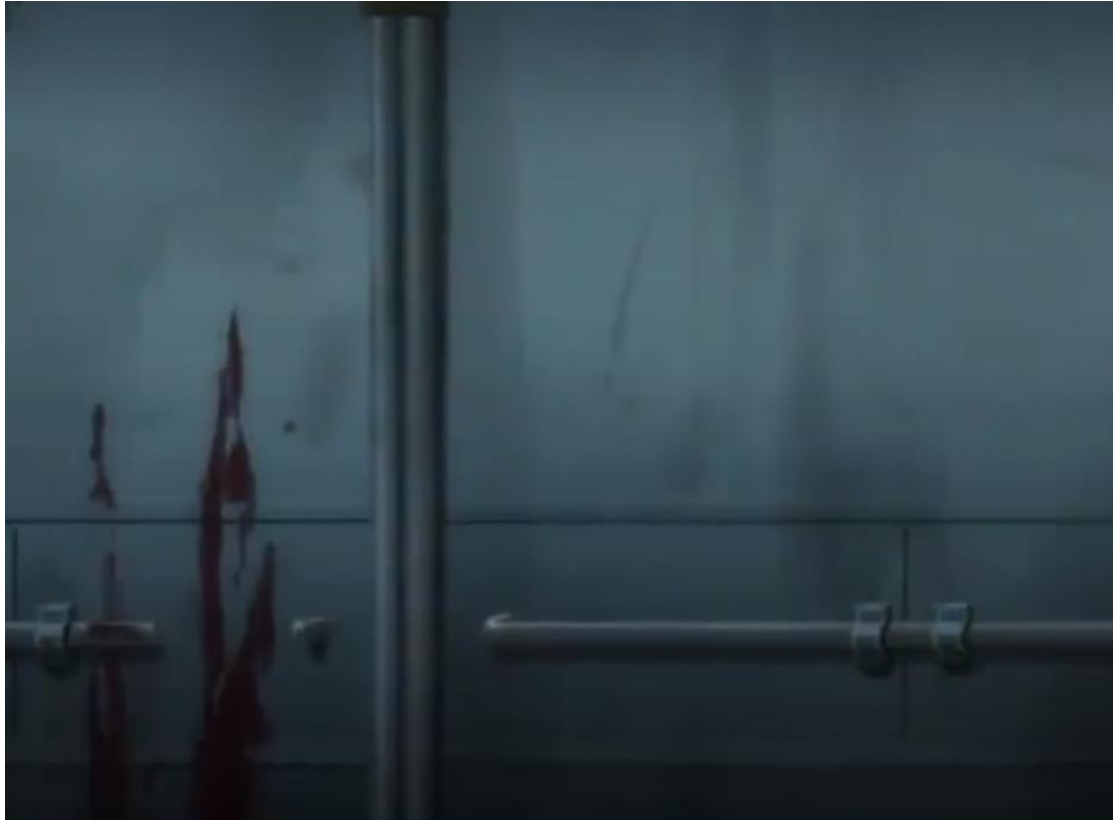
Internal blood and other signs suggest that the whole fuselage was completely broken down by Timeres. This will be discussed more in following sections. For example:

Figure 1. Internal blood suggesting fight inside

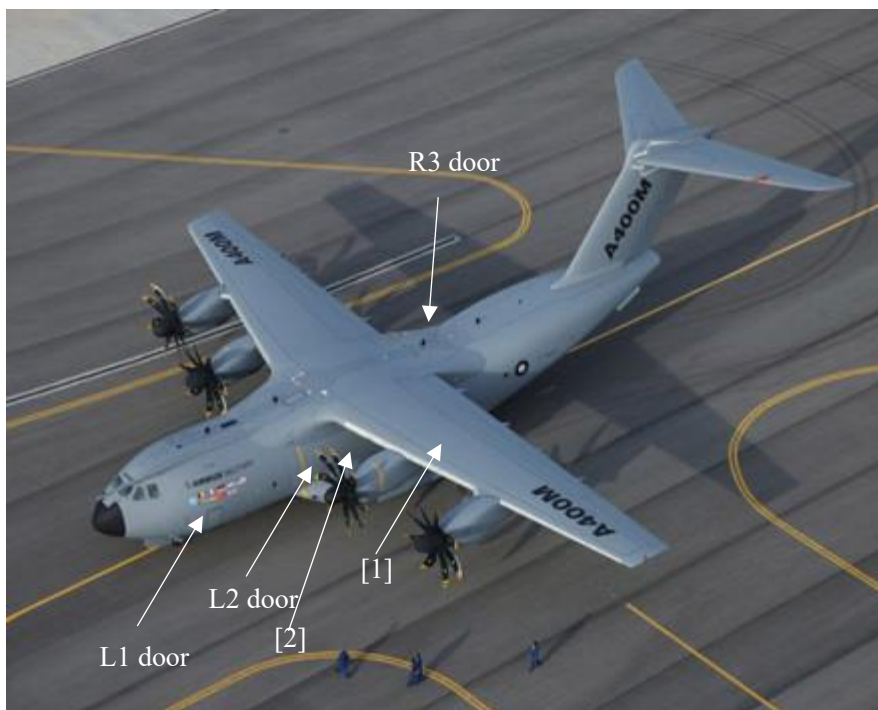
Figure 2. Damaged areas (An image of a standard A400M is used)

[1]: Several broken holes, with pipes exposed (See 1.12.4 Broken Pipes).

[2]: Broken fuselages with rivets exposed.

This kind of damage will also be discussed in *1.18.2 Beasts such as Timeres* and following analysis.

After diverting, the aircraft was repaired and returned to the fleet of the Guardian Wing Corps.

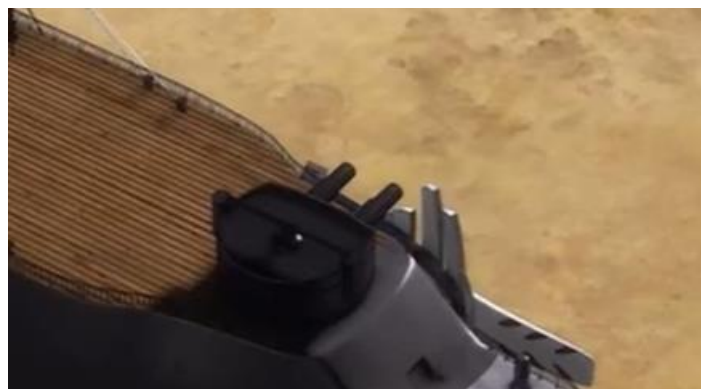
Figure 3. Cannons

The cannonballs’ sizes range from approximately 70 to 110 mm¹⁸. Guns are also provided for the aircraft and crew members. However, almost all interviewed soldiers reported that they had no effect on beasts. They reported that flames and “special weapons” (i.e., leprechauns) were the only

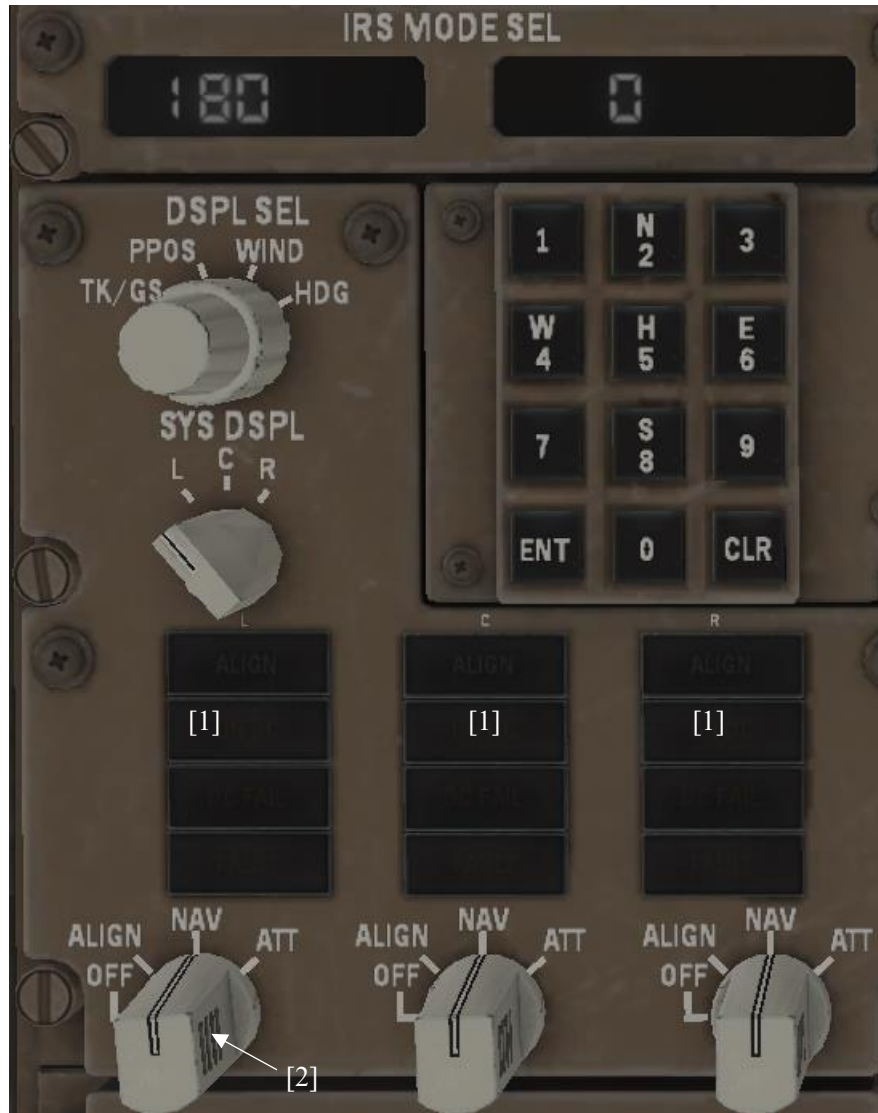
Figure 4. IRS Panel

[1]: “FAULT” – indicates IRS module is in a failure and will not provide any information.

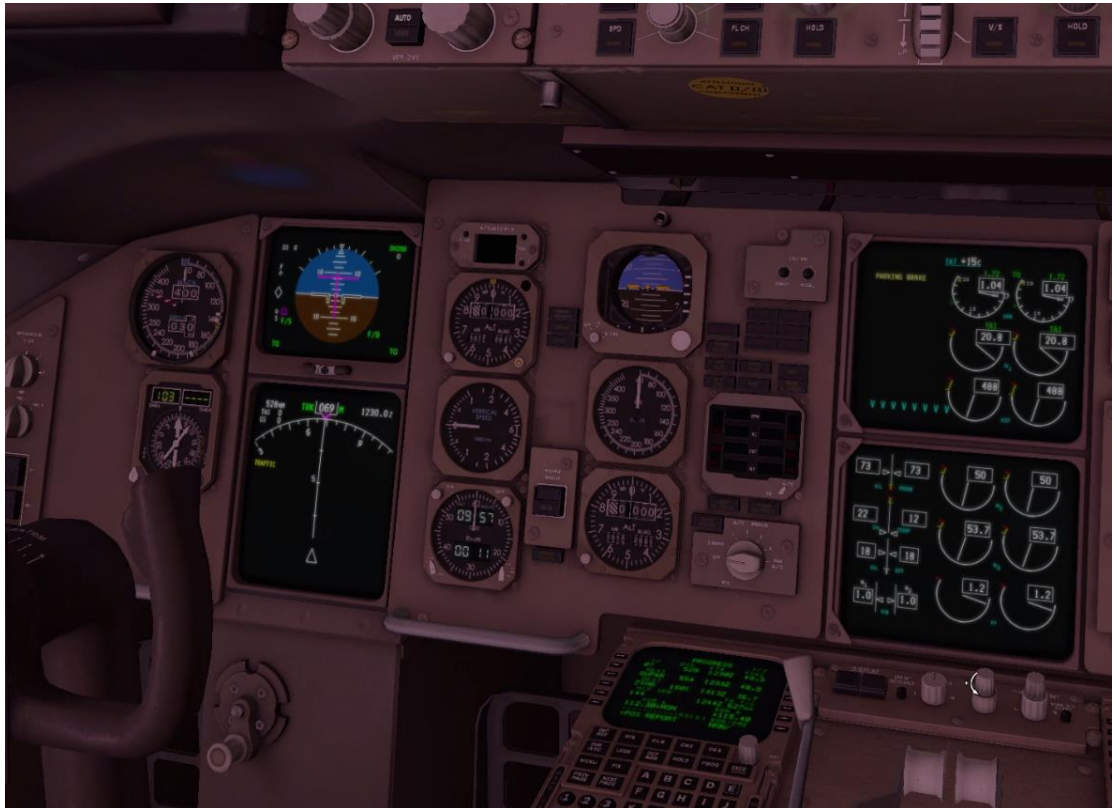
On March 11th, 431, the PFD and ND of Boeing 757/767 were adapted to the aircraft as an “electronic update”. The upgrade work followed existing procedure and showed no sign of malfunctioning.

Figure 5. Updated avionics (from a similar aircraft)

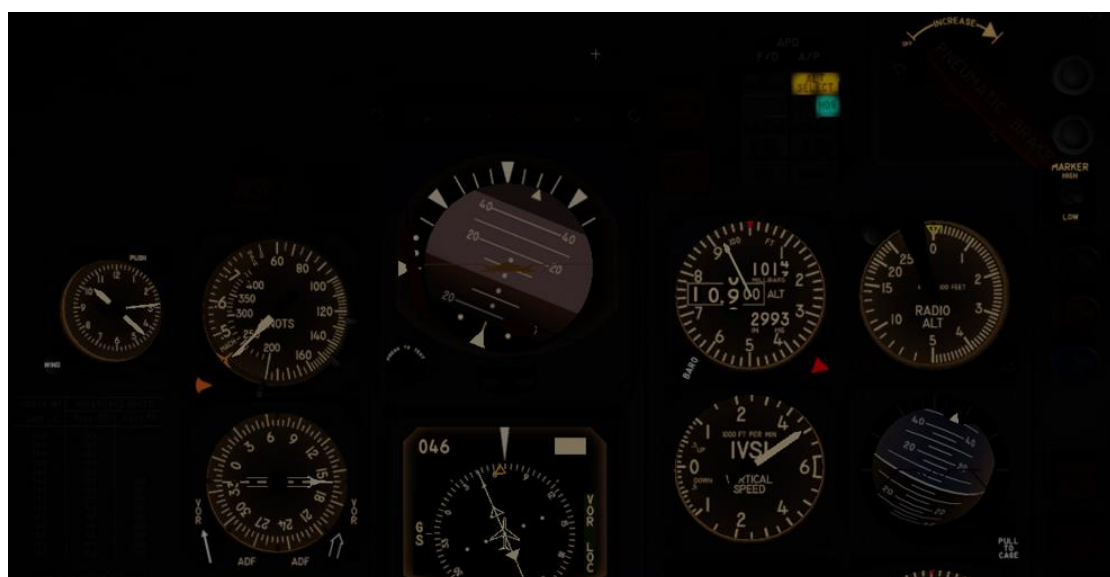
Figure 6. Avionics before upgrading (photographed by crew members on a flight before, while climbing)

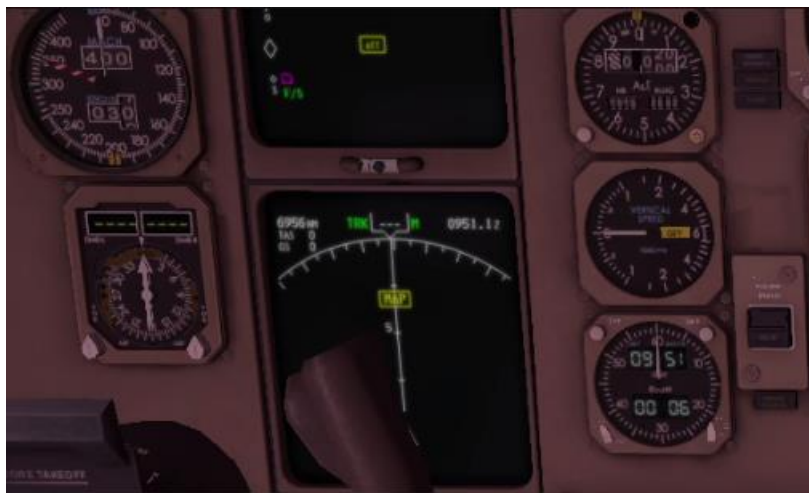
The last maintenance of the aircraft was done on September 3rd, 438 and the last examination was done on November 5th, 438, which were the same as the maintenance and examination done to other aircrafts which are commercially used and not facing such a risk of crossing war zone and facing beasts. This is because cargo aircraft, even if for military use, different from fighter jets and leprechauns, doesn't usually face the risk of beasts. The check suggested that there was no malfunctioning system. However, it was reported on August 5th that the left IRS of the airplane became inoperative during a mission.

Figure 7. Captain-side after-landing indication of the flight on August 5th

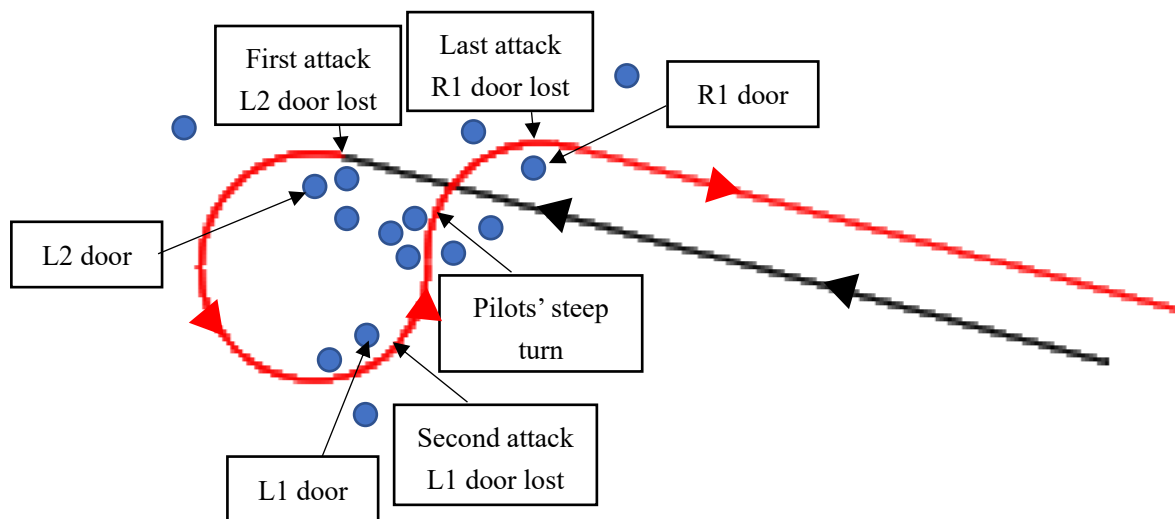
the area where the accident took place later. The general distribution as well as the flight path is given below.

Figure 8. General flight path (with FDR and ATC data) and wreckages' distribution

●: Where fallen fuselages were found.

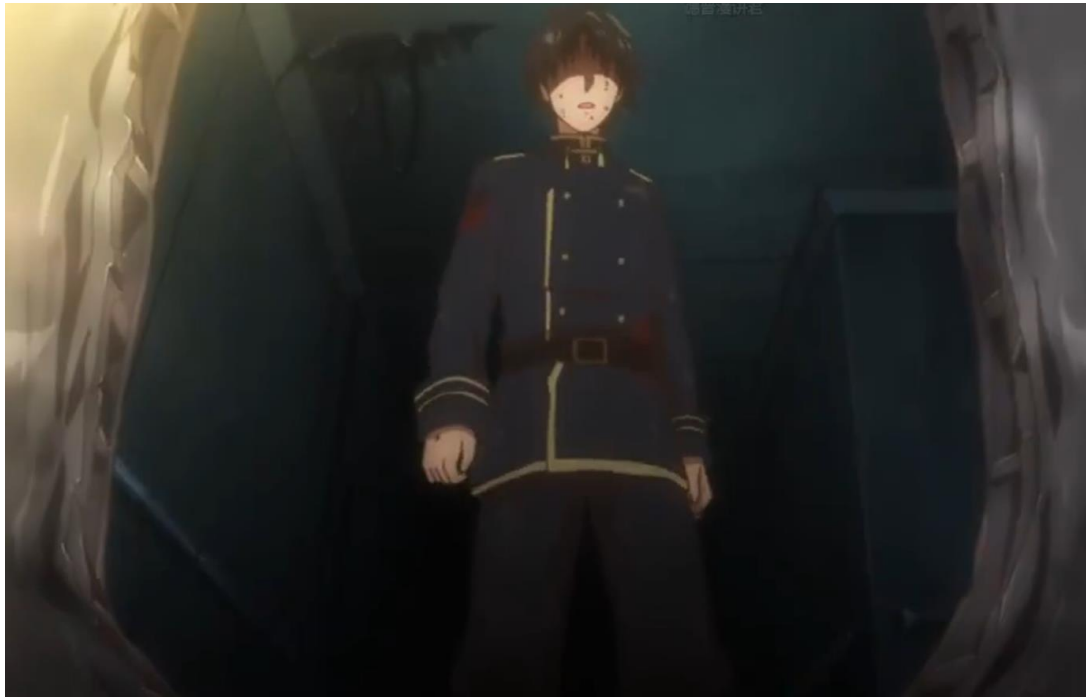
From the circumstances of the borders of the metals, the in-flight situation of the door is inferred as follows:

Figure 10. Simulated situation of L2 door; with a normal man standing behind

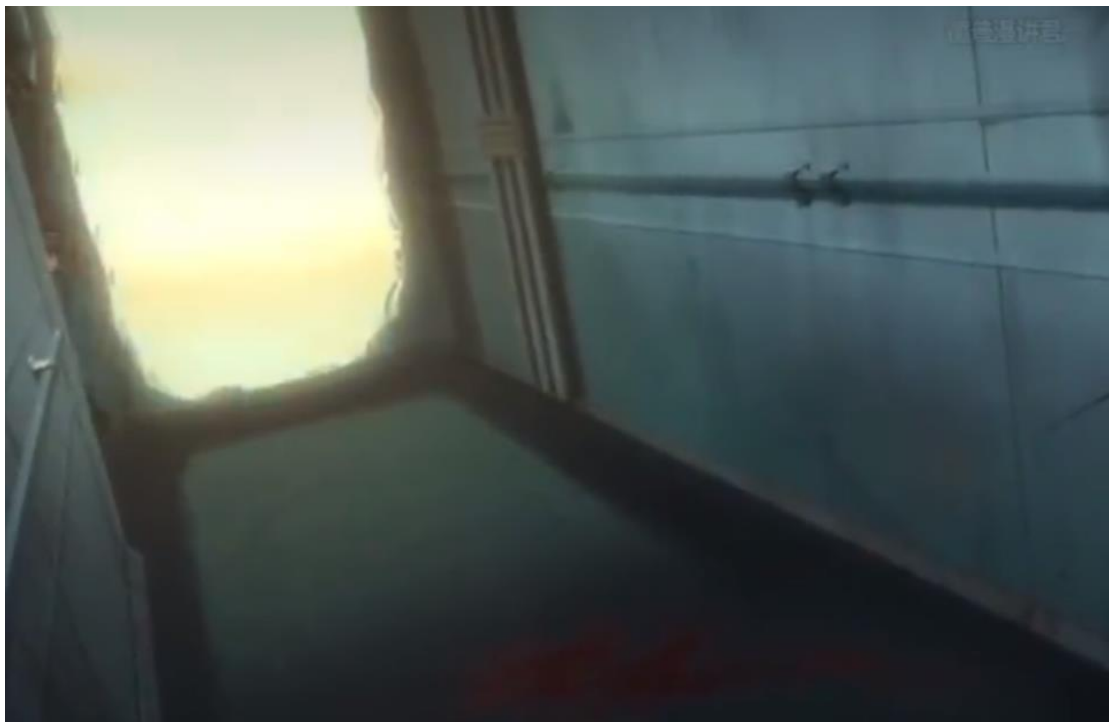
Figure 11. Inside view

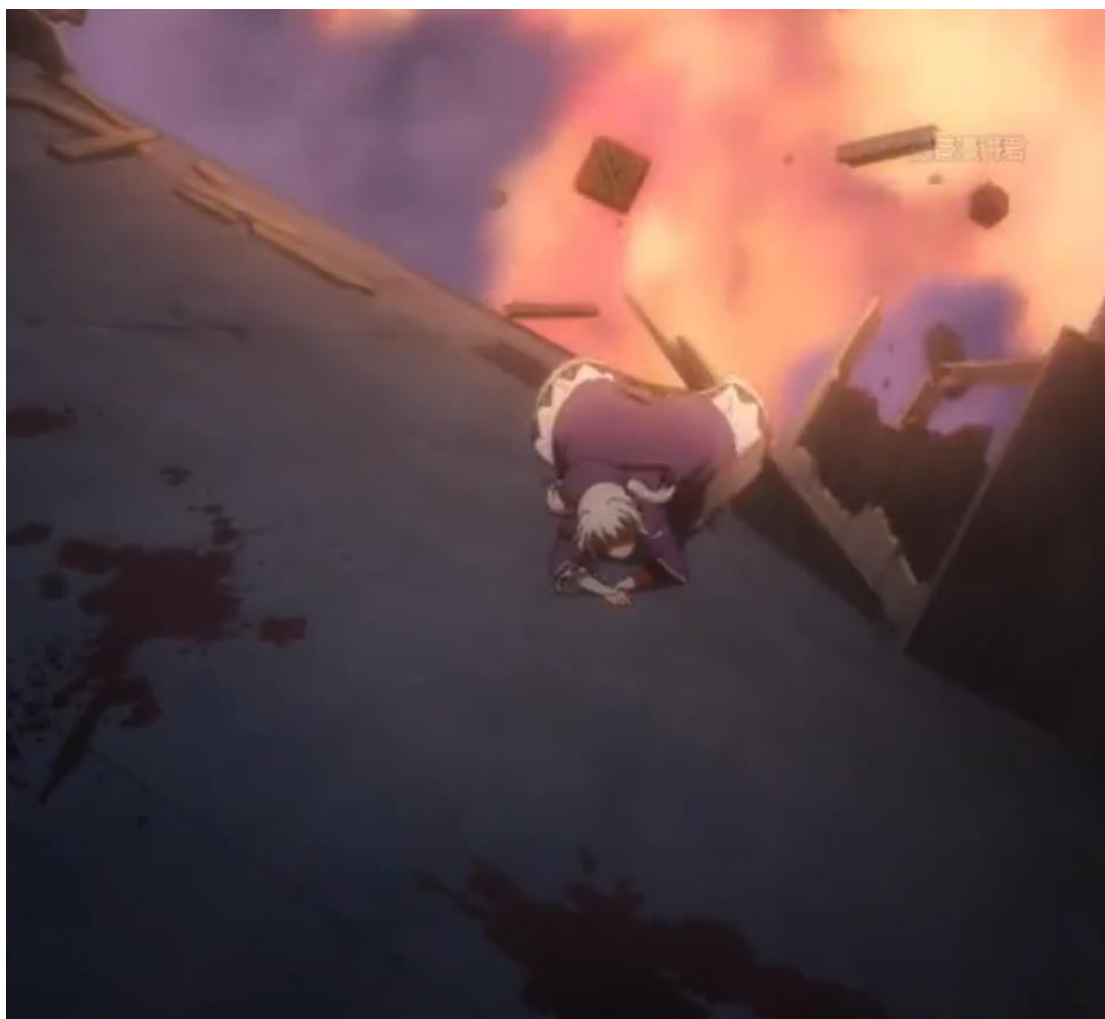
Figure 12. Simulated situation of L1 door, with a leprechaun struggling not to fall down

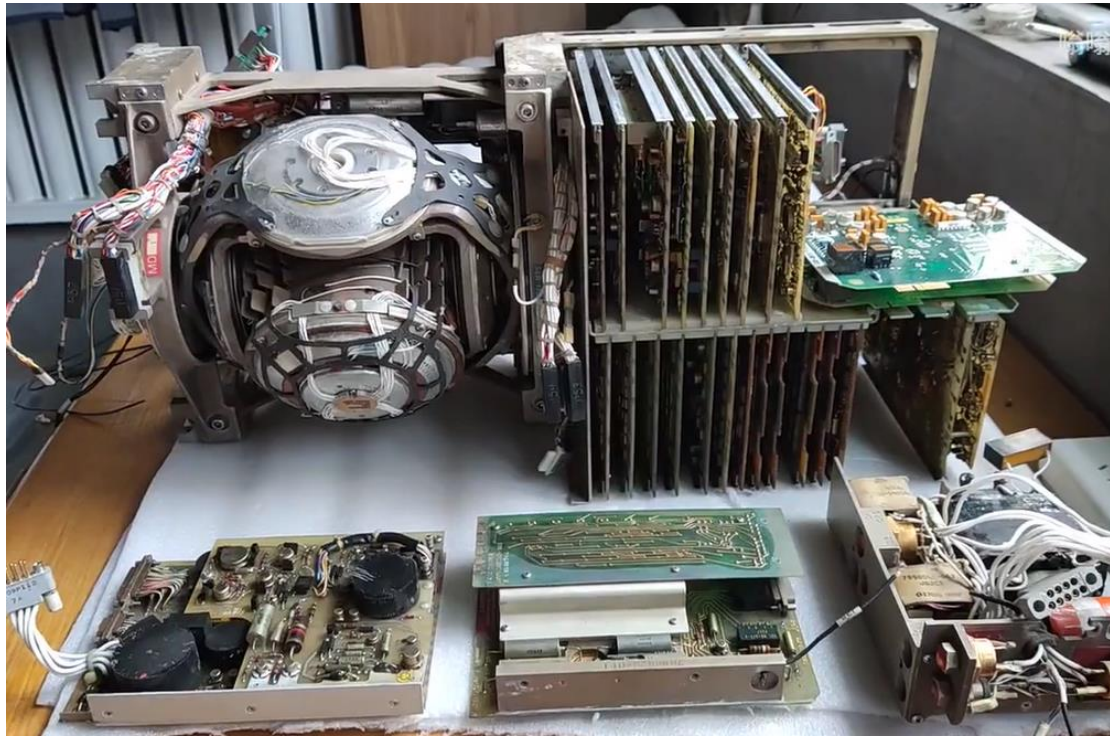
Figure 13. Destroyed IRS components

IRS components are generally complete, but investigators have found small cracks from the outer container.

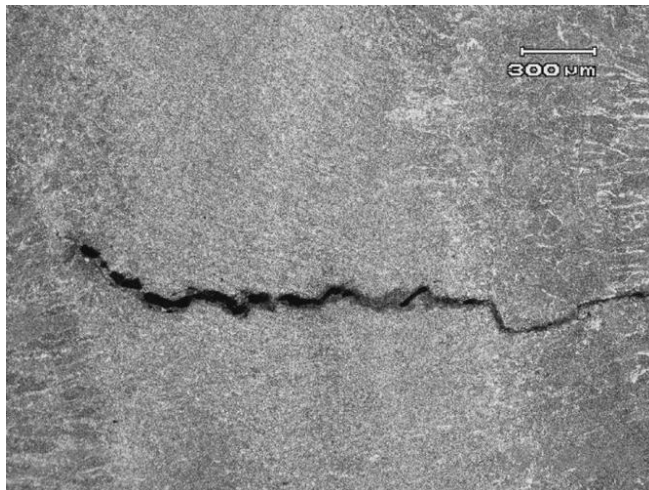
Figure 14. Cracks found (under microscope)

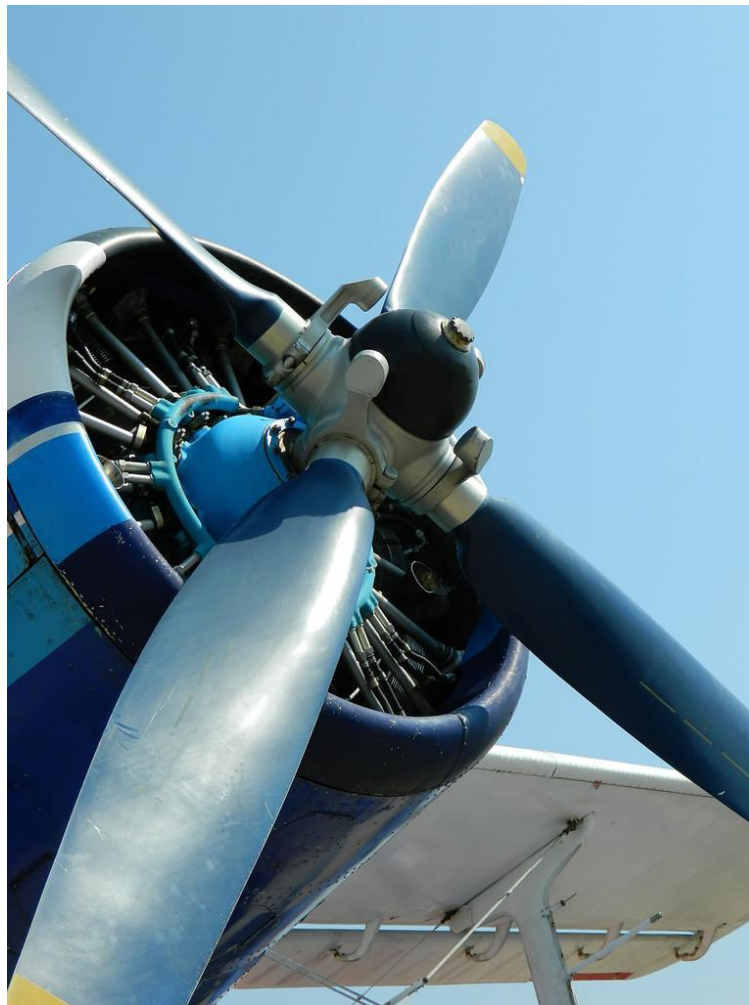
Though the incomplete emergency maintenance before departure, the engine structures were

made generally complete by in-flight repair and maintenance.

Figure 15. The engine (after touching ground)

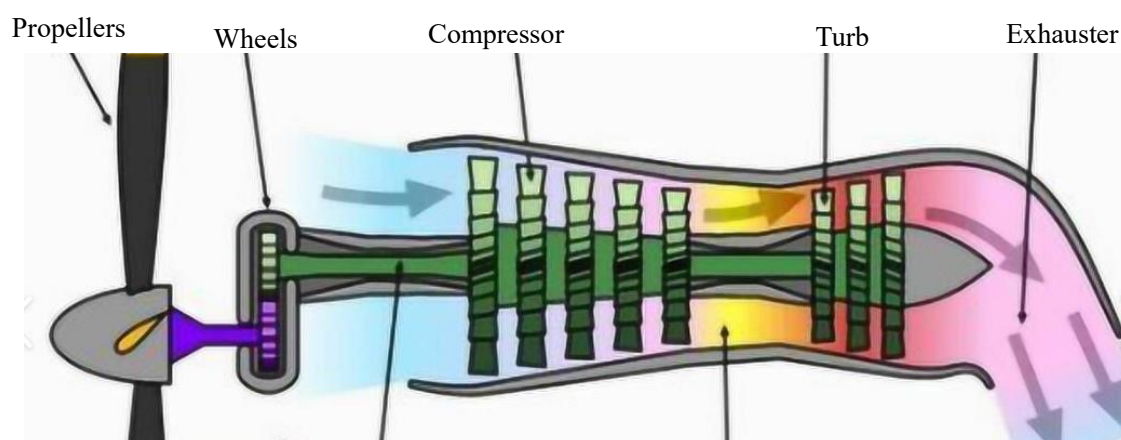
The structure of the turboprop engines can be described as:

Figure 16. The engine structures

The exhaustor usually has material that can suffer high temperature, which is only provided in a limited number of airports including Scarborough, Brisun and Lyell.

During the analysis, investigators found that the areas near exhaustors were black, suggesting hot temperature.

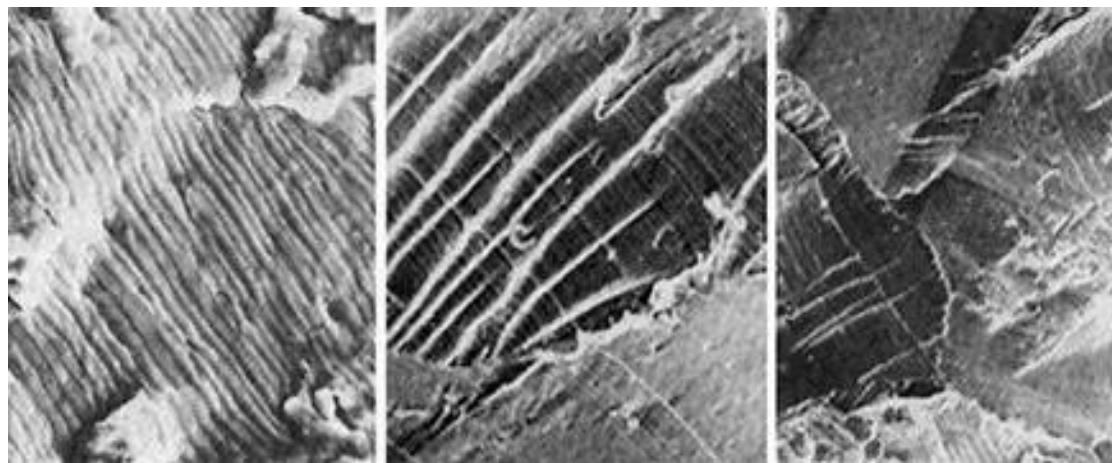
Also, investigators found the signs of metal fatigue in the damaged areas of the engines.

Figure 17. Metal fatigue found under microscope

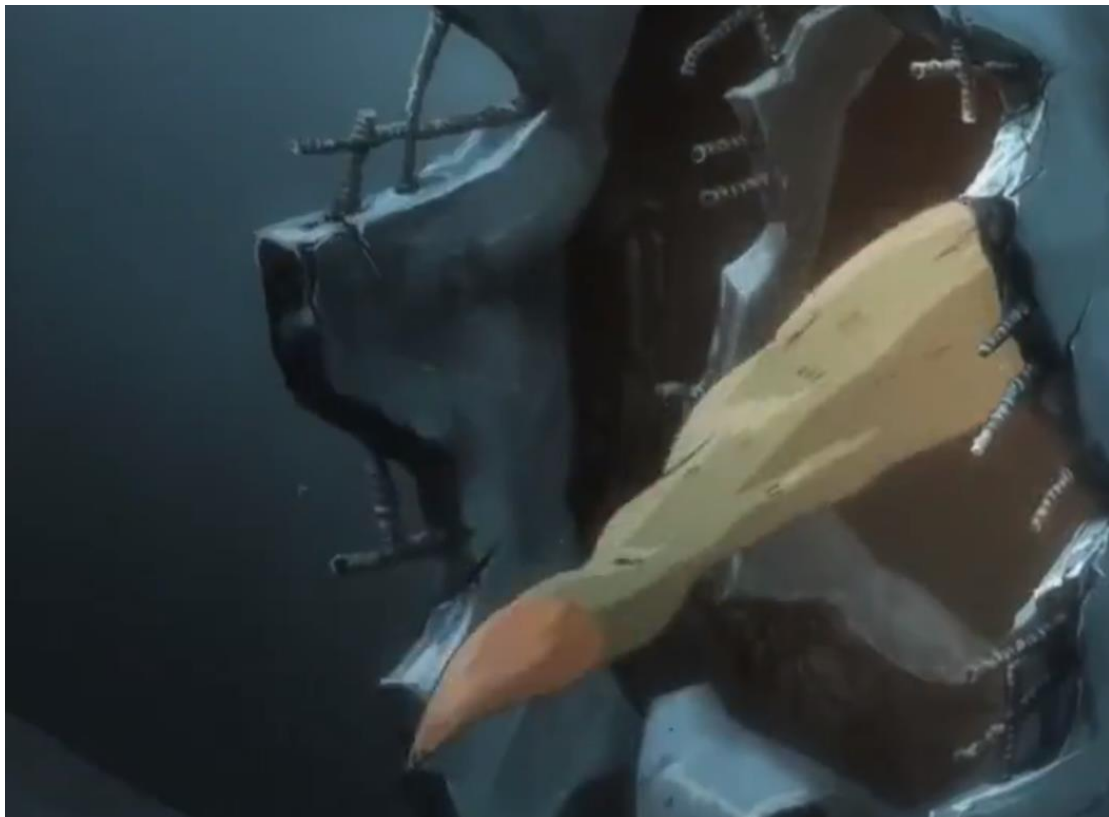
Figure 21. Fuselage completely damaged by the machine, or beast

Besides, according to former investigations⁵², the impact usually takes 30 seconds. Therefore, the emergency evacuation time is less than this value.

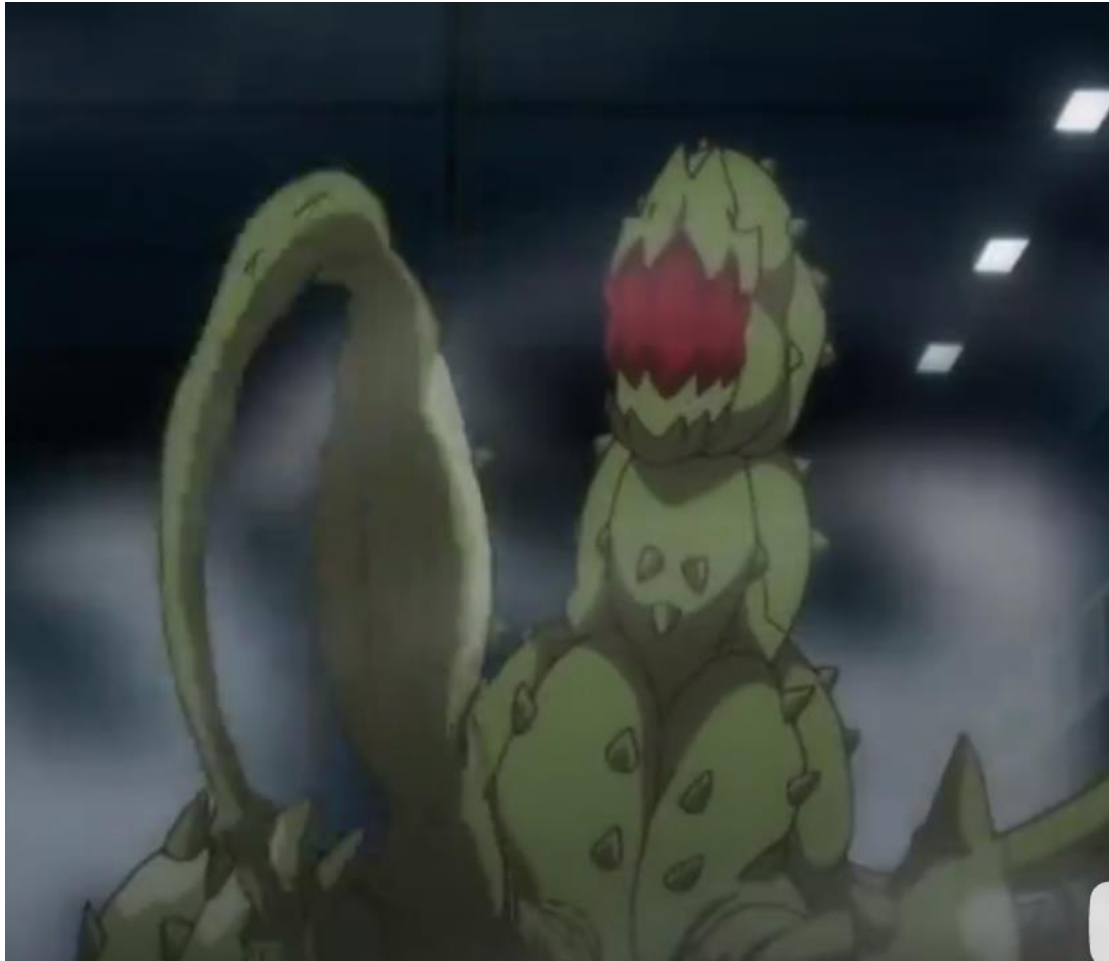
Figure 23. Timeres breaking through the fuselage and entering the cabin

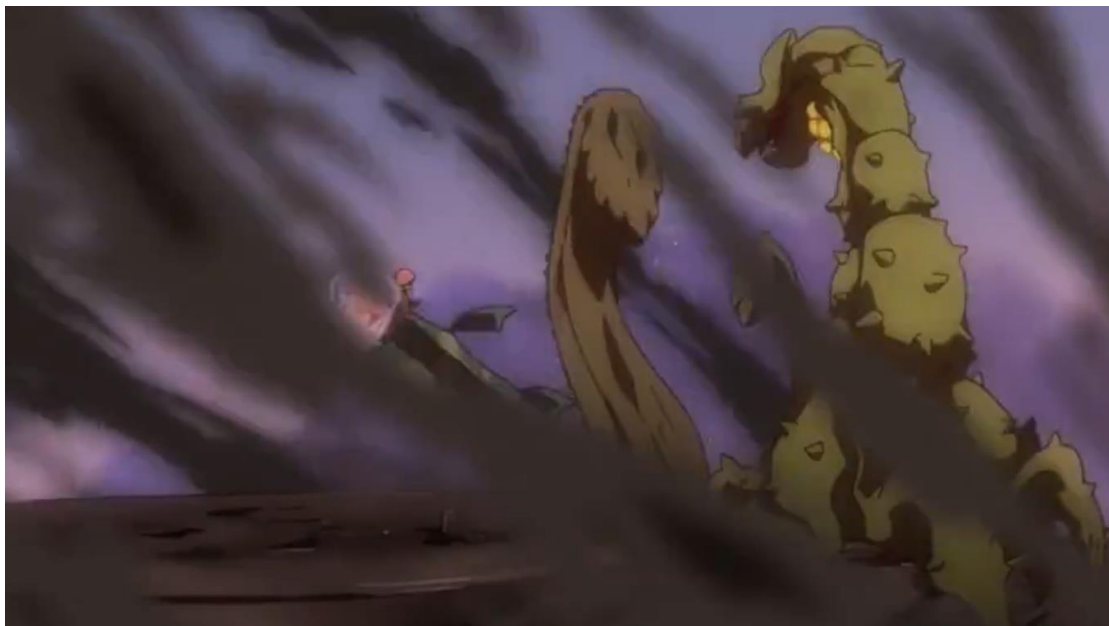
Leprechauns fighting against beasts in this accident reported to RATSC that some beasts blocked the exhausters and some of them saw smoke coming out from it.

Figure 24. Timeres sticking into the engine (These two pictures are

photographed by a leprechaun)

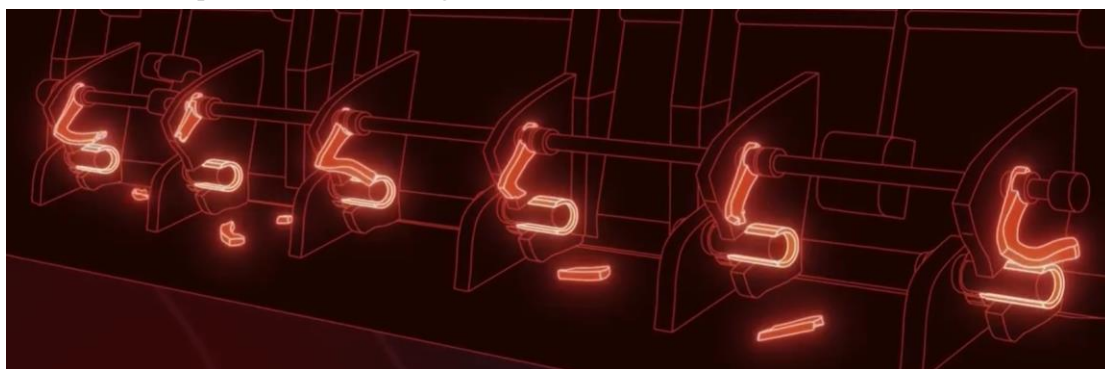
However, even though the fuselage was under such a pressure, it should have not broken apart. Examination has proved that this is because when a strong force is given directly towards the locker, the locker of the door first breaks down, making the door blown away because of the difference of the pressure (See the image below).

Figure 38. The broken locker and its structure (Simulation)

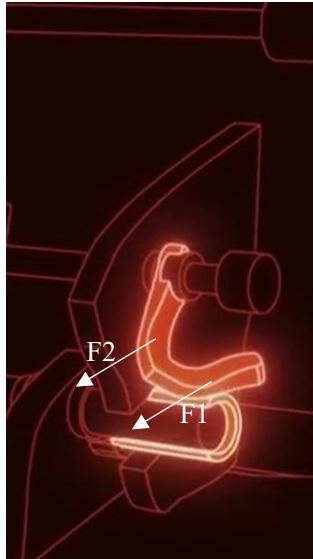
Figure 39. The forces on a single component

[F1]: The force the down part given to the locker to lock the door caused by the difference of the air pressure.

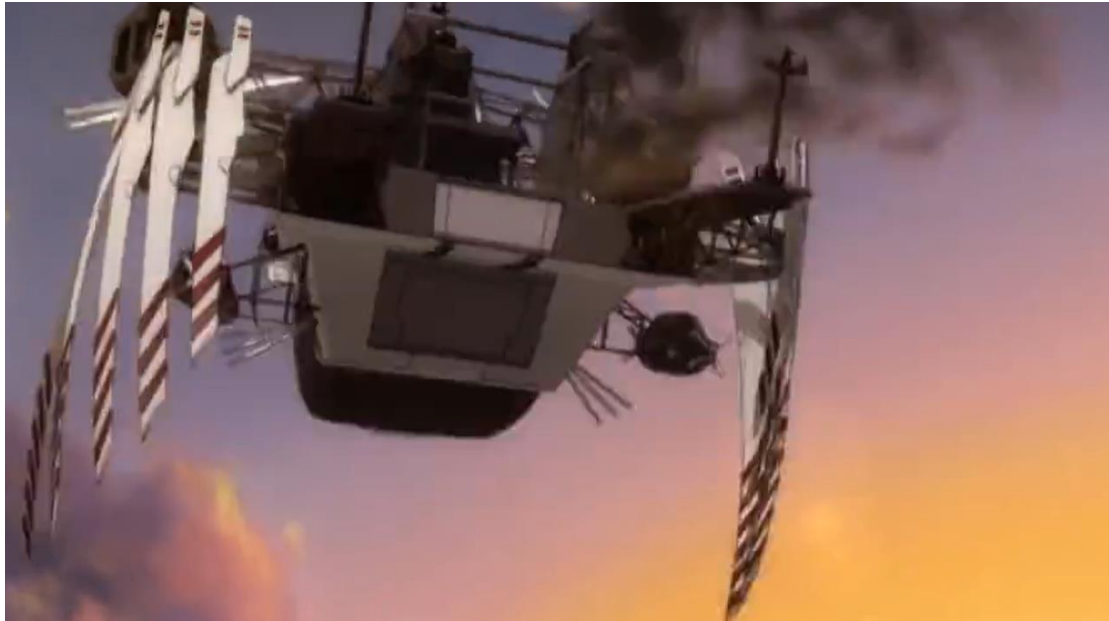
System	Causes	Consequences
Engines	Easily jammed and damaged by the Timeres because of the improper maintenance	Making controlling difficult (not significant)
Hydraulic	Damaged because of the broken fuselage destroyed by Timeres	Making controlling difficult
Doors	Damaged because of the broken fuselage destroyed by Timeres (or someone leaning on it)	Making passengers sucked out
IRS	Influenced by Chtholly	Making navigation difficult (not significant)
Autopilot	Influenced by the inoperative IRS	Making controlling difficult, increasing working pressure of pilots

Figure 40. Simulated exterior view of the aircraft during the accident

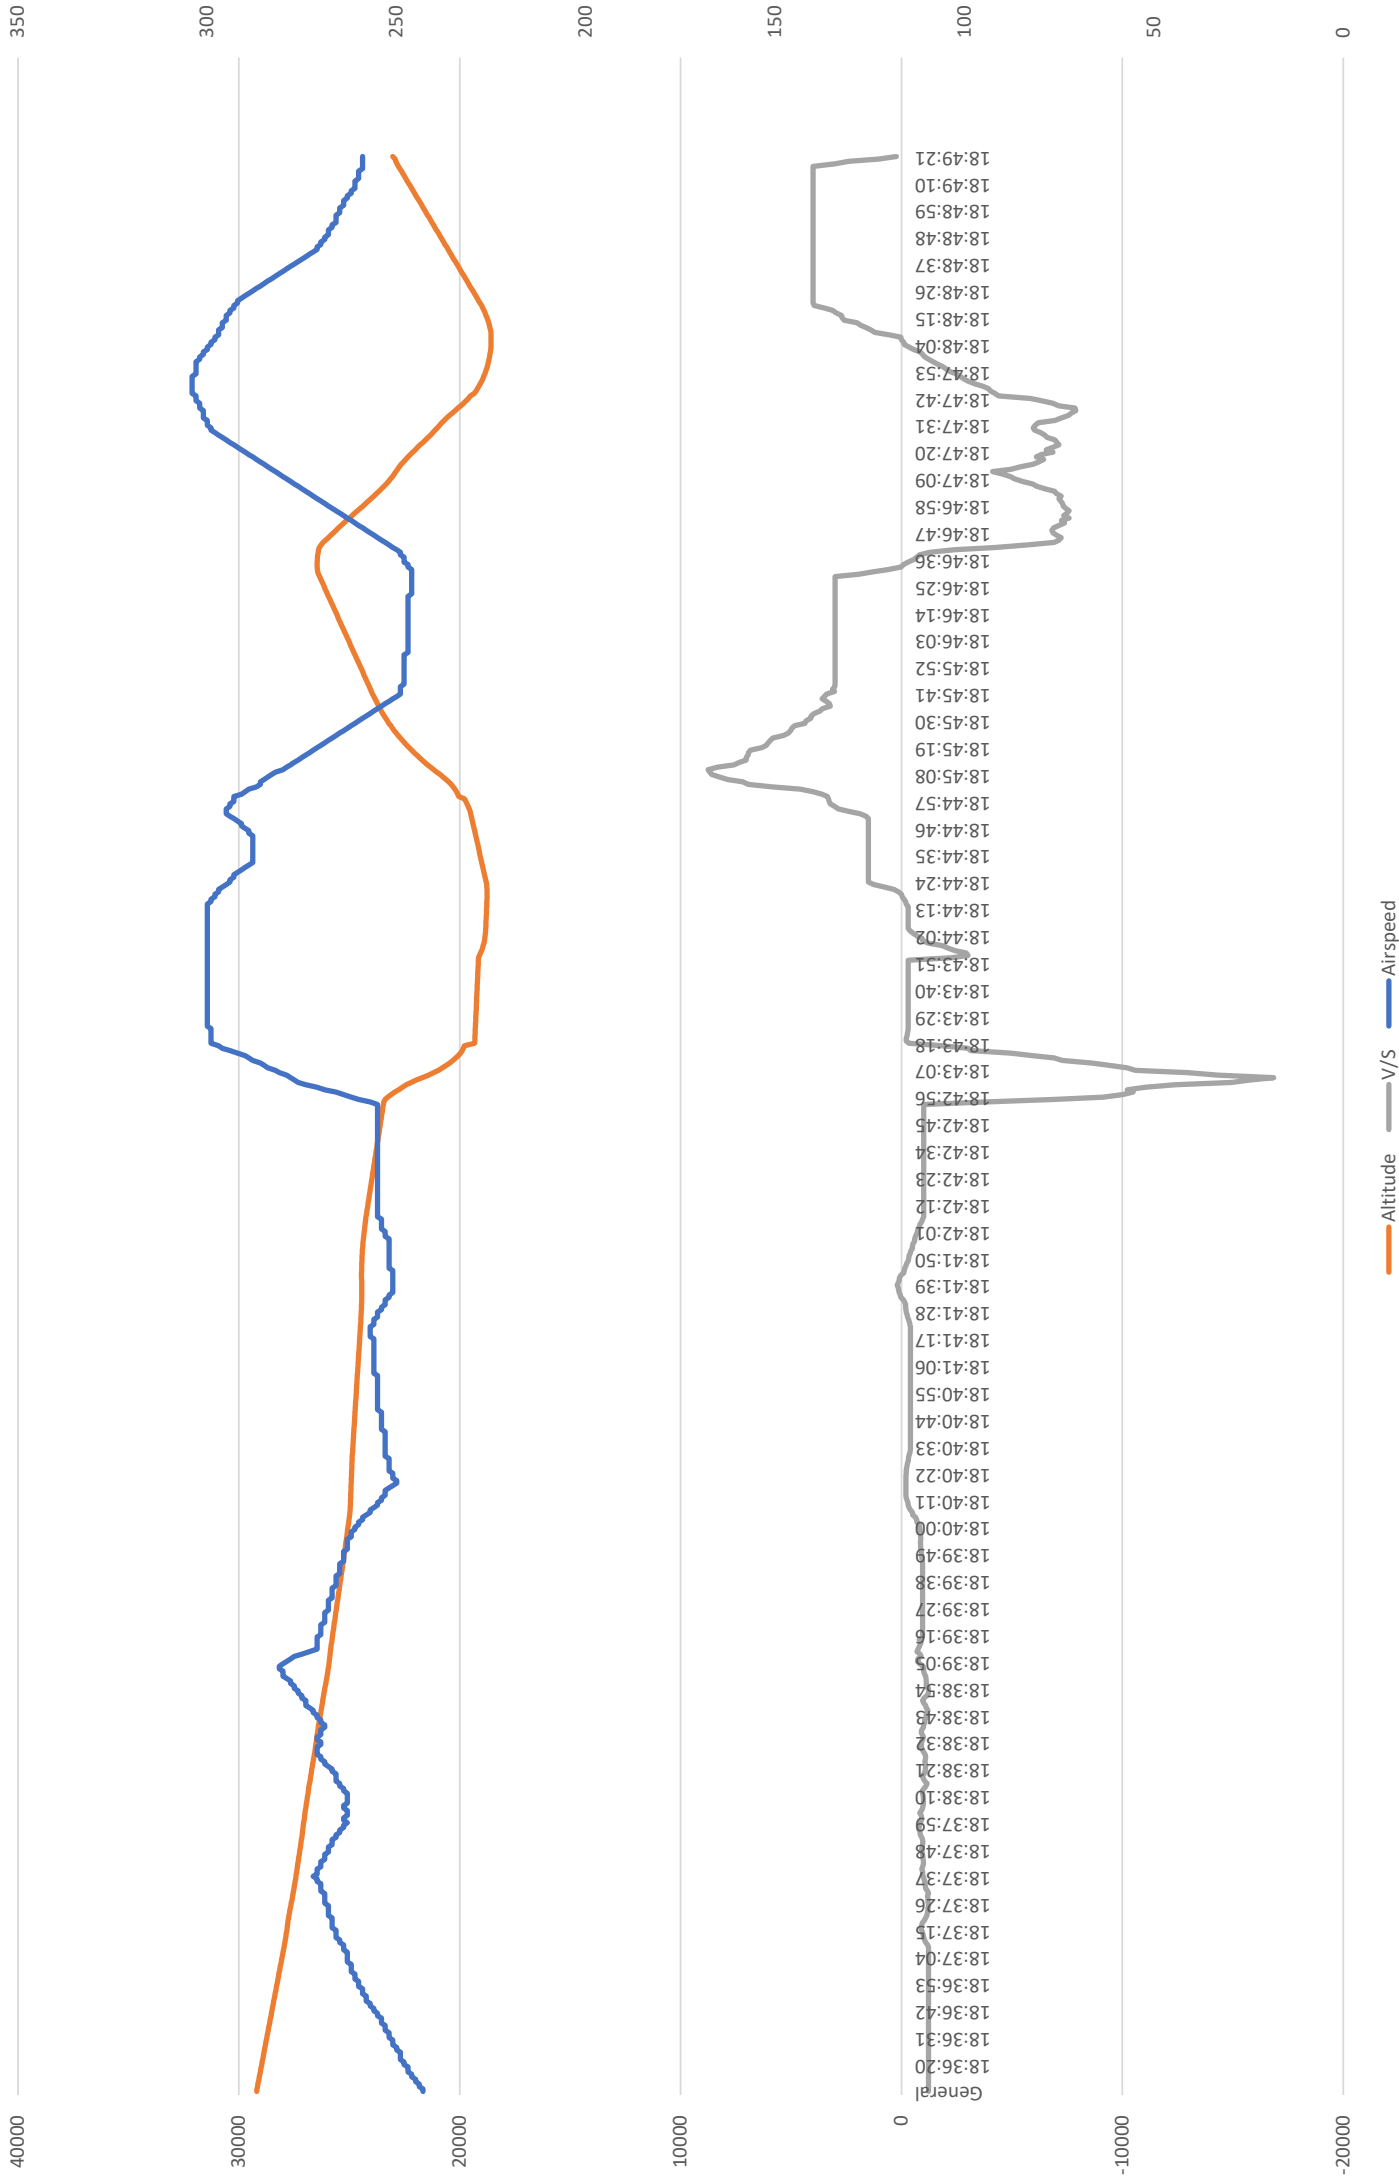
3W-CHT Gomag Accident
FDR Data (Nov 25, 438) – Altitude, Airspeed and V/S

Note: FDR and CVR timepoints may differ for no more than 20 seconds.
