CAPITAL INSPECTION

Home Inspection Report 1245 Owen Pl. NE, Washington, DC 20002

Prepared For: Steve Kuennen
Inspection Date: Thursday, April 28, 2016

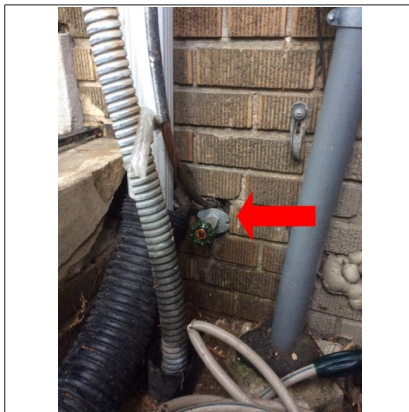
House front, right.

Comments Exterior Wall Utility Penetrations: Repair and Seal the utility hole penetrations through the front exterior walls of the house. The holes created for the electrical service cable and hose spigot are currently open and not properly sealed. Recommend installing a "duct seal" compound or other exterior sealant to prevent water and pest penetration into the house. Recommend further evaluation and repair by a qualified handyman contractor.

Exterior Wall Utility Penetrations: Repair and Seal the utility hole penetrations through the front exterior walls of the house. The holes created for the electrical service cable and hose spigot are currently open and not properly sealed. Recommend installing a "duct seal" compound or other exterior sealant to prevent water and pest penetration into the house. Recommend further evaluation and repair by a qualified handyman contractor.

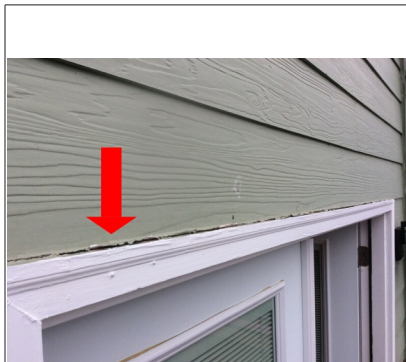
House rear.

Exterior Trim Caulking: Apply urethane exterior caulking to the casing trim above the house rear exterior door. The caulking along the top perimeter is cracked or missing, and there are open gaps to the door interior framing. Caulking is important to prevent water penetration into the house. Recommend further evaluation and repair by a qualified handyman contractor.

Exterior Trim Caulking: Apply urethane exterior caulking to the casing trim above the house rear exterior door. The caulking along the top perimeter is cracked or missing, and there are open gaps to the door interior framing. Caulking is important to prevent water penetration into the house. Recommend further evaluation and repair by a qualified handyman contractor.

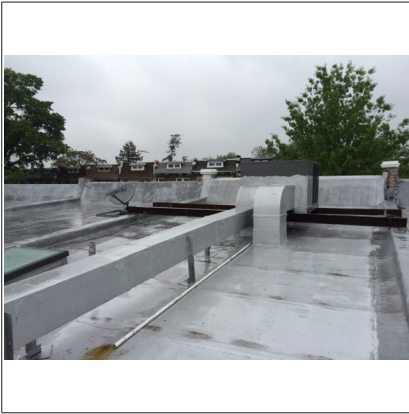
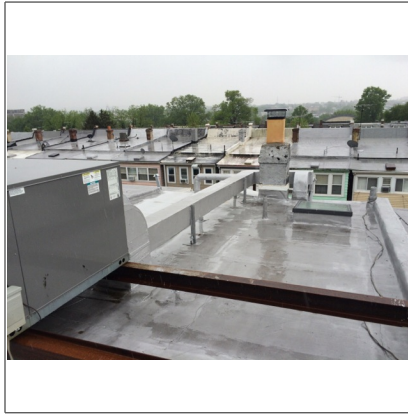
Comments Building Roofing System, Details: The Modified Bitumen Membrane roofing system is properly installed and is visually estimated to be 1-5+ years old. The roofing system is coated and sealed with an asphalt and aluminum reflective roof coating which is visually estimated to have been applied 1-5+ years ago. The roof surface areas able to be inspected were in good condition and no major areas of damaged or deteriorating material were observed. There is no evidence of recent water penetration on the inside of the house. All flashing systems appeared to be functioning properly. Modified Bitumen Membrane roofing systems have a life expectancy of 20-25+ years, although they can last longer depending on the grade of the product material, the re-application of the roof coating system every 6-8+ years, and the surrounding environmental conditions.

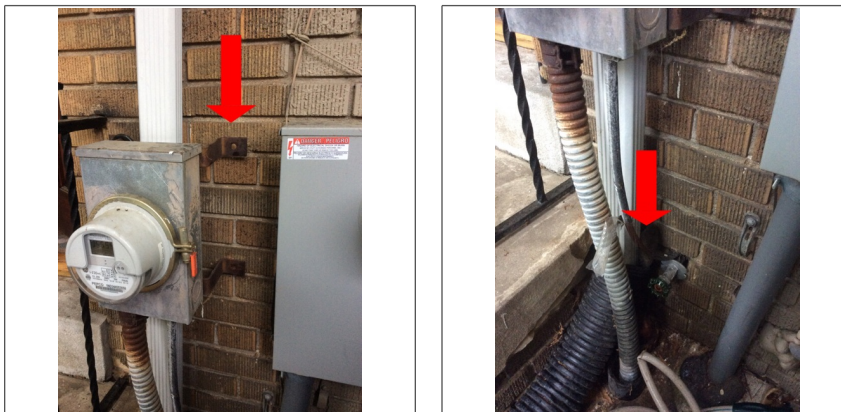
Comments Electrical Service Meter Box: Repair the attachment of the electrical service meter box to the exterior wall of the house. The anchors and screws used to attach the box are missing or have become detached from the wall. Recommend further evaluation and repair by a qualified electrical or handyman contractor.

Electrical Service Entrance Cable: Repair or Replace the plastic outer sheathing on the electrical service entrance cable that runs from the service meter box into the house. The outer sheathing that protects the service entrance wires is deteriorated and requires replacement. Recommend further evaluation and repair by a qualified electrical contractor.

Electrical Service Meter Box: Repair the attachment of the electrical service meter box to the exterior wall of the house. The anchors and screws used to attach the box are missing or have become detached from the wall. Recommend further evaluation and repair by a qualified electrical or handyman contractor.

Electrical Service Entrance Cable: Repair or Replace the plastic outer sheathing on the electrical service entrance cable that runs from the service meter box into the house. The outer sheathing that protects the service entrance wires is deteriorated and requires replacement. Recommend further evaluation and repair by a qualified electrical contractor.

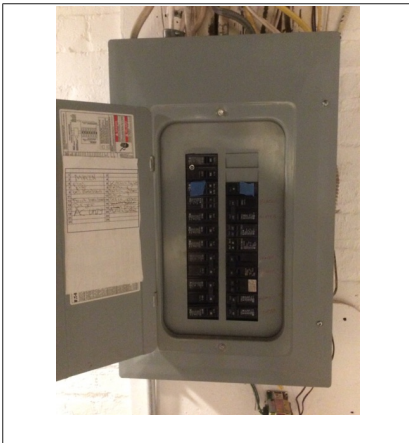
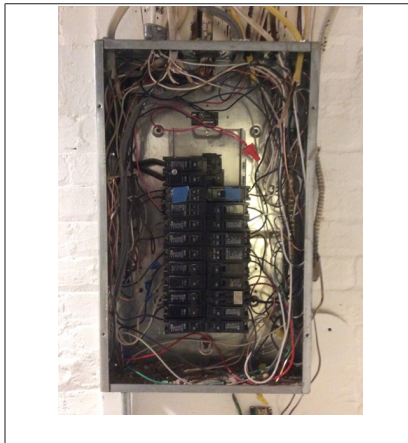
Electrical Distribution Panel, Details: The electrical service supplied to the house is estimated to be rated at 100 Amps. This is estimated based on the rating of the main disconnect switch and/or the gauge of the service conductor wires. This amperage service is good for the size of the property. The electrical distribution panel, the service entrance from the utility, the circuit breakers, and the circuit distribution wiring all appear to be correctly installed. The distribution panel wiring appears to be in good condition and is well organized and arranged.

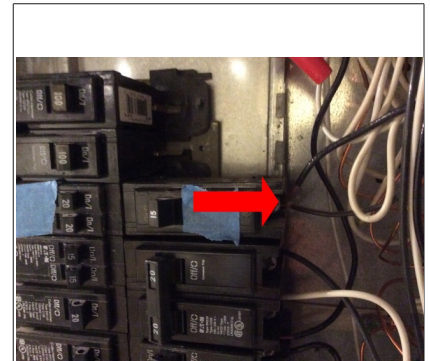
Double tapped breaker.

Electrical Circuit Breaker Wiring: Repair the circuit breaker located on the upper right side of the main distribution panel which has two separate electrical circuits wires connected to a single circuit breaker. The type of circuit breaker installed is not designed to hold 2 conductors. This configuration is not allowed by building code. Recommend further evaluation and repair by a qualified electrical contractor.

Electrical Circuit Breaker Wiring: Repair the circuit breaker located on the upper right side of the main distribution panel which has two separate electrical circuits wires connected to a single circuit breaker. The type of circuit breaker installed is not designed to hold 2 conductors. This configuration is not allowed by building code. Recommend further evaluation and repair by a qualified electrical contractor.

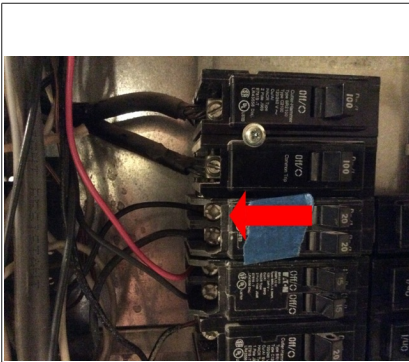
Incorrect wire size.

Electrical Circuit Breaker Wiring: Replace the circuit breaker and/or electrical wire for the electrical circuit installation on the lower right side of the main distribution panel. The electrical circuit installation utilizes a 20 Amp circuit breaker connected to 14 gauge electrical wire. Building code requires that 20 Amp circuit breakers are connected to 12 gauge (larger) electrical wire. The 14 gauge wire is undersized for the breaker and may be a safety concern. Recommend further evaluation and repair by a qualified electrical contractor.

Electrical Circuit Breaker Wiring: Replace the circuit breaker and/or electrical wire for the electrical circuit installation on the lower right side of the main distribution panel. The electrical circuit installation utilizes a 20 Amp circuit breaker connected to 14 gauge electrical wire. Building code requires that 20 Amp circuit breakers are connected to 12 gauge (larger) electrical wire. The 14 gauge wire is undersized for the breaker and may be a safety concern. Recommend further evaluation and repair by a qualified electrical contractor.

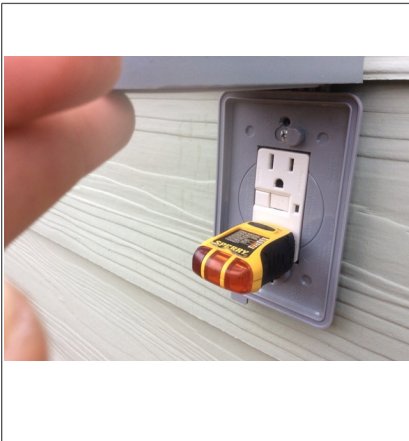
Comments Electrical Receptacle Operation: Repair the operation of the electrical receptacle located on the house rear exterior wall. The existing receptacle did not operate during the time of the inspection. Recommend further evaluation and repair by a qualified electrical contractor.

Electrical Receptacle Operation: Repair the operation of the electrical receptacle located on the house rear exterior wall. The existing receptacle did not operate during the time of the inspection. Recommend further evaluation and repair by a qualified electrical contractor.

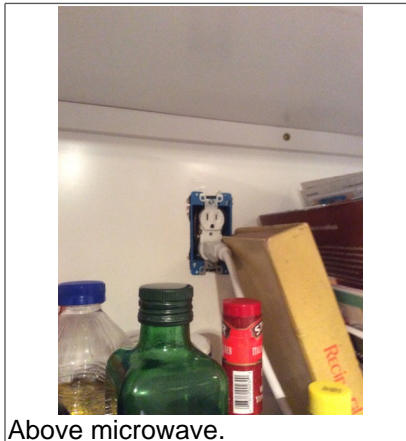
Above microwave.

Electrical Device Box Covers: Install a cover plate for the electrical device box located above the microwave. The device box(es) currently do not have wall cover plate(s) installed. Building code requires that electrical device boxes must have wall cover plates installed to fully enclose the wiring. Recommend further evaluation and repair by a qualified electrical or handyman contractor.

Electrical Device Box Covers: Install a cover plate for the electrical device box located above the microwave. The device box(es) currently do not have wall cover plate(s) installed. Building code requires that electrical device boxes must have wall cover plates installed to fully enclose the wiring. Recommend further evaluation and repair by a qualified electrical or handyman contractor.

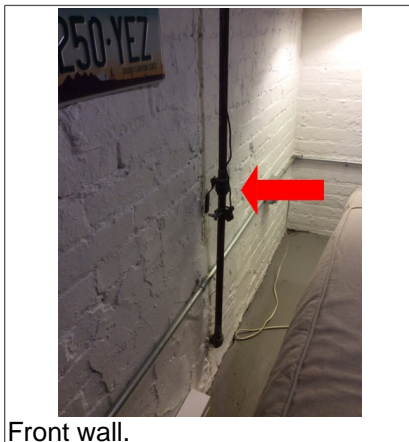
Front wall.

Comments Water Service Main Shut-off Valve: The main shut-off valve for the water supply system to the house appears to be located in the basement on the house front wall. In an emergency, or to service the complete water supply plumbing in the house, all incoming water supply to the house can be turned off at this location.

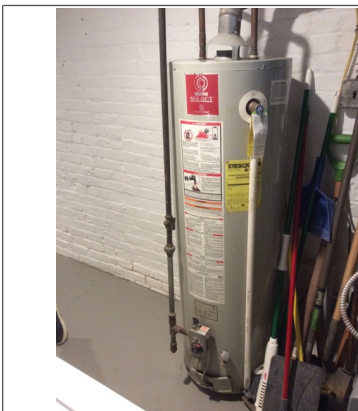
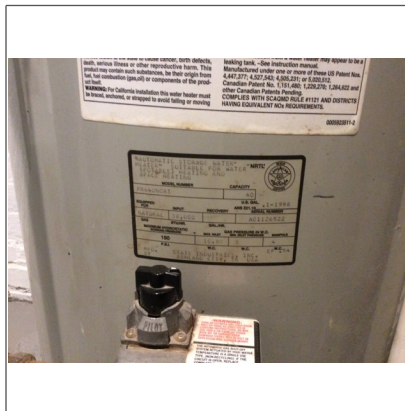
Comments Hot Water Heater (Gas Fueled)- Details: The natural gas fueled Hot Water Heater is estimated to have been manufactured in 2001, based on the device specifications label and/or serial number code. Units of this type have a life expectancy of 12-15+ years, although they can last longer if proper maintenance is observed and if they are stored in a protected area. The unit's construction materials appeared to be in normal condition for it's age and the water heater worked properly during the inspection. The 40 gallon capacity is adequate for up to 4 people with standard usage in the house. The Water Heater plumbing, ventilation system, and Temperature, Pressure, Relief (TPR) safety valve system appear to be properly installed. The water heater, however, is near the end of it's predicted lifetime at +/- 15 years. Recommend having the unit evaluated by a qualified plumbing contractor or budgeting for replacement as determined required.

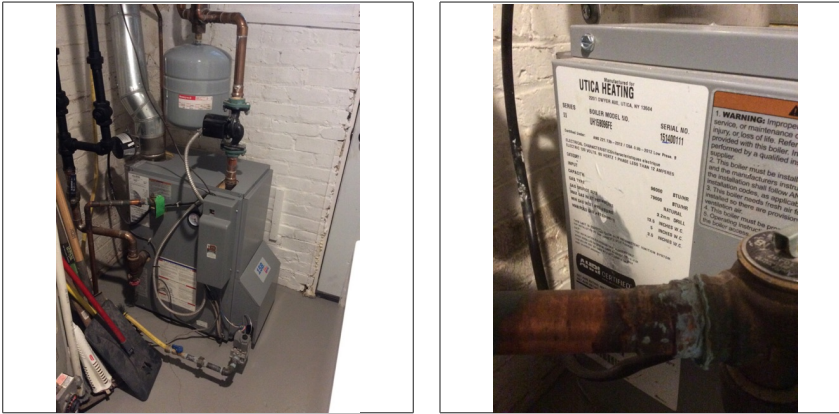
System Type	<input type="checkbox"/> Forced Air Furnace	<input type="checkbox"/> Forced Air Heat Pump	<input checked="" type="checkbox"/> Hot Water Boiler	<input type="checkbox"/> Electric Resistance
	<input type="checkbox"/> Convactor			
Distribution	<input type="checkbox"/> Air Ducting	<input checked="" type="checkbox"/> Metal Radiators	<input type="checkbox"/> Underfloor Pipe	<input type="checkbox"/> Underfloor Cable <input type="checkbox"/> Convactor
Comments	<p>Radiator Hot Water Boiler (Gas Fueled), Details: The natural gas fueled Hot Water Boiler for the Radiator heating system is estimated to have been manufactured in 2014, based on the device specifications label and/or serial number code. Units of this type have a life expectancy of 20-30+ years, although they can last longer if proper maintenance is observed and if they are stored in a protected area. The unit's construction materials appeared to be in good condition and the heating system worked properly during the inspection. The hot water output from the unit appeared good and heat was present at all radiators tested throughout the house.</p>

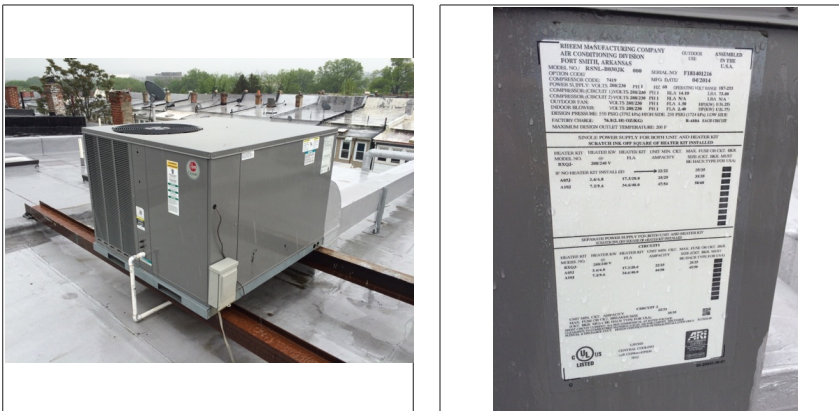
Comments Air Conditioning System (Electric), Details: The electric powered Air Conditioning cooling system for the house is estimated to have been manufactured in 2014, based on the device specifications label and/or serial number code. Units of this type have a life expectancy of 15-20+ years, although they can last longer if proper maintenance is observed and if they are stored in a protected area. The unit's construction materials appeared to be in good condition and the cooling system worked properly during the inspection. The air flow from the air registers was good and appeared to cool the building space effectively at the time of the inspection.

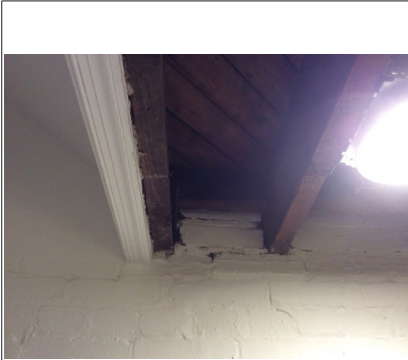
Basement.

Comments Smoke Detector Installation: Install a new smoke detector for the house basement and 2nd level. The is not a unit currently installed in the basement and the unit installed on the 2nd level did not operate to test properly. Building code requires that operating smoke detectors are installed for every floor of the house, including the basement, and within 15' or inside of bedrooms. Recommend further evaluation and repair by a qualified electrical or handyman contractor.

Smoke Detector Installation: Install a new smoke detector for the house basement and 2nd level. There is not a unit currently installed in the basement and the unit installed on the 2nd level did not operate to test properly. Building code requires that operating smoke detectors are installed for every floor of the house, including the basement, and within 15' or inside of bedrooms. Recommend further evaluation and repair by a qualified electrical or handyman contractor.
