Recovery of Rotorua geothermal field, New Zealand: Progress, issues and consequences

Bradley J. Scott^{a,*}, Dougall A. Gordon^b,
Ashley D. Cody^c

Abstract

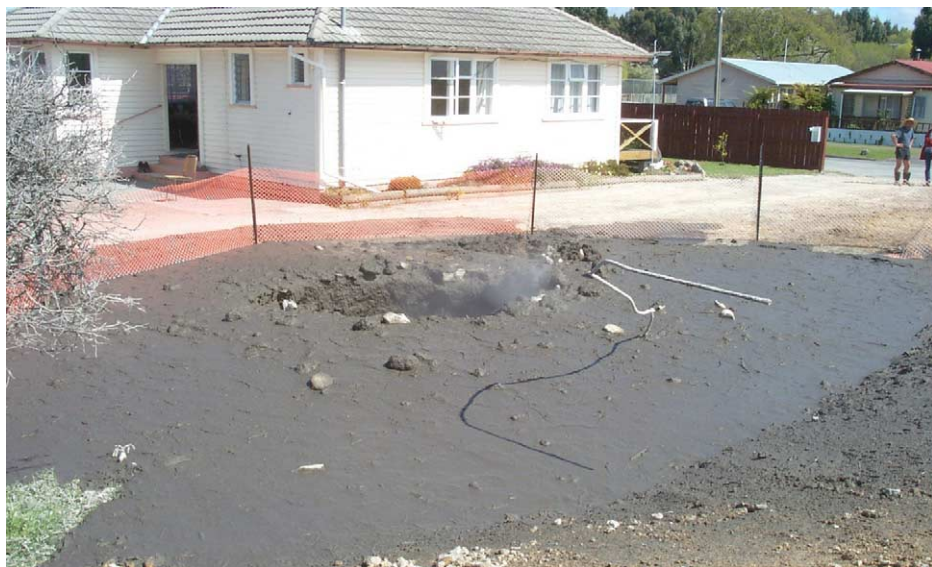
Fig. 9. View of a small scale overflowing event on 18 September 2000 in Tarewa Road. This event followed removal of the shallow concrete foundations of a rotary clothesline (photo: B.J. Scott, GNS).

flow events continue to date (Figs. 6–9). The resumption of activity in the Tarewa Road area resulted in several houses being damaged or forced to be relocated.

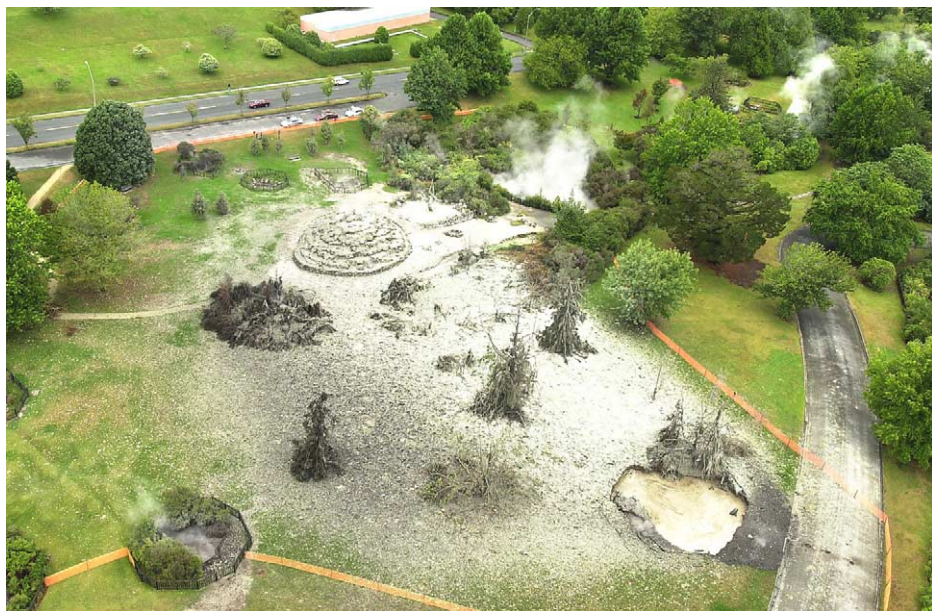
Fig. 10. Aerial view taken shortly after the 26 January 2001 eruption of Spring 721 in Kuirau Park, Rotorua (photo courtesy of the Daily Post newspaper).
