## Examples of how to NOT data center!

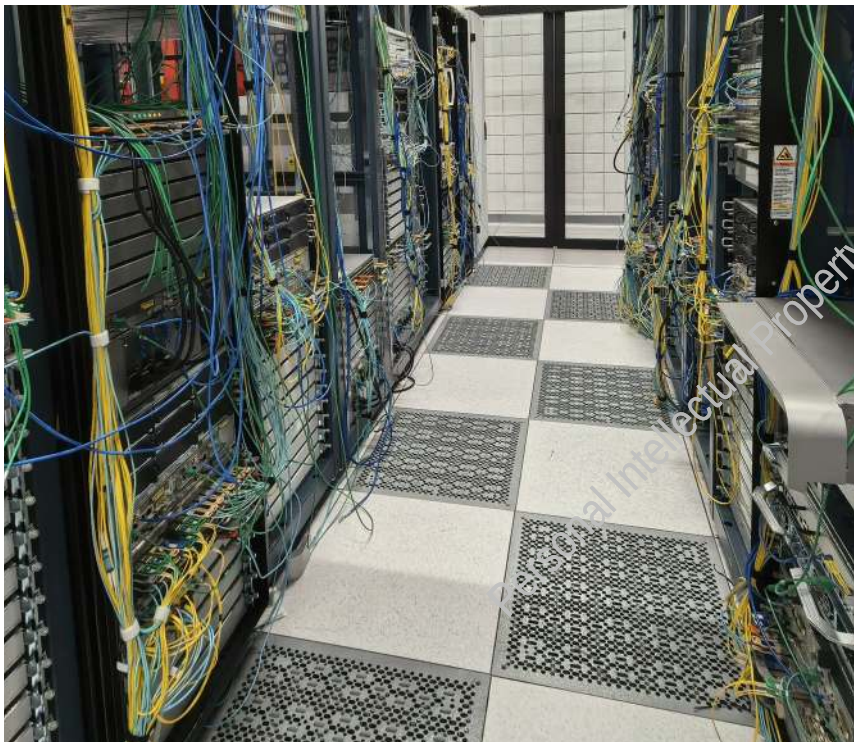
Just bad cabling management  
No Use of cable management trays  
Inappropriate cable length procurement for use

BAD design practice – only 2 tile space:

barely any room for maneuvering crash carts, equipment pallet jacks, etc...  
checkered perforated airflow tiles, budget constraints approach for equipment airflow utilization rather than full solid rows of perforated tiles for adequate airflow/cooling
