Ceramic Consultants

INDEX

- Normatives
- Tiled shower floors – falls to waste.
- Tiled balconies – falls and restrictions.
- Wet area – cracked wall tiles.
- Floor tiles – cracks and expansion joints.
- Strata – anti slip requirements

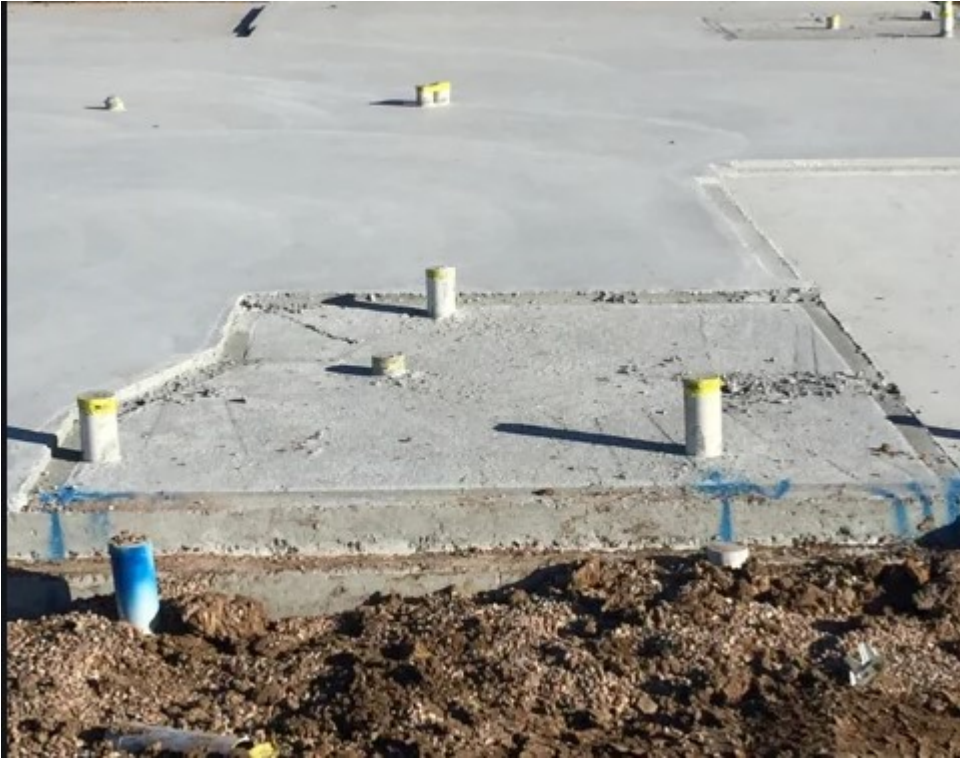
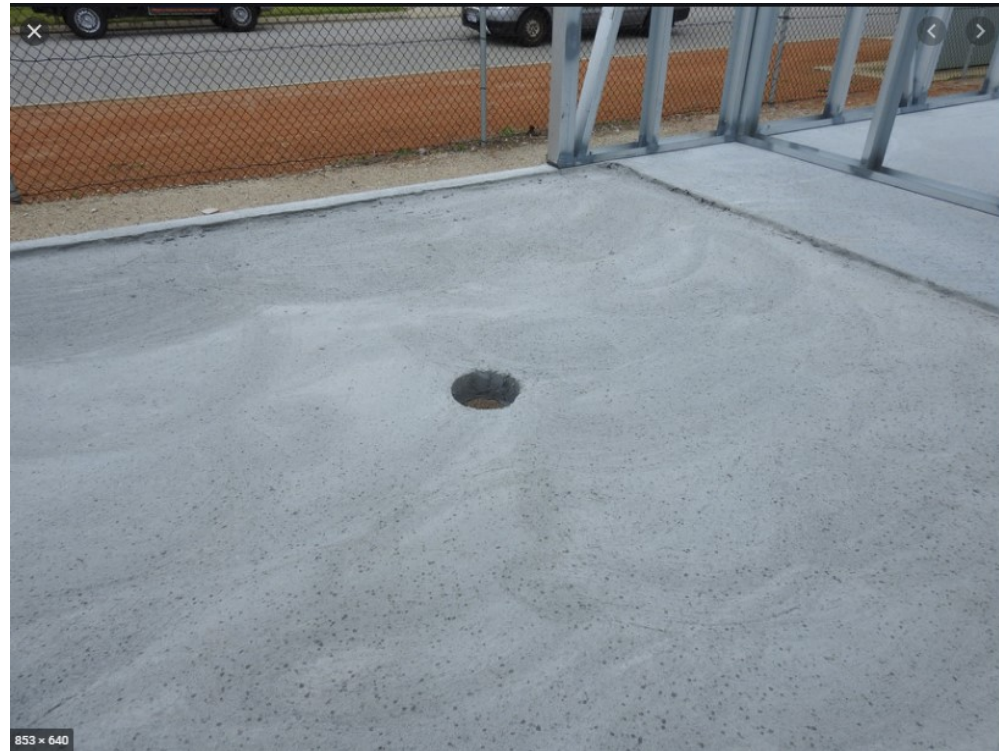
Possible issues affecting fall ratio:

- Insufficient concrete set down. Particular in hob-less installation.

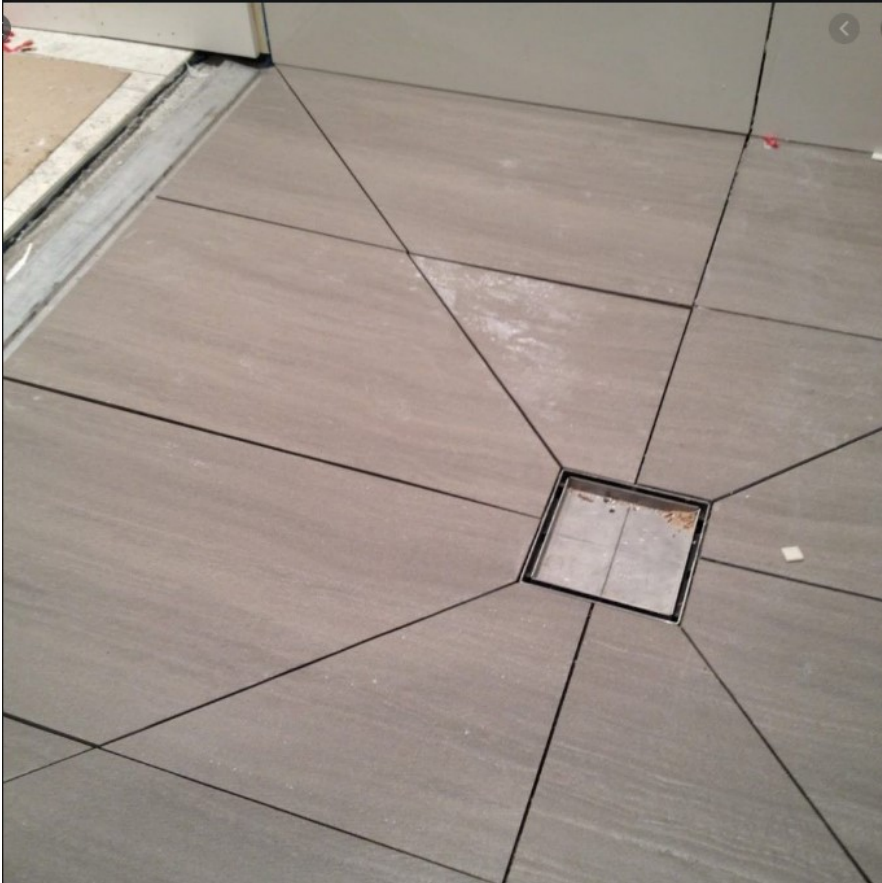
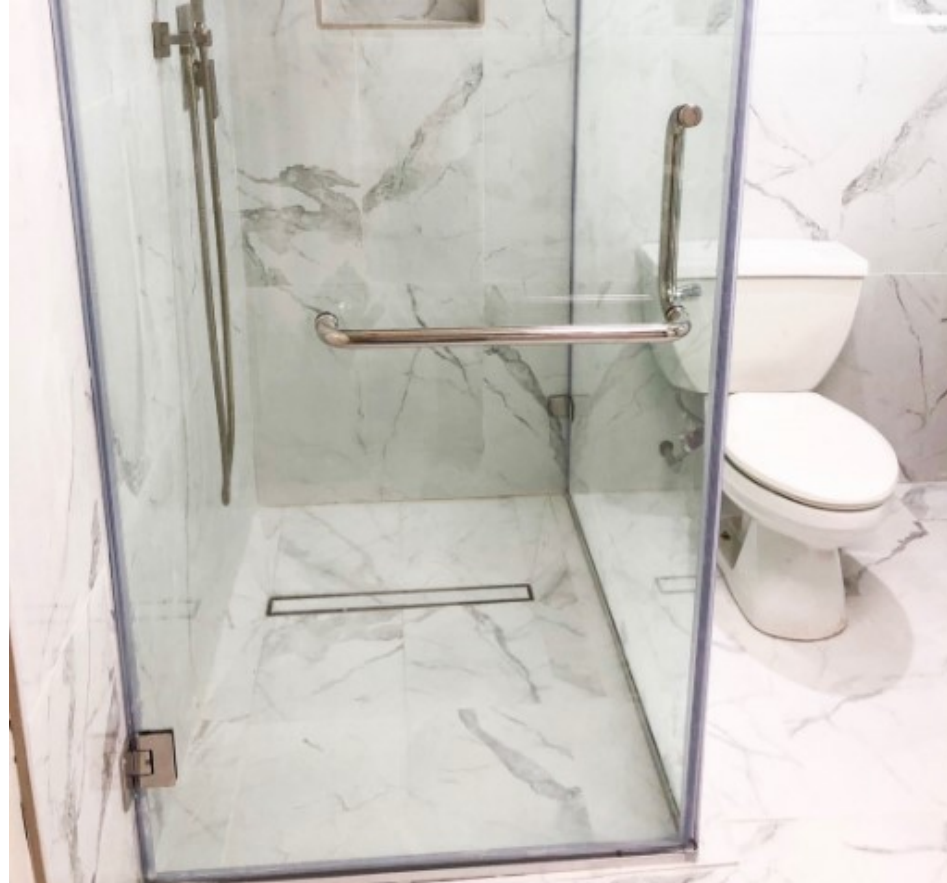
- Tiles too large. Will cause lipping or ponding.
- Location of floor wastes.

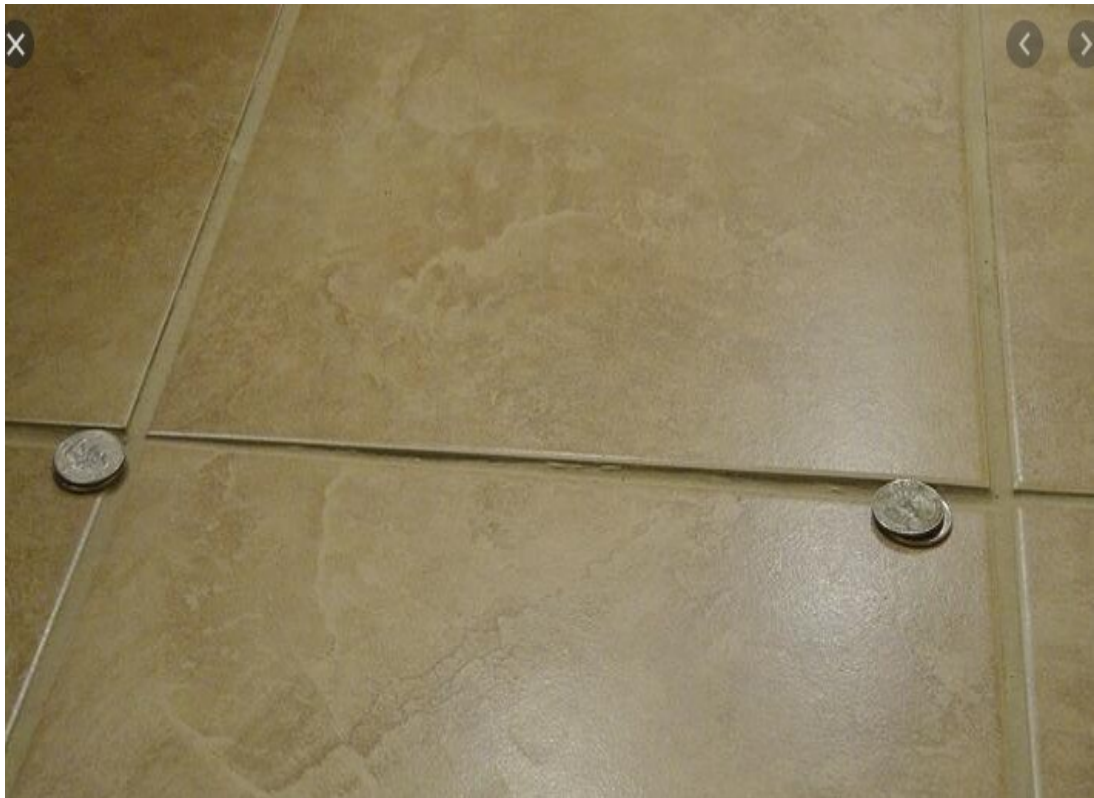
Inexperienced installer.

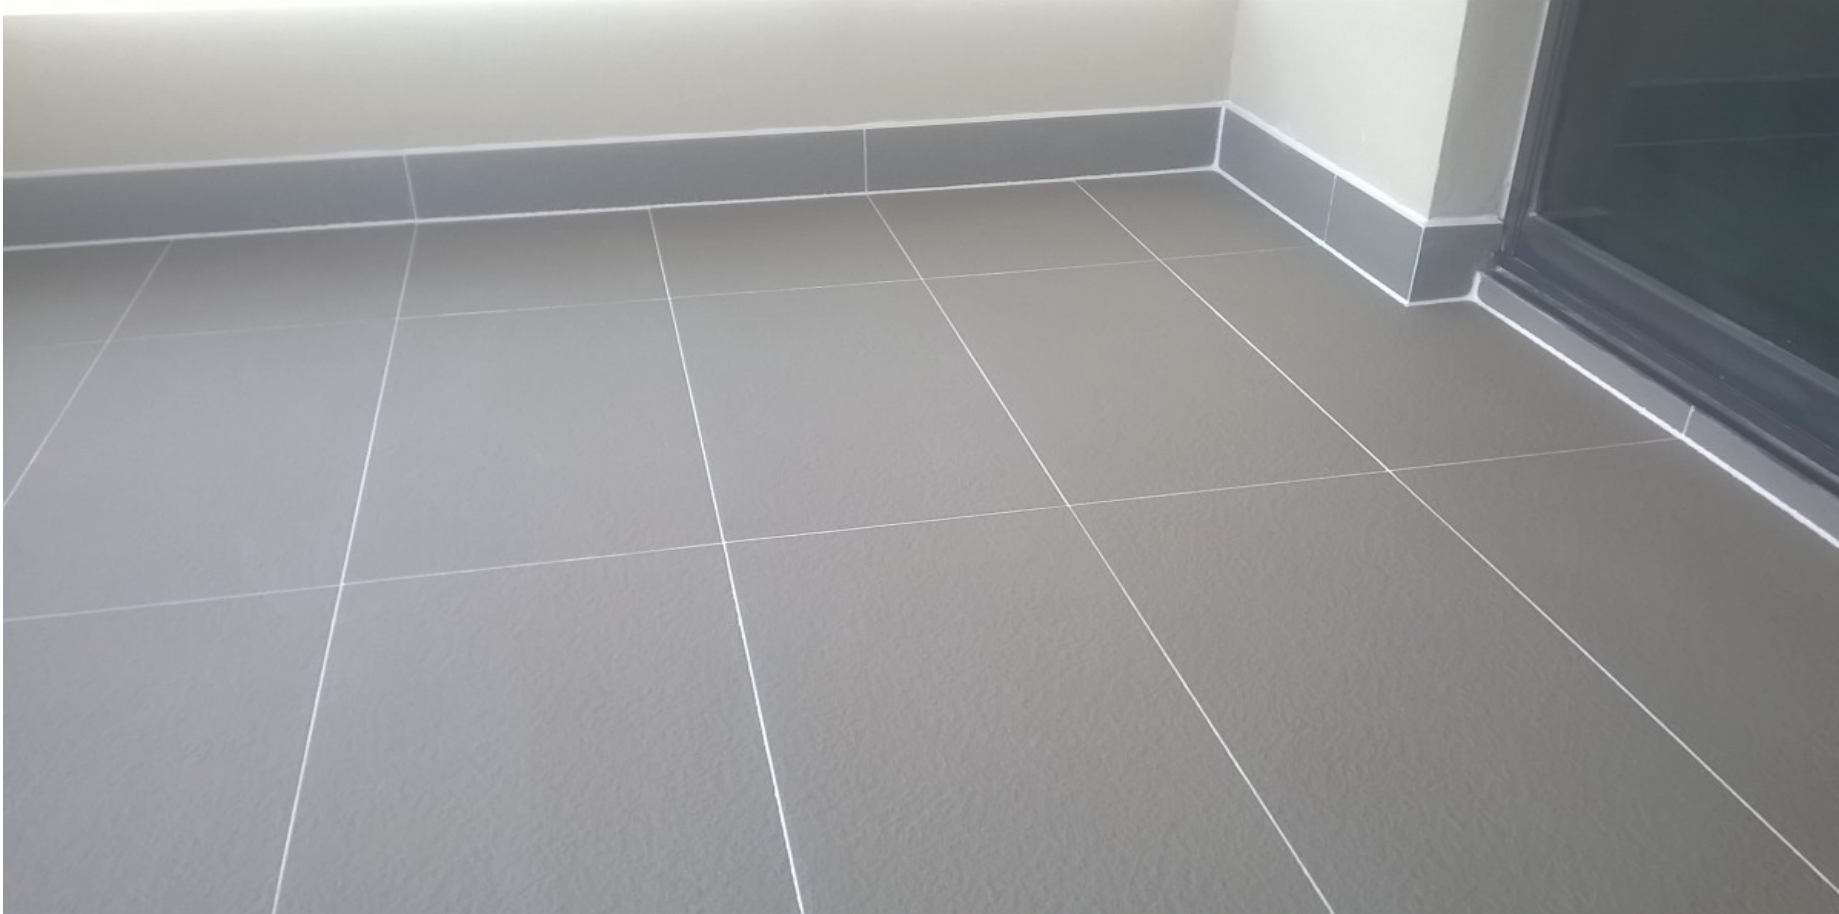
- Threshold requirement.

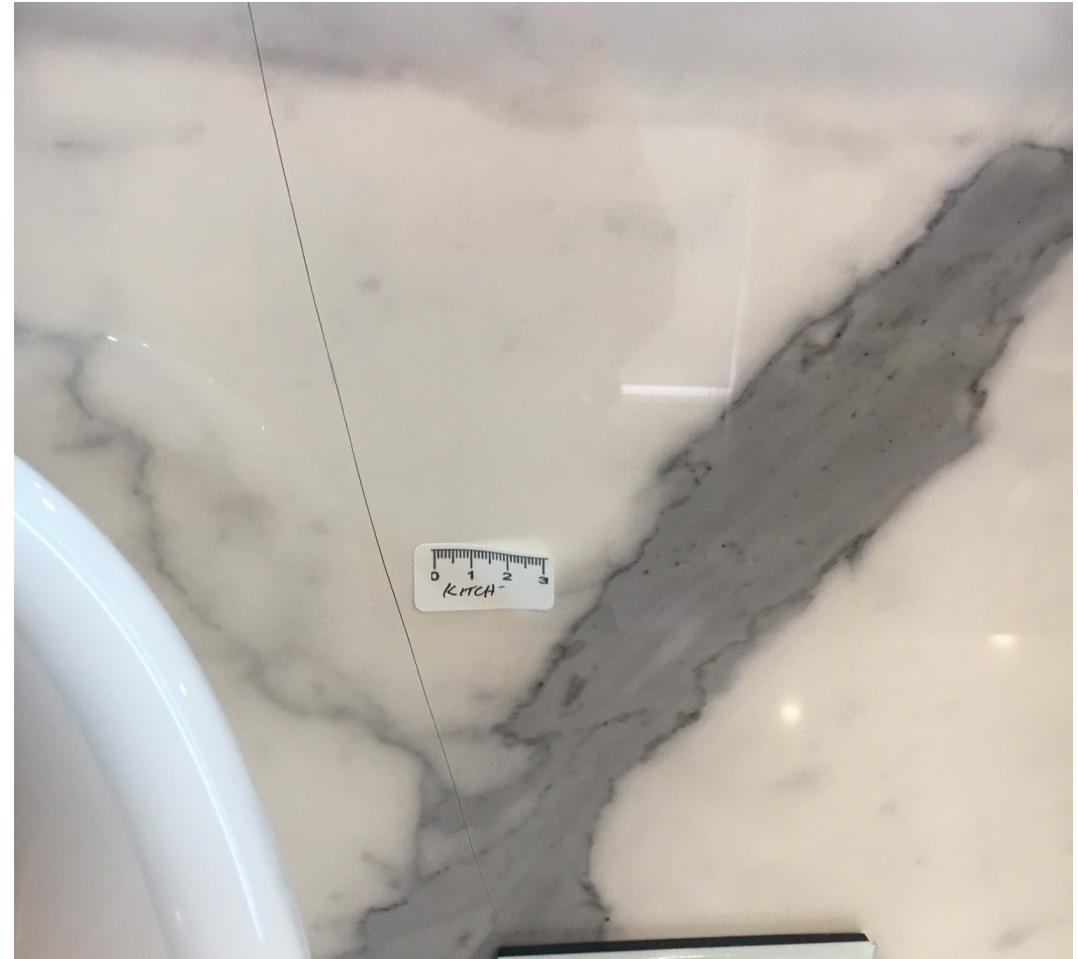
- 1. Nature of the crack, multiple tiles cracking, cracks following each other, and cracked substrate.

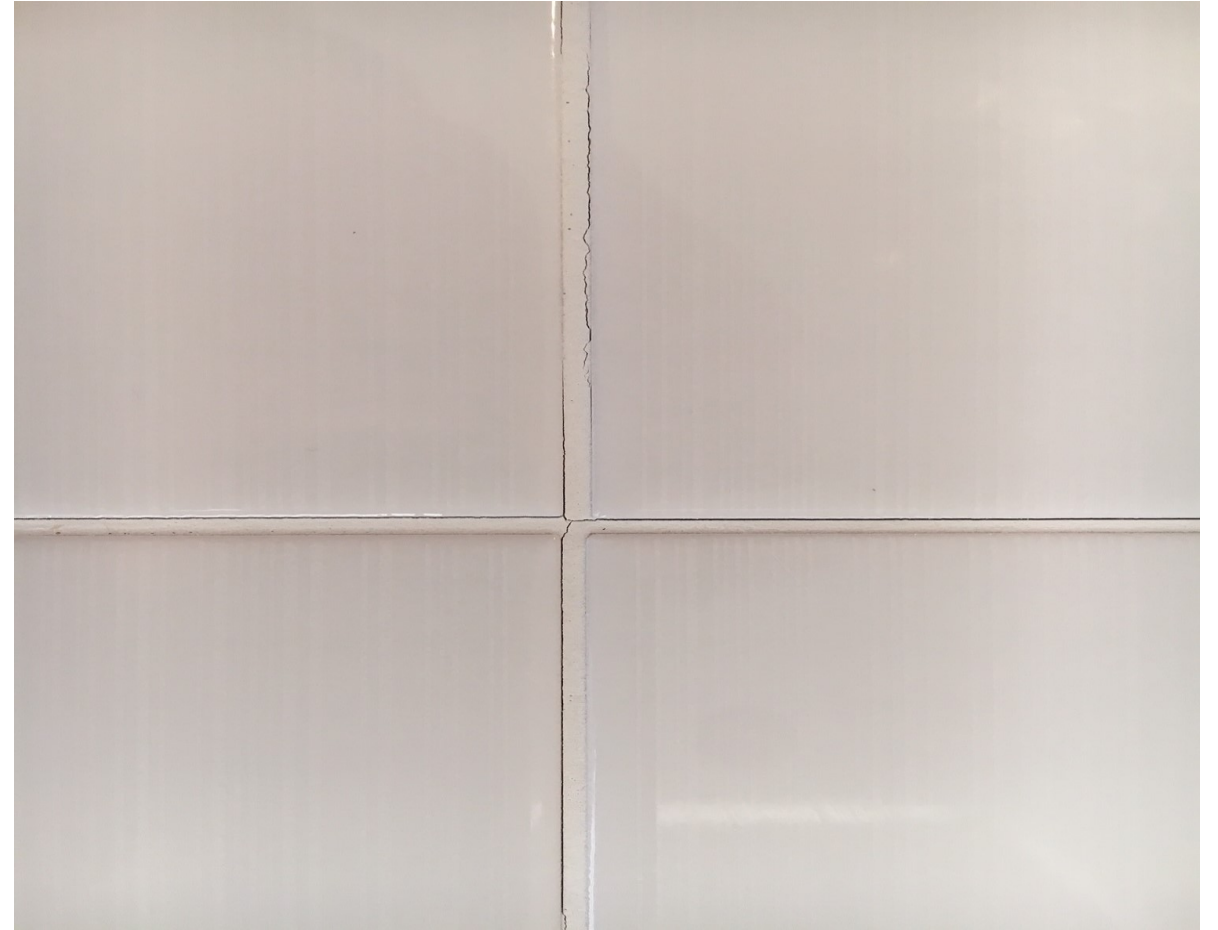
- Cracked grout joints in both axes.

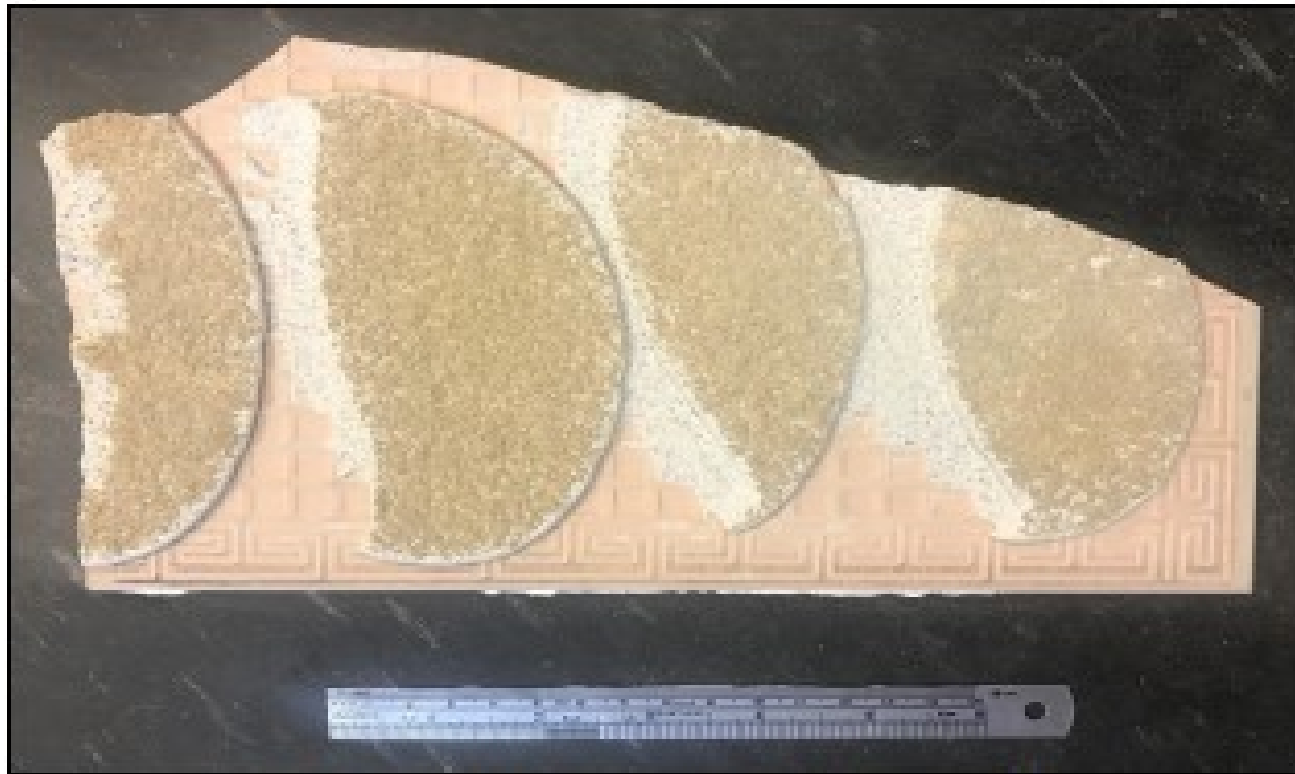
Sometimes a destructive investigation is required.

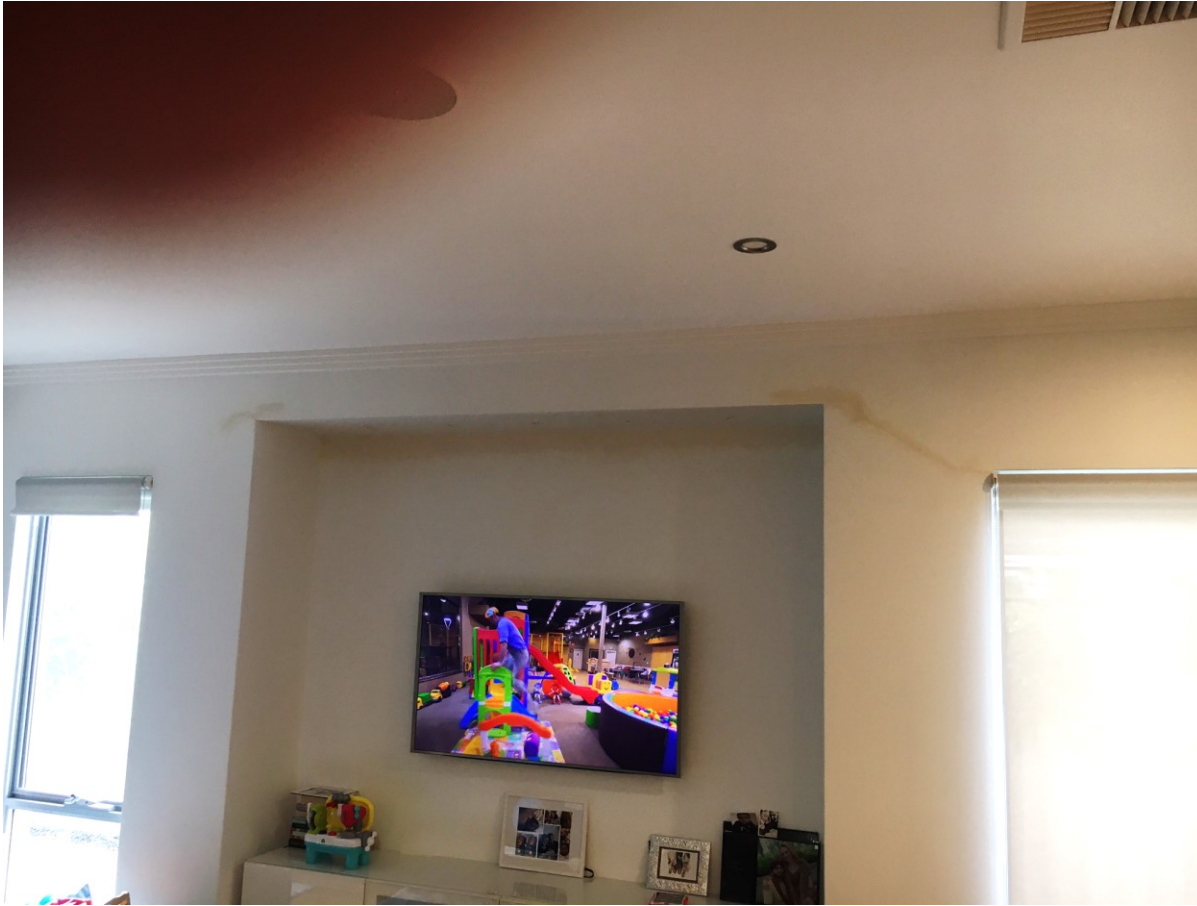
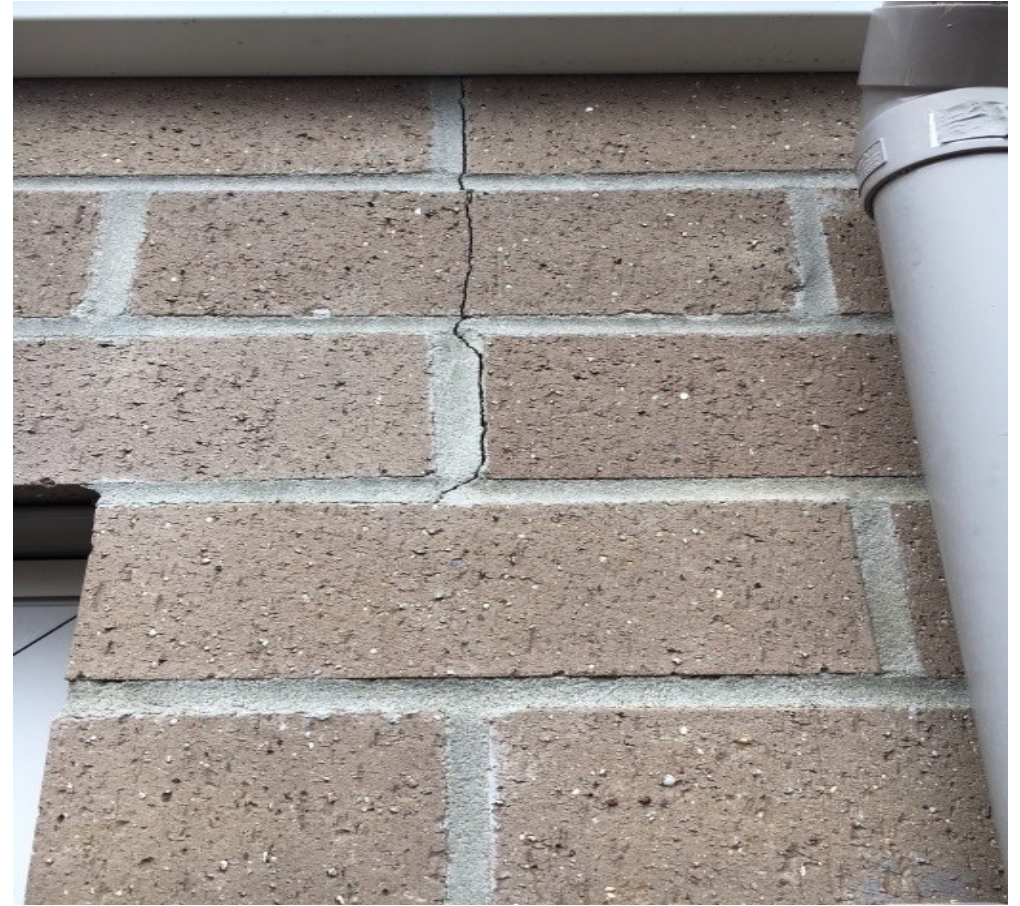
Other signs of structural movement

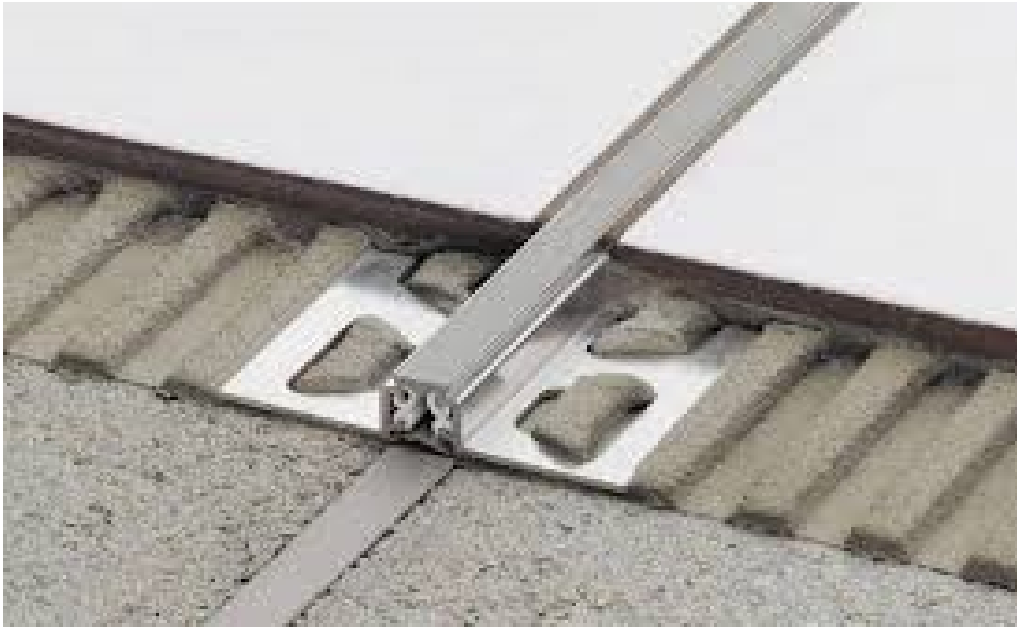
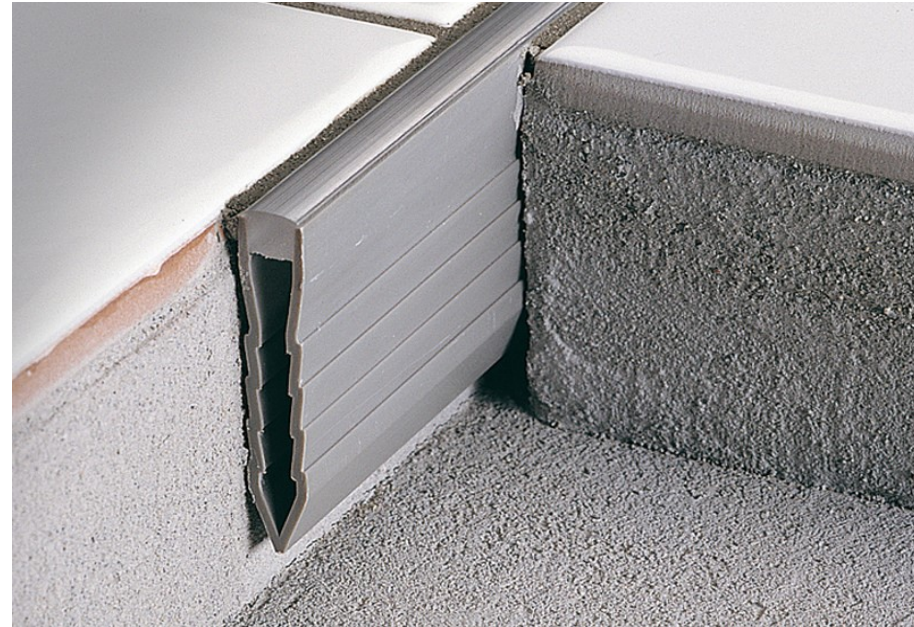
- AS 3958.1 requires any structural movement joints in the substrate to be “continued” in the tiling installation . This includes any screeds.
- The stresses of expansion/contraction of the various materials within the localised building element, thermal stresses and building element deflection will have a discernible impact on tiling installation.

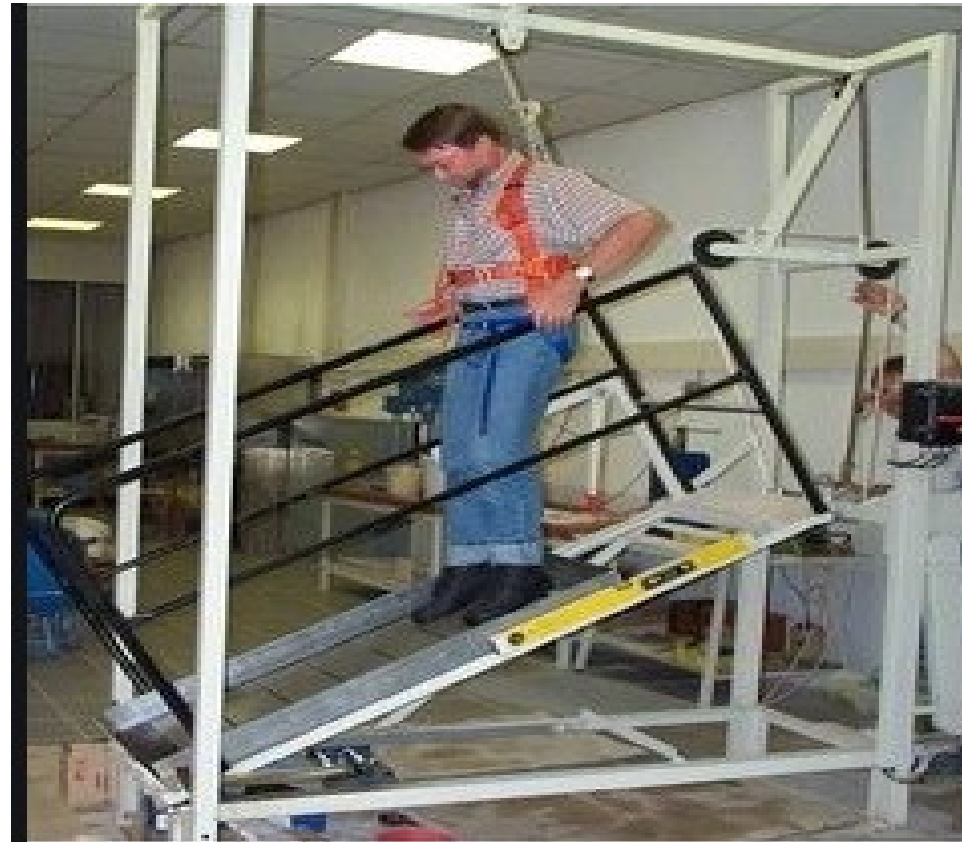
- The “R” rating is determined using the German Ramp Platform. The platform is adjusted to pre set angles and a human walks up and down the platform until an angle is reached where they slip.
- Ratings range from R9 (least slip resistant) to R13 (most slip resistant).

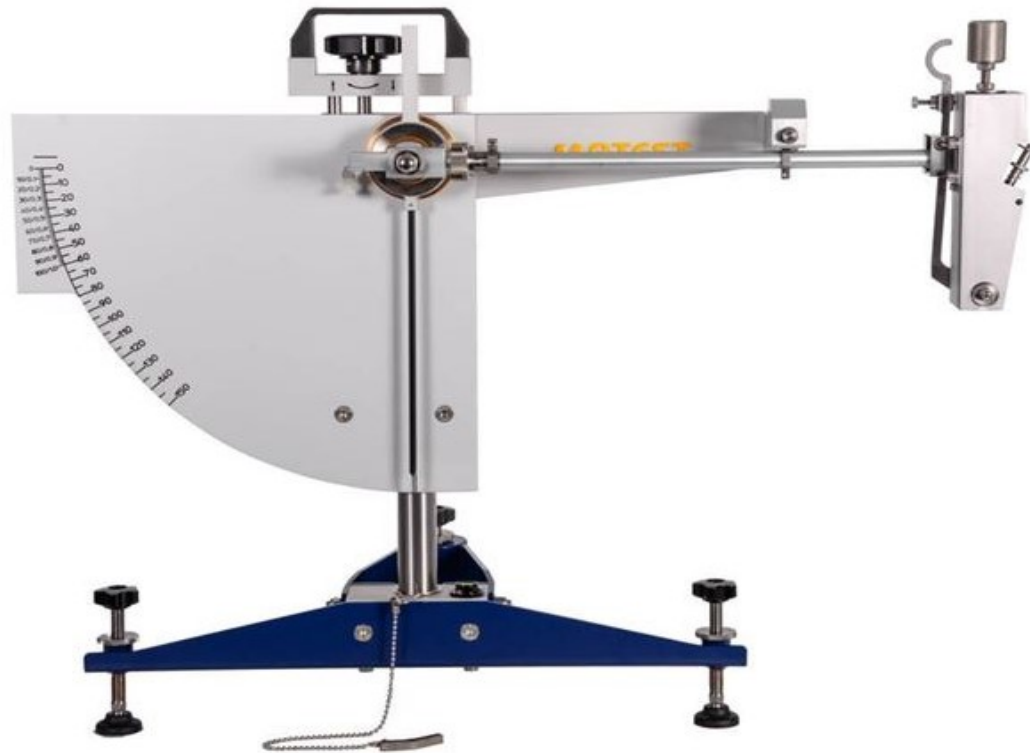
- The “P” rating is determined by using the British Pendulum Tester.
- A swinging arm with a rubber foot stiles the surface and the amount of resistance the rubber fot encounters is measured by a needle and corresponding numbers.
- PO is the lowest resistance and P5 is the highest resistance.
