Lightning Incident with Multiple Natives Injured in the Sierra Nevada de Santa Marta - Colombia

Description of Scenario

Abstract— This paper reports the lightning-caused tragedy on October 5th, 2014, when 11 Colombian Indigenous inhabitants died and 15 were seriously injured inside an Unguma, a ceremonial house constructed with traditional methods. The accident scenario and the possible interaction mechanism that produced several traumata in the indigenous men are described. The ground potential rise inside the Unguma and the energy absorbed by a simulated human body placed on the floor surface at eleven different positions and distance spans from the possible lightning impact point are calculated. The calculation was performed through electromagnetic numerical simulations of a lightning direct impact on a simplified model. A parametric analysis was performed with four soil resistivities.

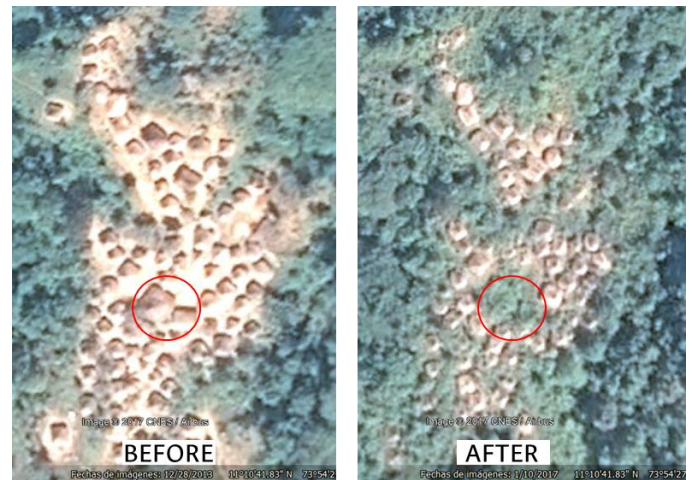
Fig. 6. Satellite images from Kemakumake before (12/28/2013) and after tragedy (1/10/2017). The circle encloses the *Unguma* location. Source: adapted from Google Earth.

The lightning-caused incident ended in the tragedy that left 26 casualties, 11 people dead and 15 injured. Among the fatal victims were 7 men of the same family of the Mamo who was leading the meeting and their son, also a leadership of the village. After the lightning tragedy, the village of Kemamumake was totally abandoned as shown in Fig. 6.

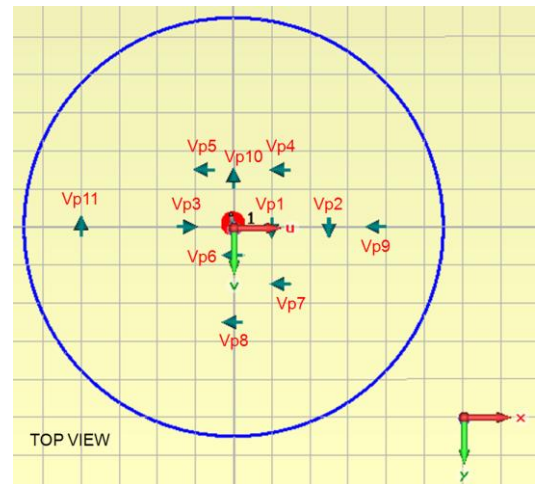
Fig. 8. Top view showing the location of the eleven voltage probes on the floor surface. The grid is 1 meter between the squares.

Results summarized in Table 1 show energy levels below 20 J for configurations of type A, with a distance span of 1 m and placed at more than 1 m away from the surface strike point.

Note: Probe refers to monitor of voltage for each of the eleven location as shown in Fig. 8.; Orientation refers to each of the relative three direction (lengthwise, crosswise and diagonal) of probes from the center to outside; Distance to strike point is the distance from the lightning impact point to the probe; ρ_n is the soil resistivity.
