FRAME 2 OF 4
REV F

ELECTRO-MOTIVE DIVISION
GENERAL MOTORS CORPORATION
LA GRANGE, ILLINOIS, U.S.A.

AIR DUCT ASSEMBLY
AND APPLICATION

8363313

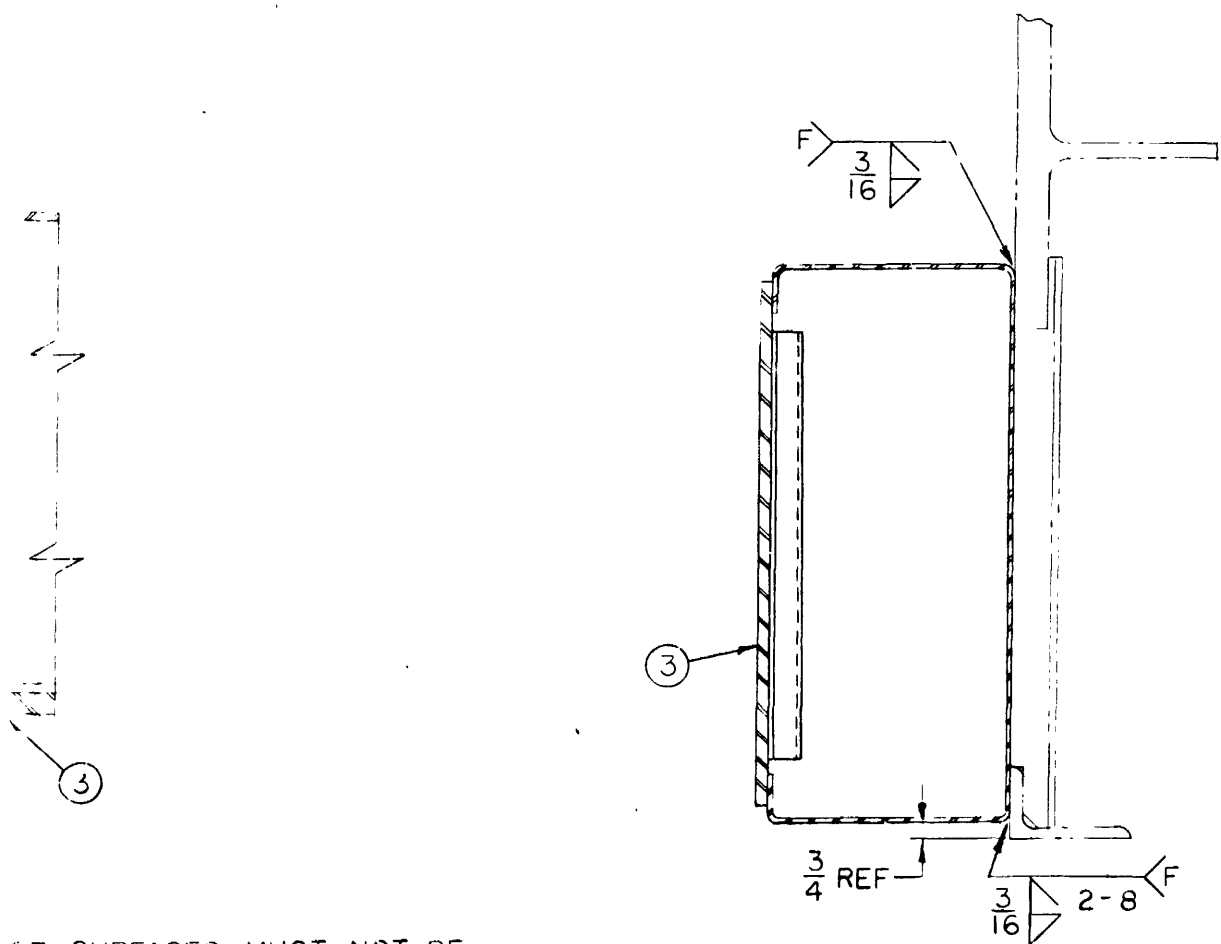
SECTION H-H

SE SURFACES MUST NOT BE
ATED BACK OF EDGE OF TOP
TE OR FLOOR SUPPORT ANGLES.
ICAL FOR ITEMS 1 AND 4.
