# Predictive Analytics for Transit Optimization

Leveraging Traffic Data and Cloud AI

Brett Tackaberry

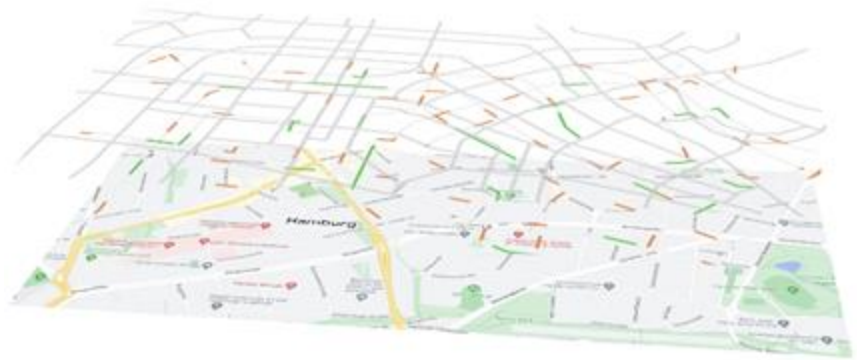
Calculate intersection traffic flow metrics:

- Car count
- Delay time
- Split failures
- Queue length
- Stop events

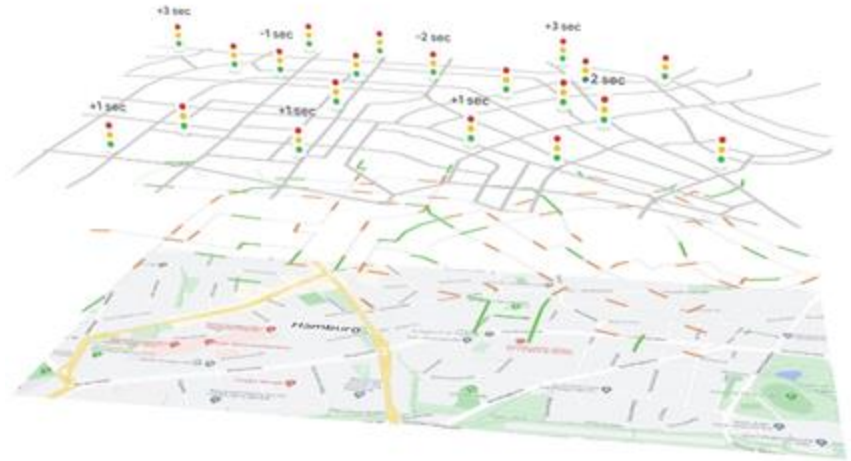
Google calculates an improved plan that better fits traffic patterns

The city then receives these recommendations

Once received, the city can then validate & implement the recommended modification

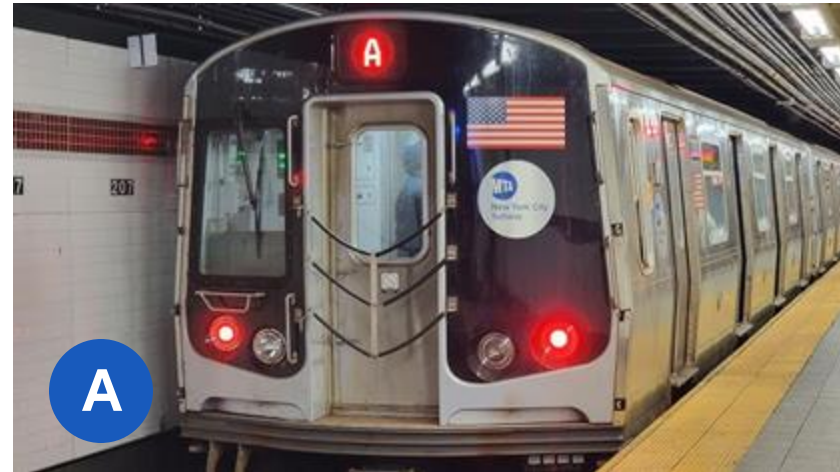
- Smartphones retrofitted onto subway cars
- Capture subtle vibrations and sound patterns through built-in sensors
- Data sent in real time to cloud-based systems, for AI/ML to generate predictive insights.

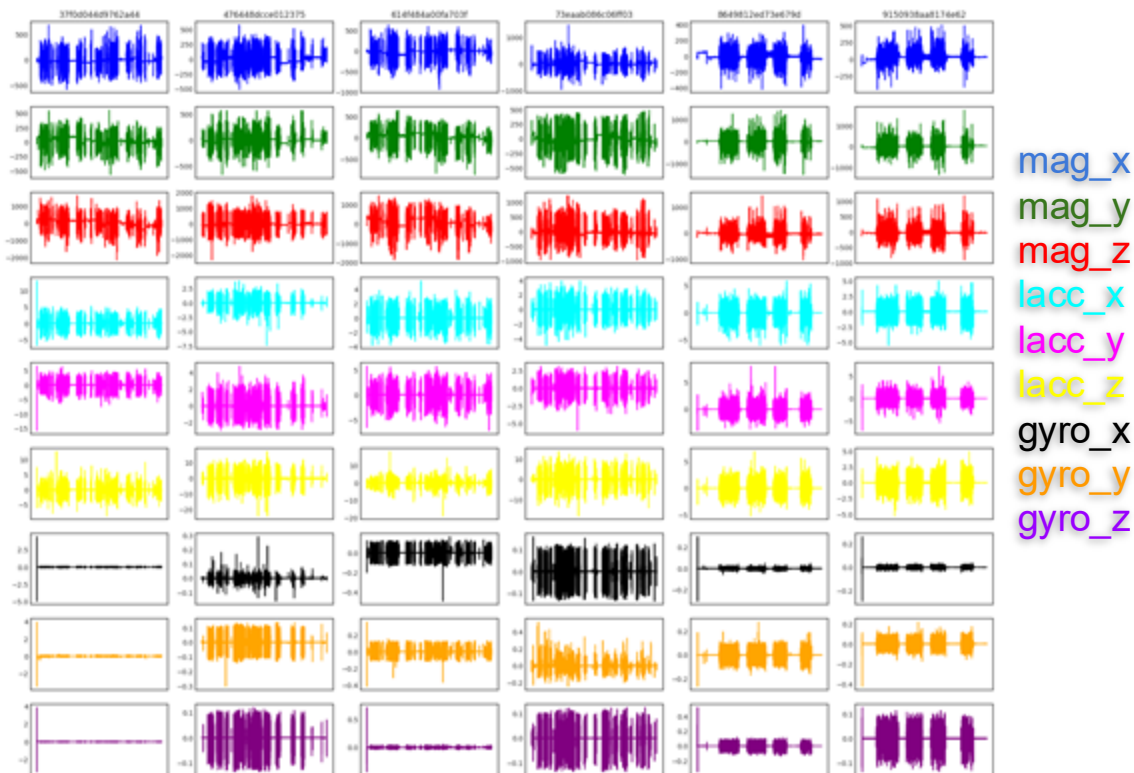
➤ **3 sensor data types; 3 axes; 6 phones**

- Magnetization, Acceleration, Gyroscopic Precession

- Which track is the train on?
- Where (1 ft precision) is the train?
- At every point in time, is the train running over a defect?

- 190-200 used for training
- 201-203 saved for test

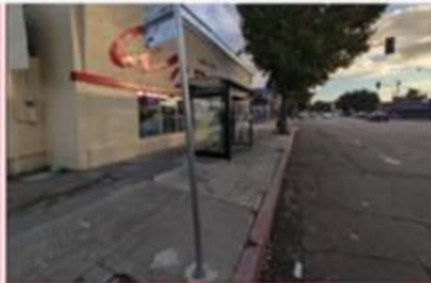
The bus stop appears to be moderately dirty. There is some litter on the sidewalk and along the curb. The bus shelter has graffiti on the glass. The sidewalk has some cracks and appears to be in need of repair. There are no immediate safety concerns. The bus stop sign is in good condition. The street appears to be in a state of disrepair with cracks in the asphalt. The overall cleanliness of the bus stop is poor due to the litter and graffiti. The safety level is good as there are no immediate hazards.

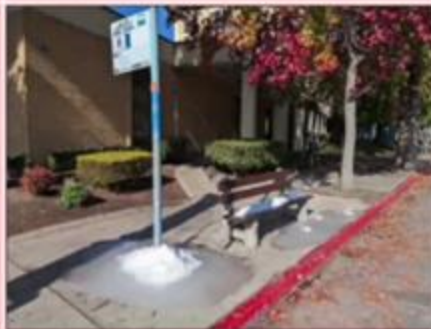
The bus stop appears to be in a state of mild disrepair. There is a bus stop sign, a bench, and some landscaping. The bench has a small amount of snow on it. There is a large patch of ice on the ground around the bus stop pole and a smaller patch near the bench. The presence of ice on the ground creates a potential safety hazard, making the area unsafe. The area is generally clean, with no visible litter or graffiti. There are some leaves on the ground near the curb. Two people are visible in the background.

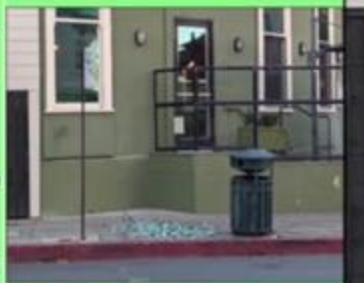
18 SC

The bus stop area shows a significant cleanliness and safety concern. There is a large amount of broken glass scattered on the sidewalk near the trash can. This poses a direct safety hazard due to the risk of cuts. The presence of broken glass also significantly lowers the cleanliness level. The trash can appears to be in good condition. There are no people visible in the image. The bus stop sign is present and appears to be in good condition. The building behind the bus stop has a glass enclosure, and there are lights on the building. The sidewalk is otherwise clean, but the broken glass is a major issue.

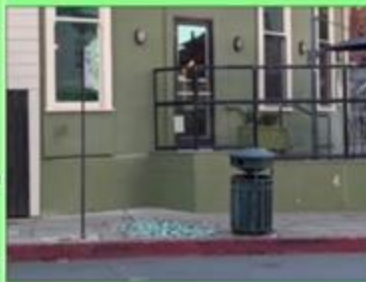
18 SC

The bus stop area shows a significant cleanliness and safety concern. There is a large amount of broken glass scattered on the sidewalk near the trash can. This poses a direct safety hazard due to the risk of cuts. The presence of broken glass also significantly lowers the cleanliness level. The trash can appears to be in good condition. There are no people visible in the image. The bus stop sign is present and appears to be in good condition. The building behind the bus stop has a glass enclosure, and there are lights on the building. The sidewalk is otherwise clean, but the broken glass is a major issue.
