Lostine River/City of Lostine diversion Structure Replacement

Completion Report
For

Bonneville Power Administration Project Number 1992-026-01

By R. Coby Menton, Grande Ronde Model Watershed

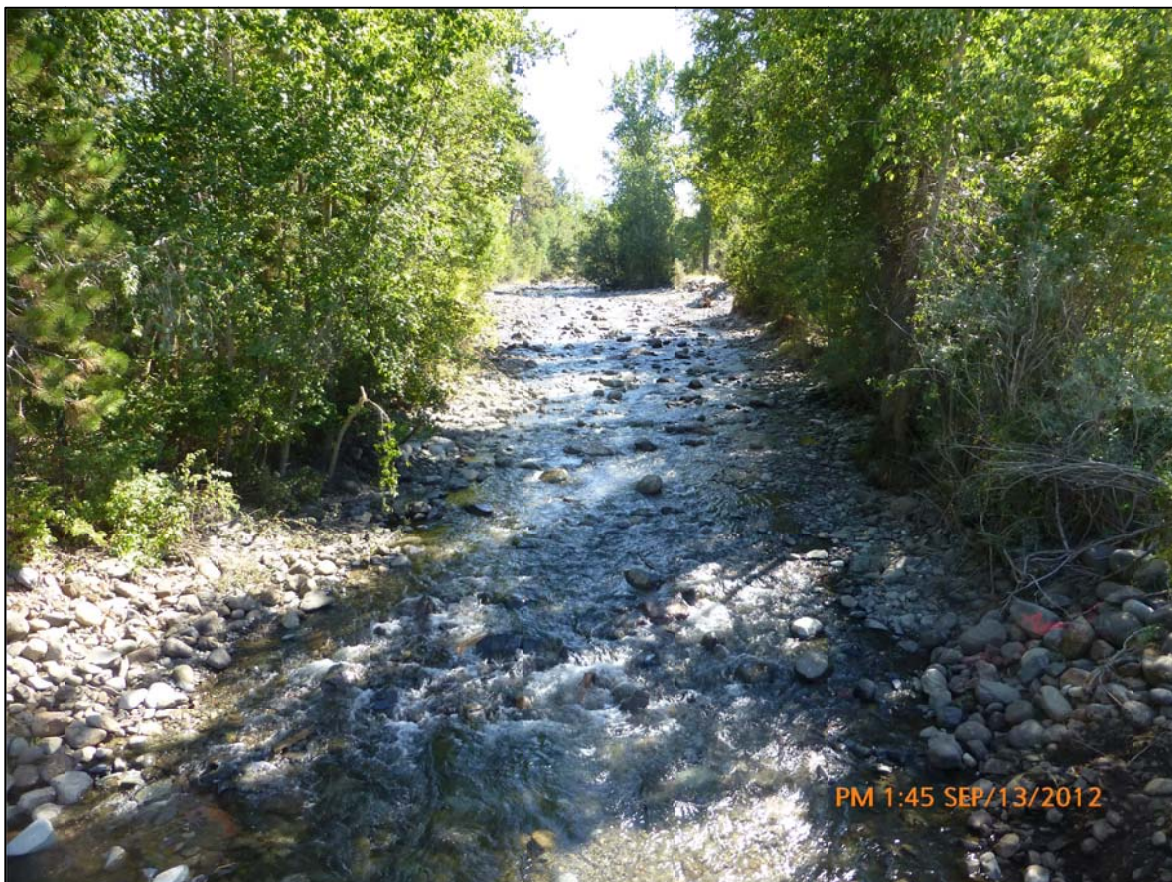
Photo 1: Looking upstream at the completed fishway and passage restoration project. Photo by R. Coby Menton.

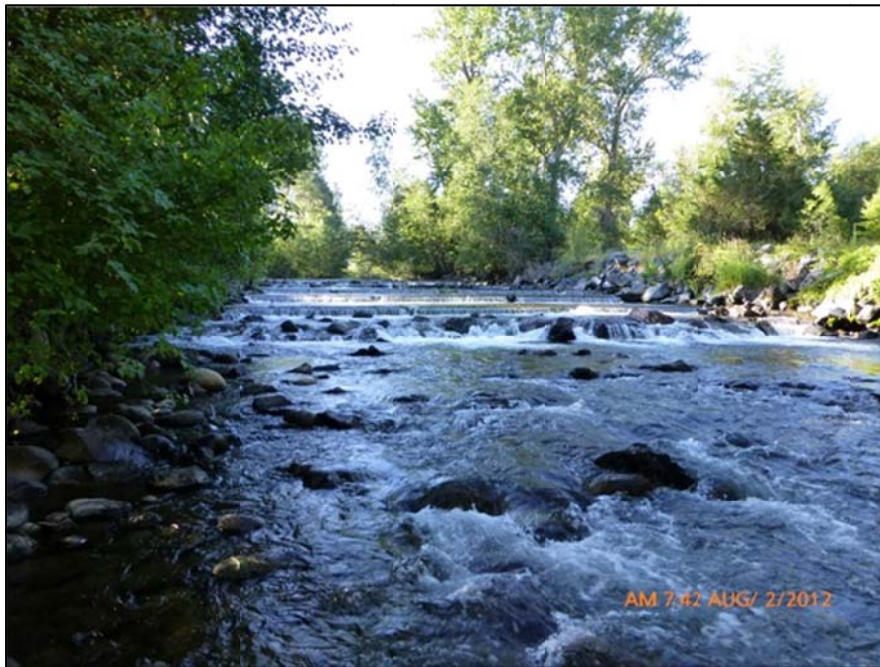
Photo 2: This photo taken on August 2, 2012 before project construction shows the fish ladder from the downstream side. What looks like piled rocks at the bottom is the rock, concrete and metal used to shore up the lowest wall. Low flow notches are visible in the 5 walls and the elevation difference between each wall is 15-inches.

Problems with this fish ladder include its deteriorating condition, passage for all ages of aquatic organisms was not provided for and it does not meet current fish passage criteria as directed from both the State and Federal fish management agencies. Including the above pictured sixth structure the concrete walls had to be stabilized at least one other time following initial construction. This temporary fix required an excavator to push the walls back to a vertical position and shore them with large boulders. Due to high flow and age the walls were tipping over and becoming increasingly unstable. Had the structure washed out the ditch company would have had no provisions to divert irrigation water except by once again constructing a push-up dam.

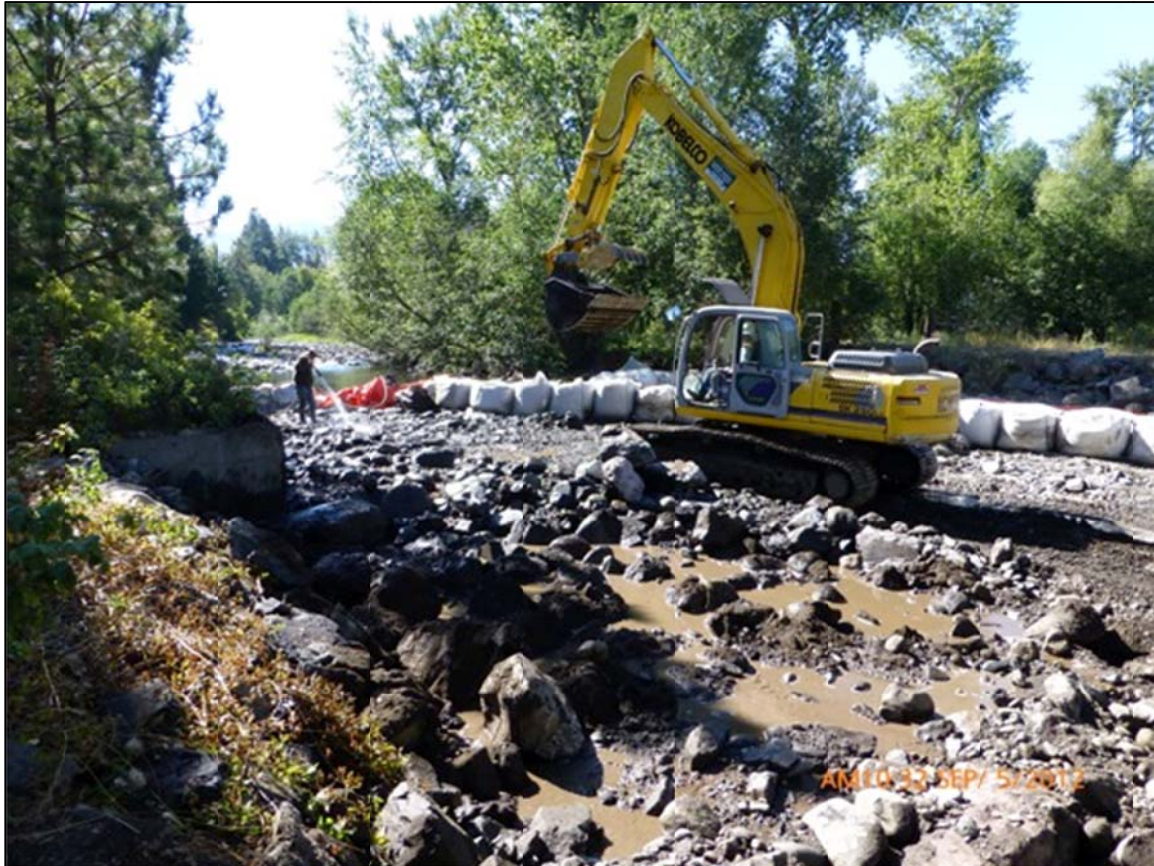
Photo 3: Photo taken on September 5, 2012 near the upstream end of the project looking upstream. In this photo the contractor is blending channel bottom material to prevent flow from going subsurface. The excavator places the material, provides compaction and the high-pressure water seals the channel bottom. To implement instream projects flow is diverted around the work area and in this case flow has been moved to one side of the river channel and isolated with the white sand bags and plastic tarps.

A second component of construction was the placement of river gravel between each of the vanes. This process is necessary to simulate a natural stream bottom and stabilize the cross-vanes. The size of this material ranged from sand to medium sized cobbles and was installed by a process called blending. Blending is a method by which the material is installed in small amounts, incorporated with existing material, compacted with heavy equipment and sealed with high-pressure water. Blending results in keeping river flow on the surface rather than subsurface as could happen in loose unconsolidated material.

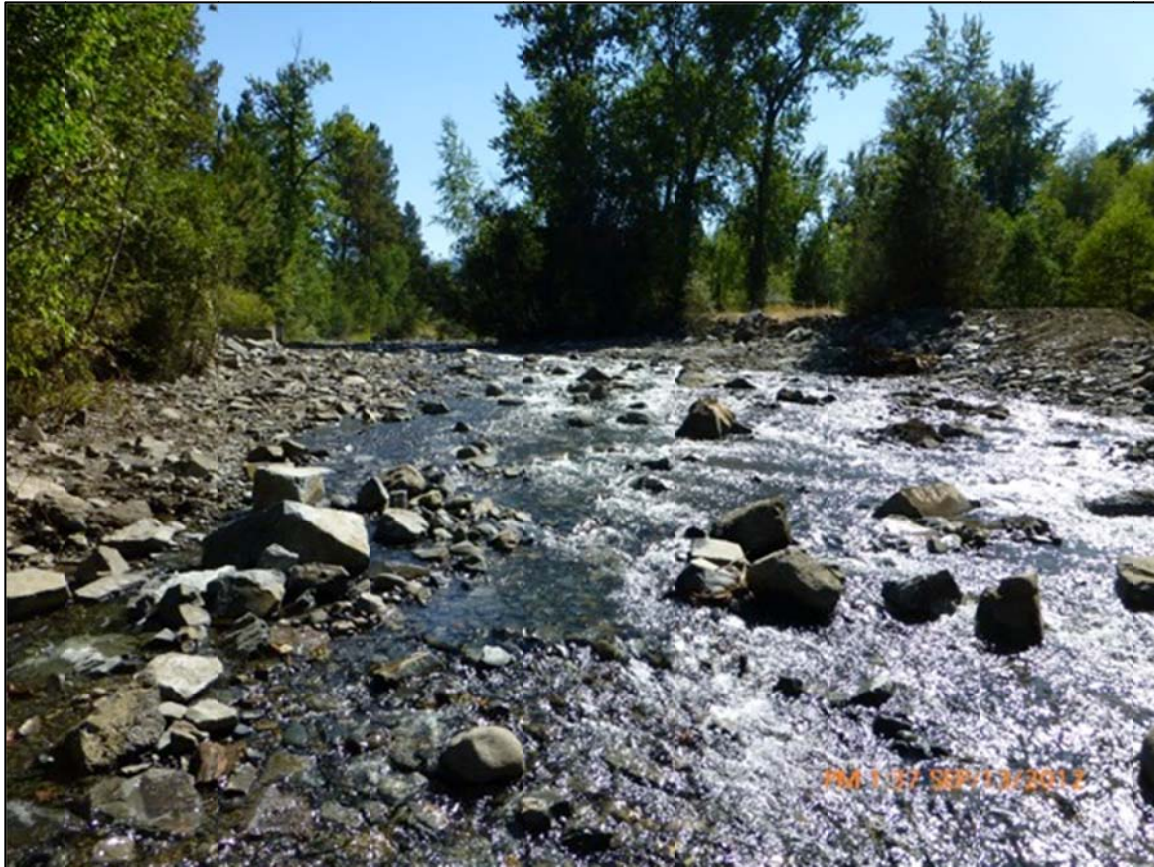
Photo 4: This photo taken on September 13, 2012 is from the same location as photo number 2. At the time of the photo water had been running through the newly constructed project for 2 days and flow did not go subsurface. The fishway built in the 1960's has been overtopped with a natural channel design fishway that gives the river a more natural appearance as well as restoring fish passage.

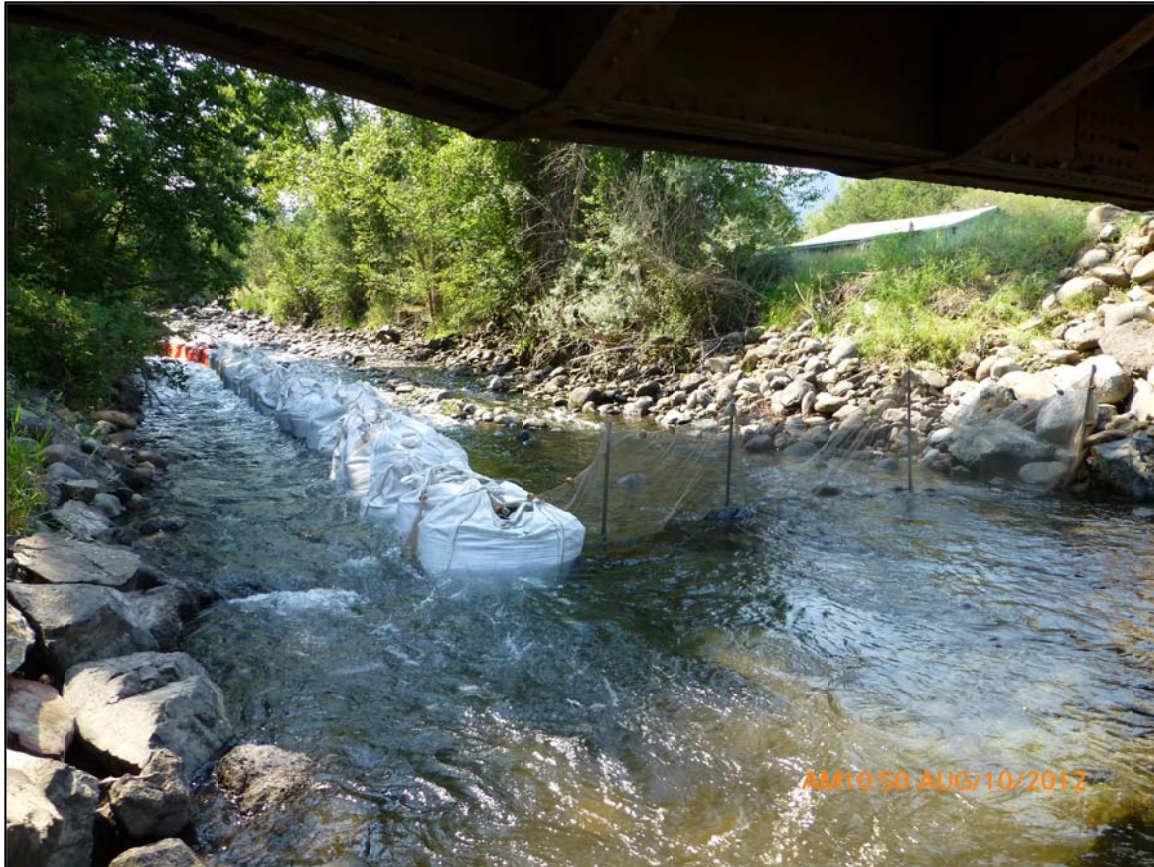
Photo 5: Photo taken on August 10. Standing under the bridge at the bottom of the project. The flow on the left is the fish passage channel and the block-netted portion on the right is the side of the river that was salvaged.

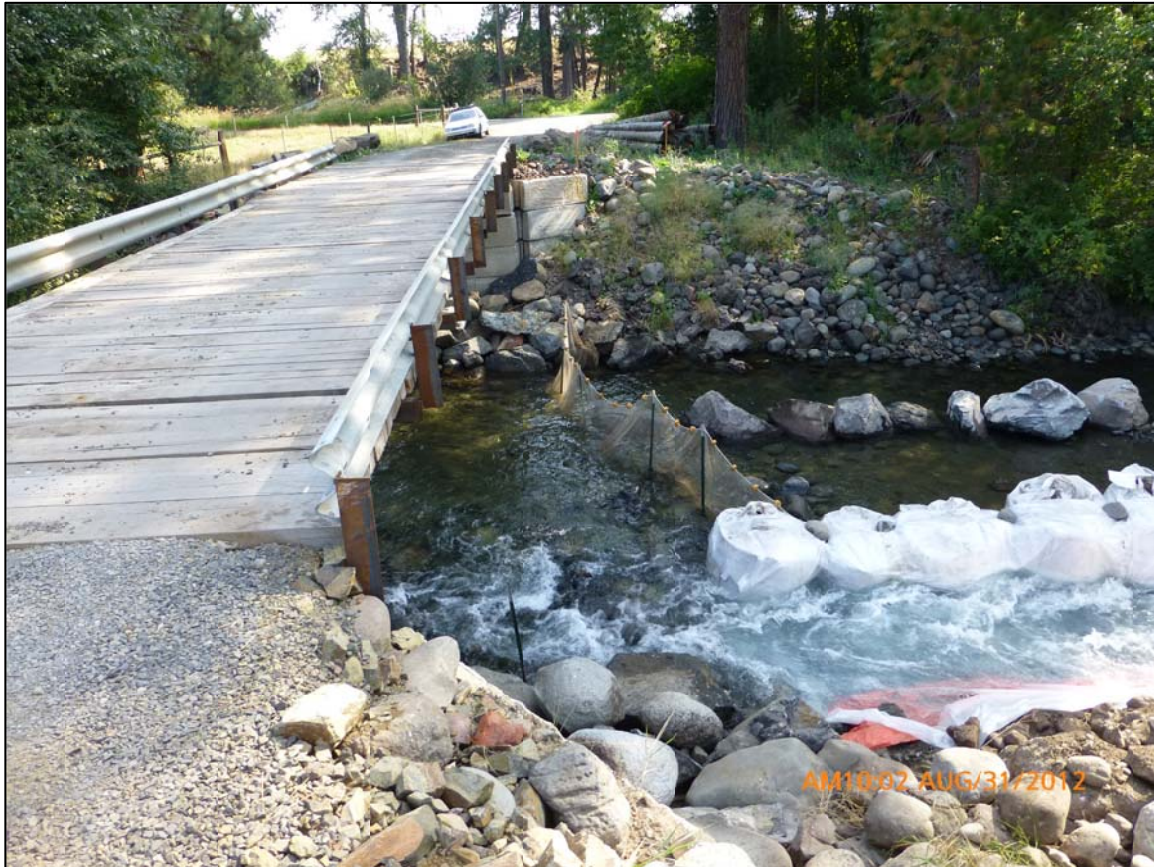
Photo 6: Photo taken on August 31, 2012. Standing on the west bank of the Lostine River at the downstream end of the project. The second salvage has been completed, the bypass channel is in the foreground and the salvaged area is in the background.

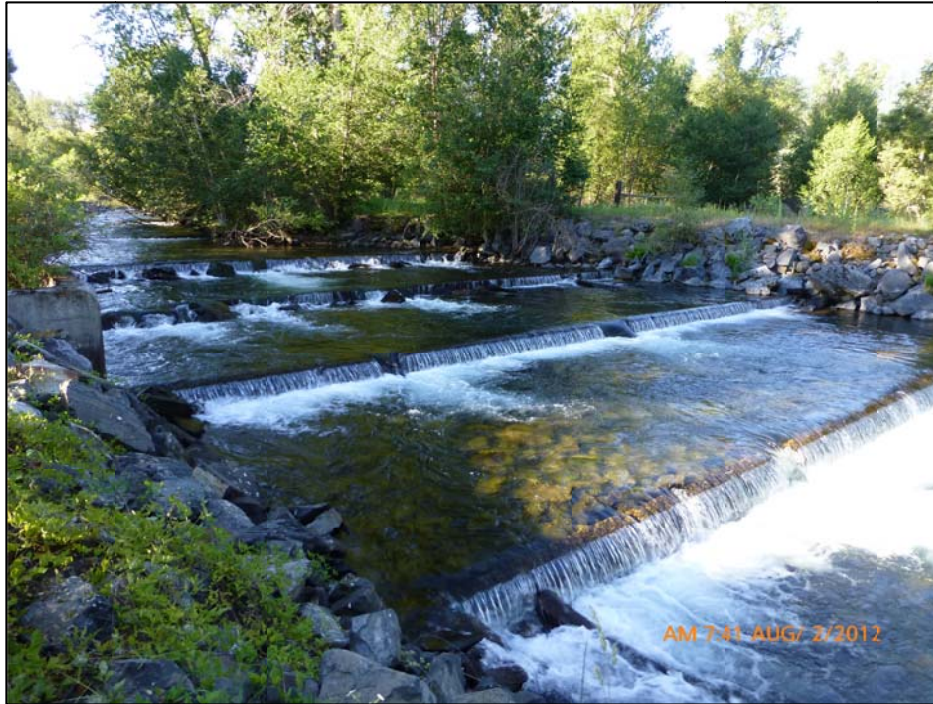
Photo 7: This photo taken on August 7, 2012 prior to start of construction shows the top 4 walls of the concrete fishway. The top wall serves as the irrigation diversion check wall and the Lostine Ditch Company asked that this wall be left undisturbed. Jump height at each wall exceeds State and Federal criteria.

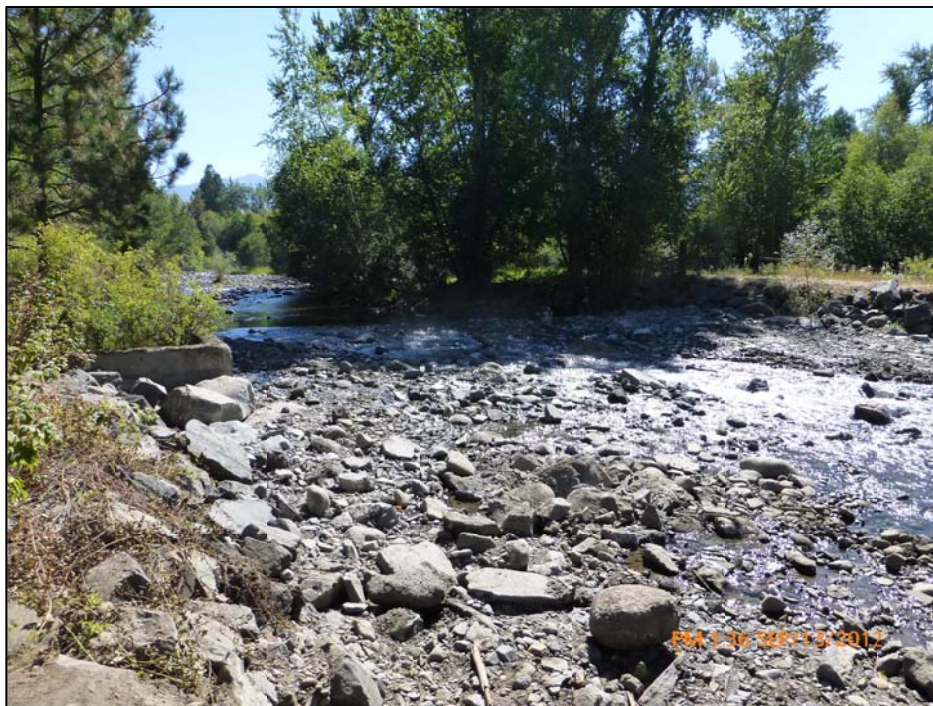
Photo 8: Photo taken on September 13, 2012 at the same location as photos 3 and 7. The concrete fishway has been modified and overtopped with a roughened channel, natural channel design fishway. Flow had been activated through the project reach for 2-days at this time, it did not go subsurface, and there are no barriers for fish as they pass through the area.

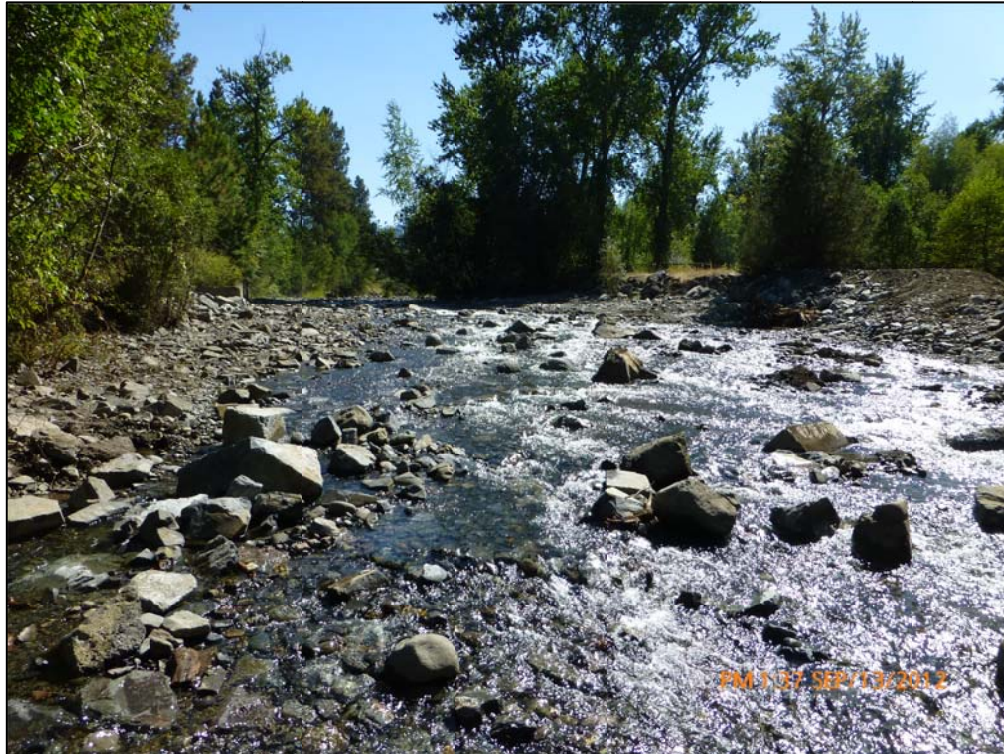
Photo 9: This photo taken in the same location as photo #2 is at mid project looking upstream. Flow is centered in the channel as intended. Rock clusters have been placed between the cross-vanes to provide flow velocity diversity and resting areas for fish.

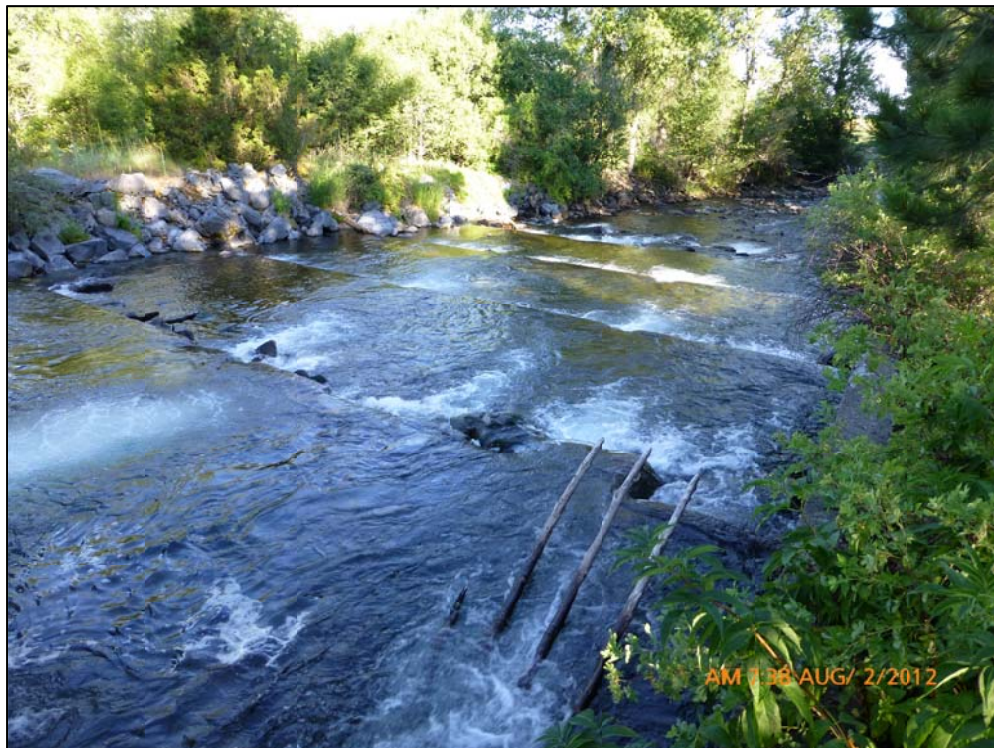
Photo 10: Standing near the top of project looking downstream on August 7, 2012. The large boulders below the wall in the foreground were used to shore this wall during a past maintenance activity.

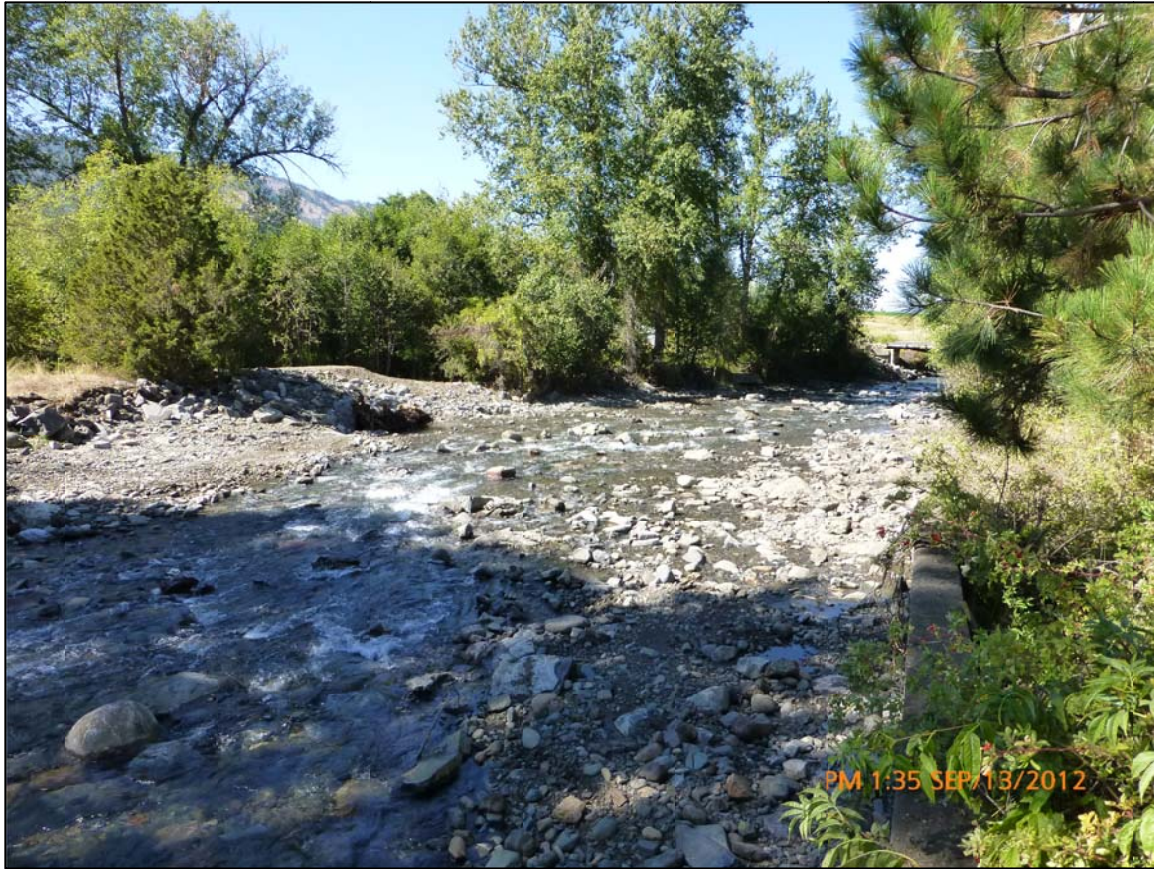
Photo 11: Standing in the same location as photo 10 after project completion.

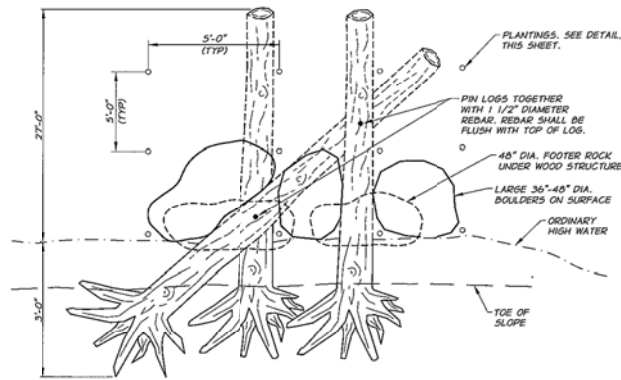
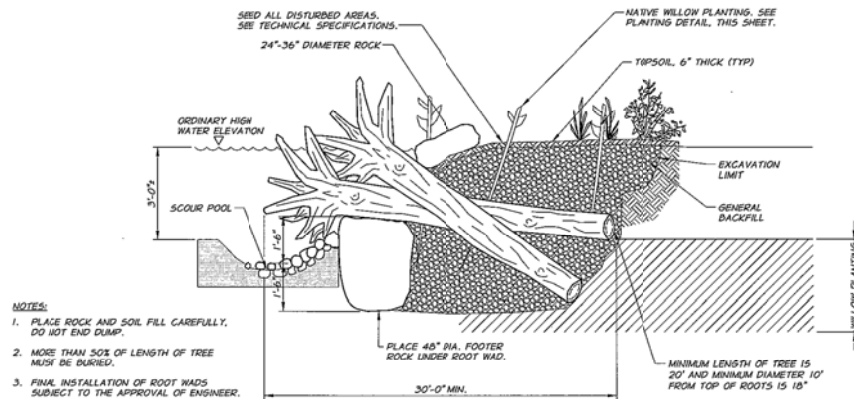
GRANDE RONDE MODEL WATERSHED
LOSTINE DIVERSION
FISH PASSAGE
WOODY DEBRIS DETAILS

WOODY DEBRIS PLAN
N.T.S.

WOODY DEBRIS SECTION
N.T.S.

- NOTES:
1. PLACE ROCK AND SOIL FILL CAREFULLY. DO NOT END DUMP.
 2. MORE THAN 50% OF LENGTH OF TREE MUST BE BURIED.
 3. FINAL INSTALLATION OF ROOT WADS SUBJECT TO THE APPROVAL OF ENGINEER.

- f. Woody Material – Three woody debris features will be installed. These features provide some bank stability and enhance fish habitat value in the area. The woody debris structures are built using three

rootwads with a length of 20 feet and a diameter of no less than 18 inches 10 feet from the root wad. The logs are woven together, pinned, keyed into the bank 15 feet, and held in place with large boulders.
