Wallowa River/6-Ranch Habitat Restoration

Completion Report

Bonneville Power Administration Project Number 1992-026-01
Contract #37387

June 2010

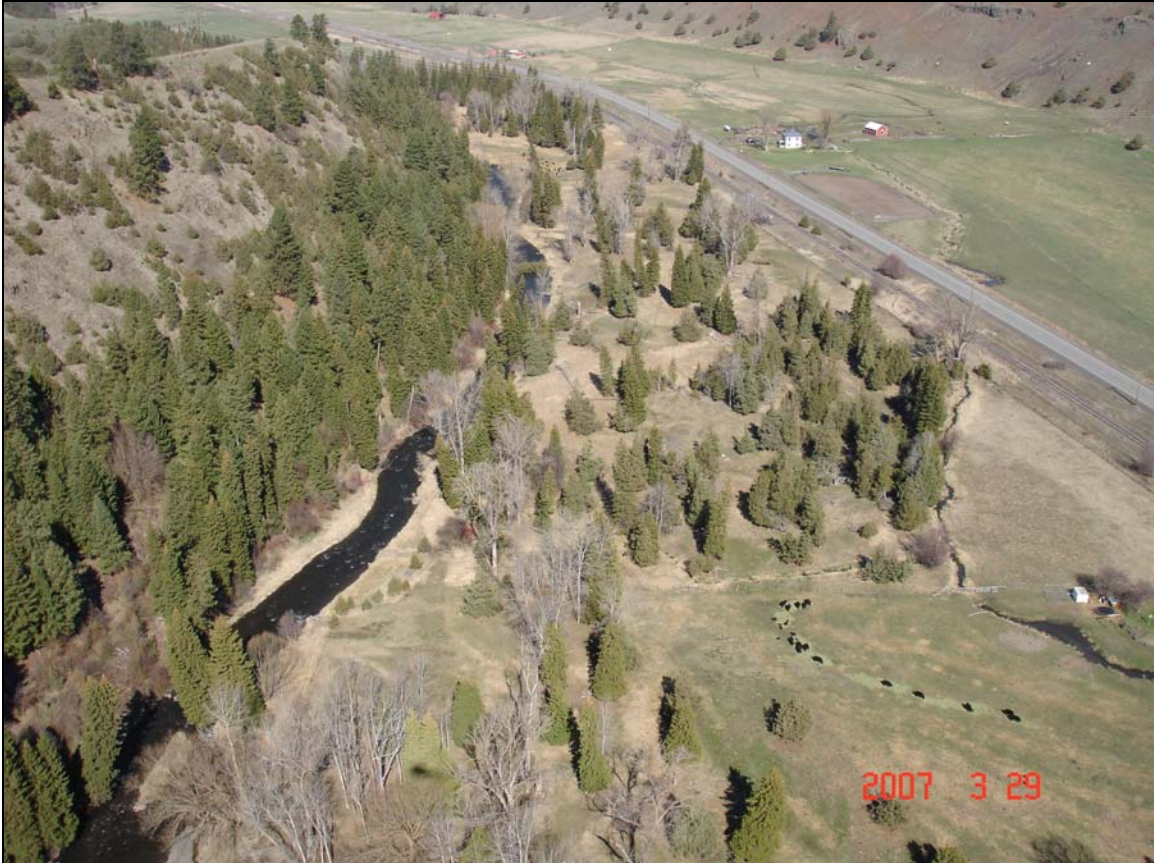
Aerial photograph taken by Allen Childs on March 29, 2007. Upstream end of project is at lower left side of photo. Contracted actions detailed above transformed this channelized section of the Wallowa River into a river that has access to its floodplain, meanders across the landscape and improves habitat.

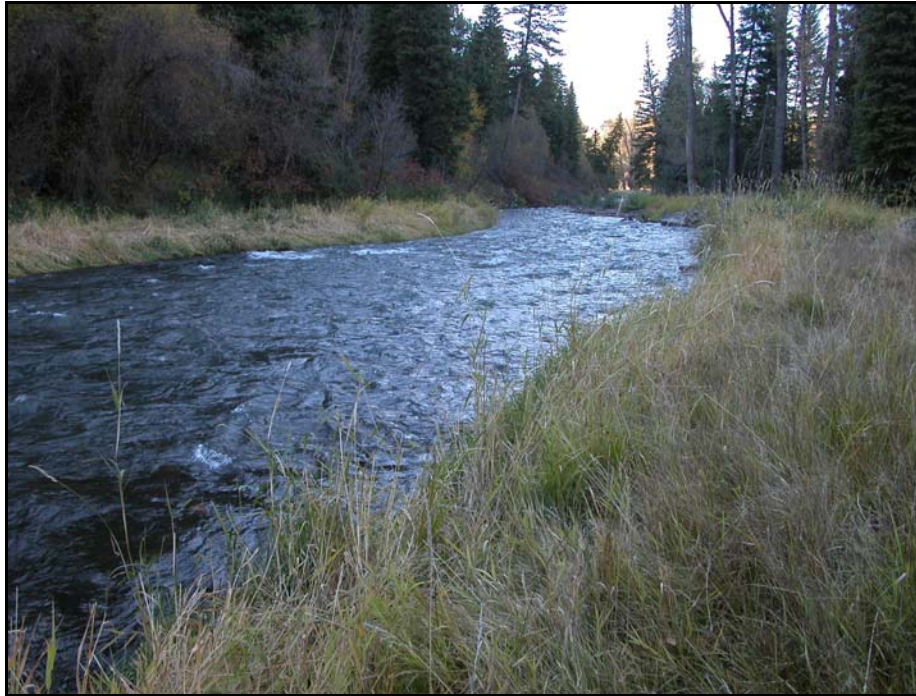
Photo 1: Photo taken in October 2006 showing predominant channel type prior to construction. The river through the 6-Ranch property is ~ 90% riffle and lacks pools, wood and other habitat complexity. The following 3 photos are taken from the same spot.

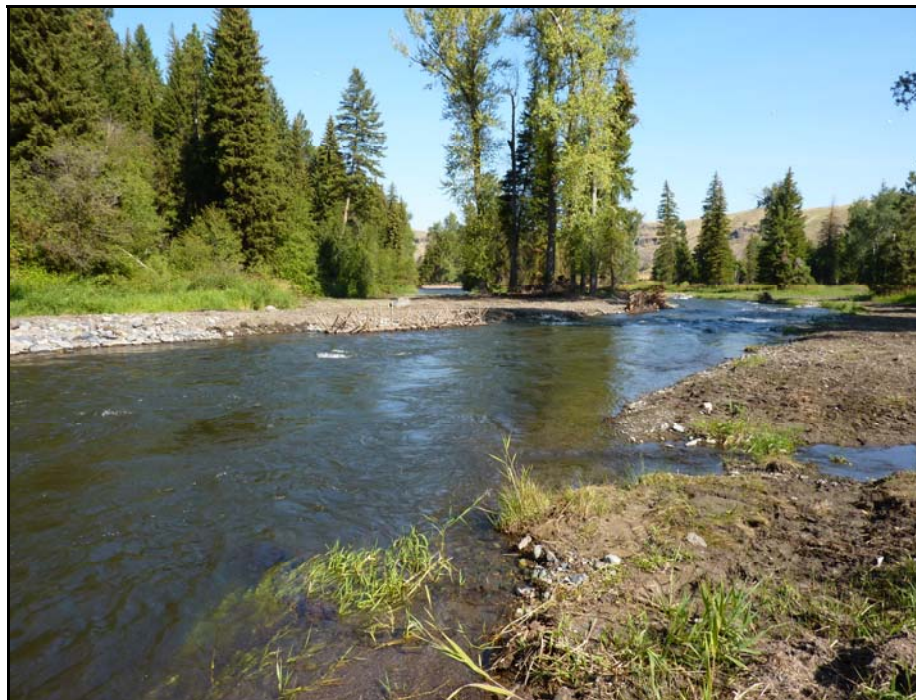
Photo 2: Photo taken on August 2009 following construction. The channel is now complex with pools, large wood and other habitat features expected in a naturally occurring channel.

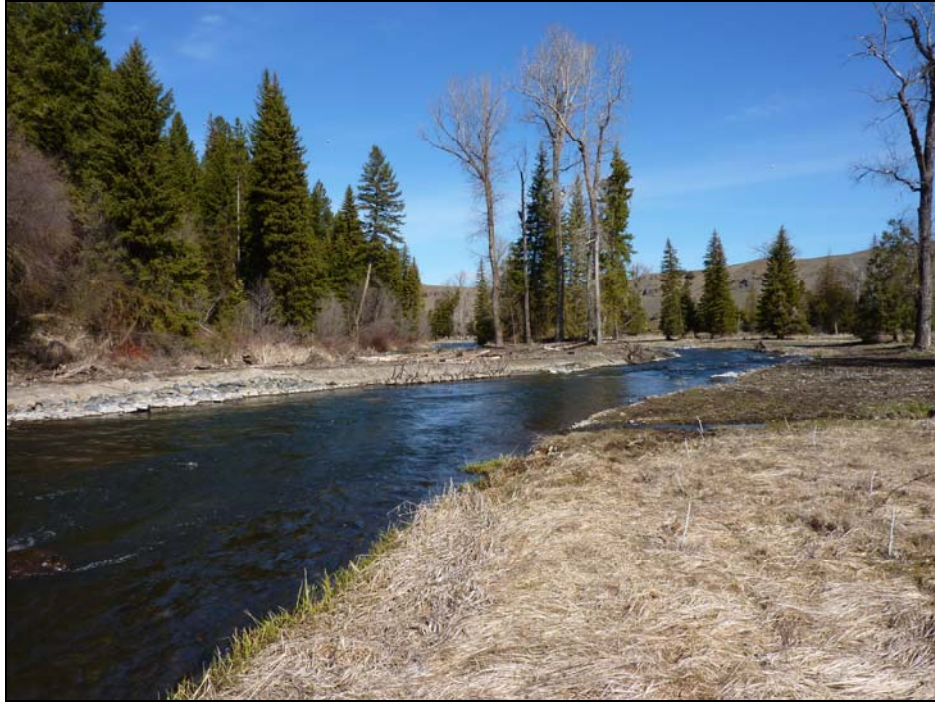
Photo 3: Taken on April 14, 2010 prior to high spring flow in the Wallowa River. Planting efforts can be seen in the foreground and includes native seeding, live whip and containerized shrub installations.

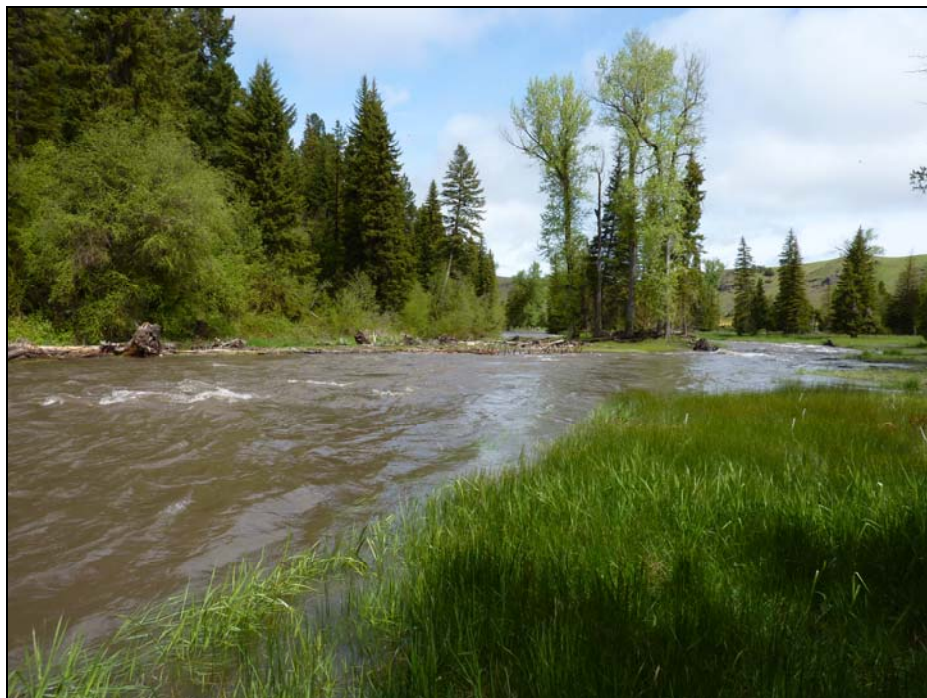
Photo 4: Taken on June 3, 2010 at flood stage. The floodplain is activated, large wood has been recruited and revegetation efforts are showing robust results all objectives of the project.

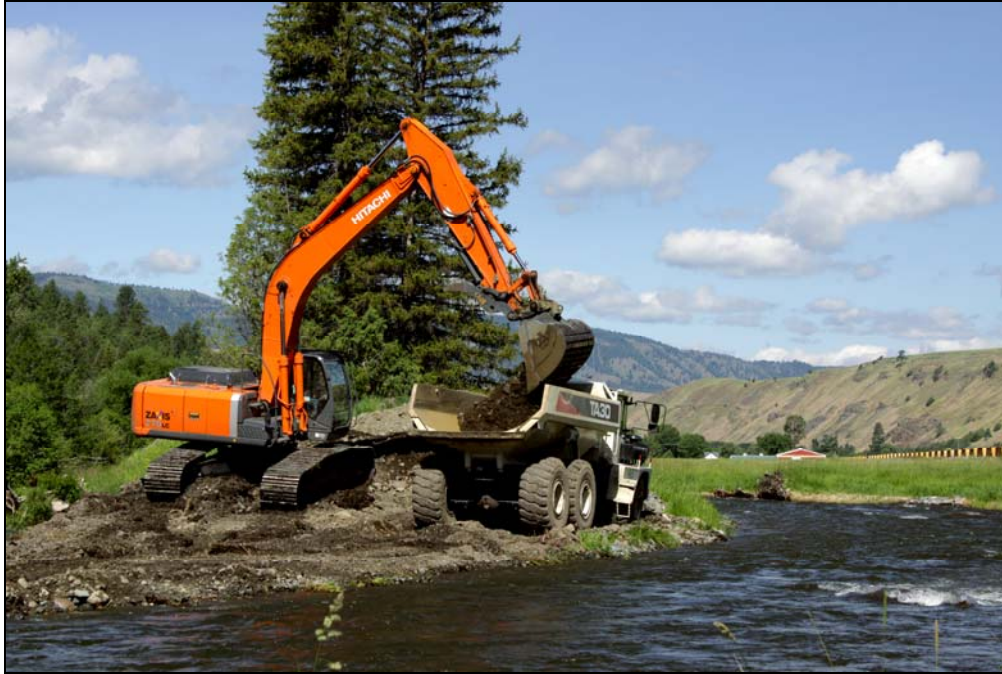
Photo 10: Excavator, off-road articulating dump truck and a small dozer were the tools used to move 26,000 yards of material, install channel structure and reclaim abandoned sections of the old channel.
