RIPPLES *in the* GRANDE RONDE

VOLUME 3, ISSUE 3

The McIntyre Sustainability project

Salmon Creek: Stream temperature and riparian conditions after 14 years

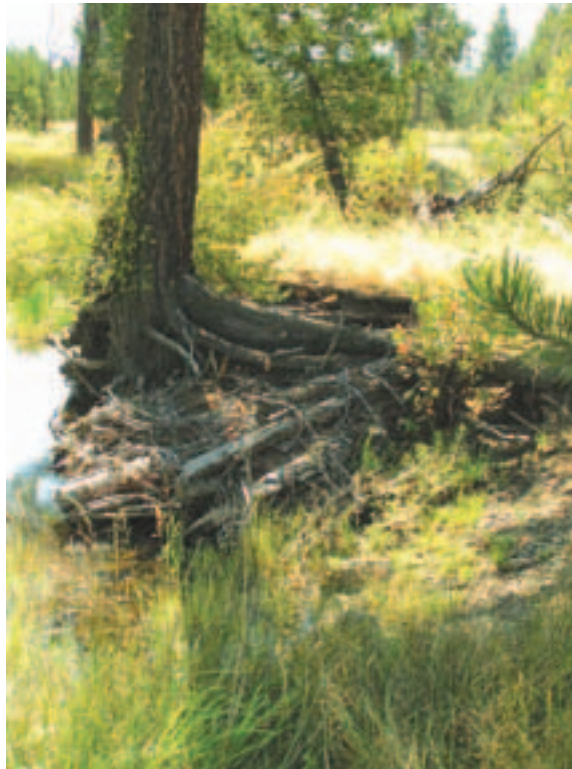
A example of a bundled barrier doing its job on McIntyre Creek
© Rock Rabbit Photo

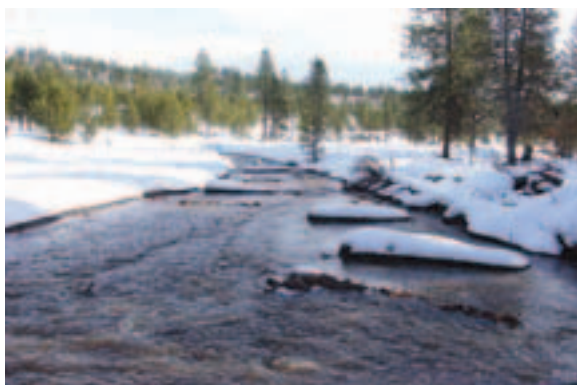
McIntyre Creek Bundles at work
USFS photo

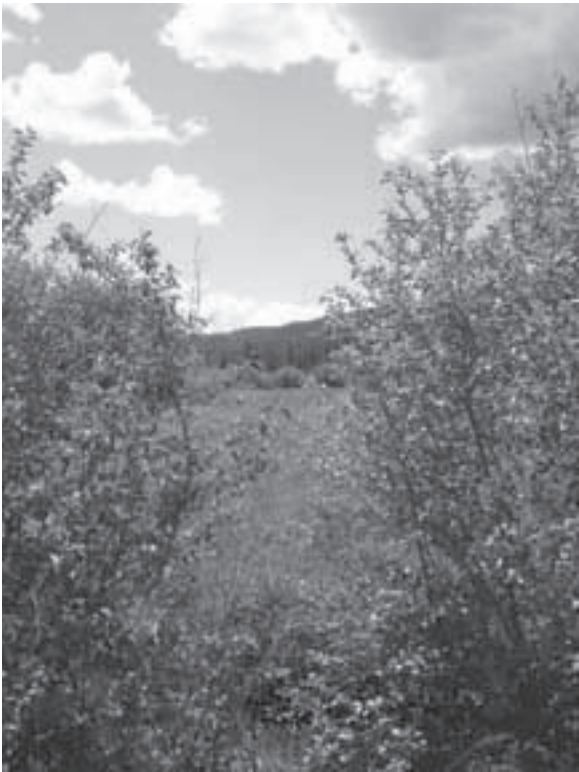
Swamp Creek-riparian regrowth
© Rock Rabbit Photo

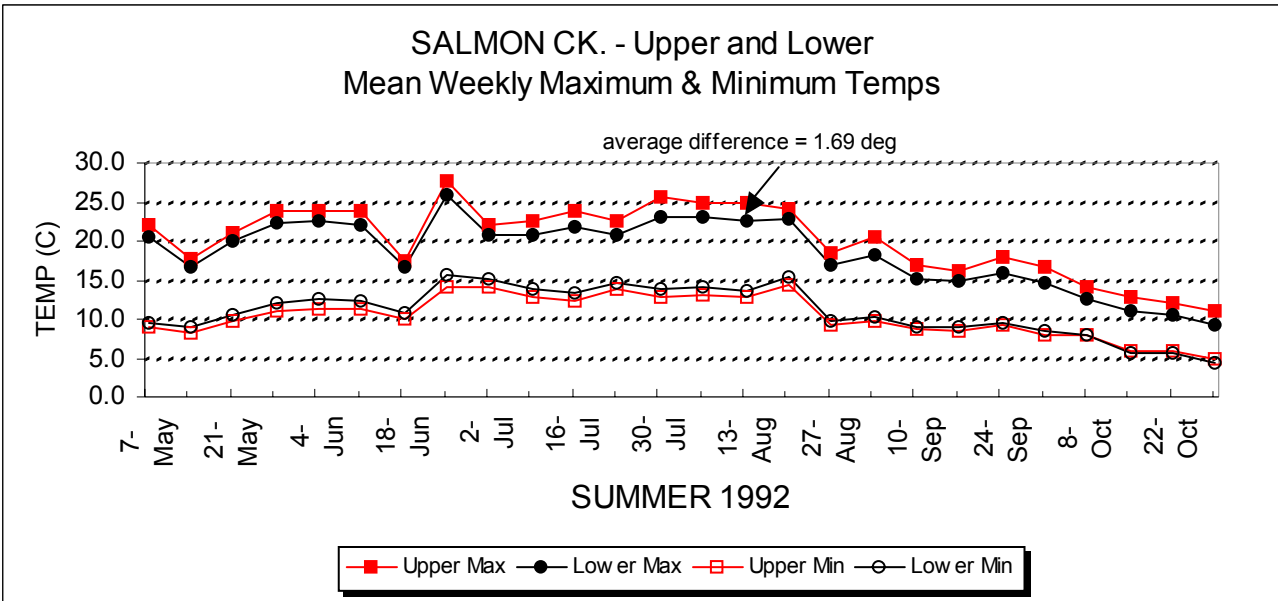
The preceding chart shows the mean weekly maximum and minimum temperatures for the upper (red) and lower (black) monitoring locations on Salmon Creek in 1992. The lowest lines with the hollow markers detail mean weekly minimum temperatures and the highest lines with the solid markers detail the mean weekly maximum

temperatures. For the maximum temperature lines the average difference between sites was calculated at 1.69 degrees Celsius with the upper site recording warmer mean maximum temperatures for the monitoring period of May 7th through October 22nd.

The above chart for 2003 is formatted the same as the 1992 chart. This chart shows a similar pattern to the 1992 chart where calculated minimum temperatures closely track each other and warmest calculated maximum temperatures occur in the mid summer months. The calculated average difference of 4.43 degrees Celsius between the upper and lower mean maximum temperatures compared to 1.69 degrees Celsius in 1992 is the most notable difference between years. It is difficult to determine over an eleven year time period if Salmon Creek stream temperatures have cooled but by comparing the upper site (above treatment) to the lower site (below treatment) we can see that the relative differences have increased.

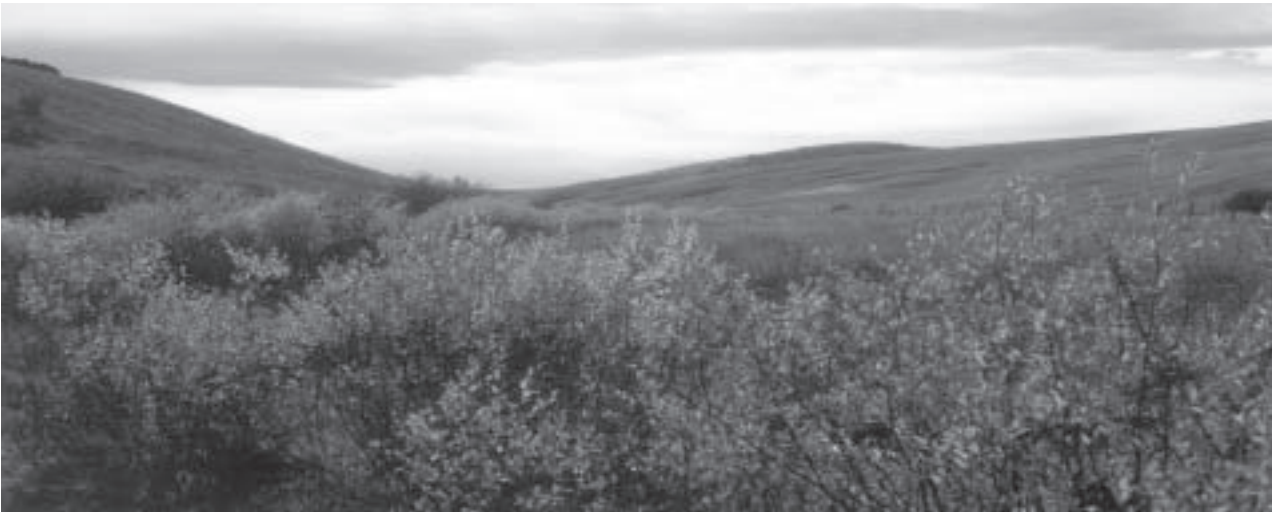
Figure 2: Photo point #6 taken October 23, 2003.

The 1989 photo depicts riparian conditions lacking woody vegetation and stream shading. After fourteen years of altered grazing management woody vegetation has returned, shade to the stream has increased, and bank stability has improved. All

The following photos show conditions in the project area at the time of project implementation and what conditions currently look like (as of last photo monitoring in 2003).

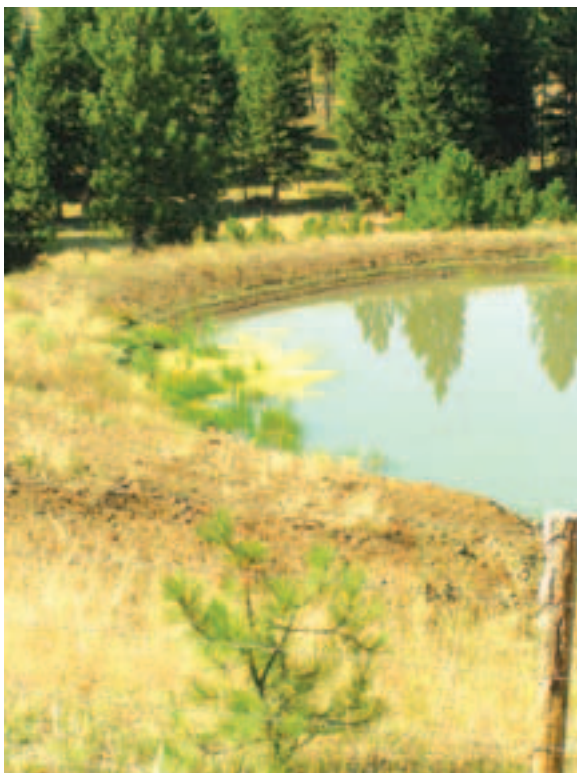
New pond with fencing in place, showing aquatic plant growth.

These ponds were designed to be deep, with steep sides, to hold water longer into the dry part of the year. Shallow ponds tend to become choked with grasses and other aquatic plants that take away from the amount of retained water in only a few short years. The ponds, developed by the ODF have the steep sides to limit the aquatic plant growth that tends to encroach on the ponds, restricting the amount of stored water over time, giving them greater, useful, life spans.

After a year of allowing cattle on the ponds to trample the earthen dam, using their weight and movement to help the banks seal, the ponds are fenced off and a siphon system is installed to carry water from the ponds over the bank and into a water trough equipped with a float valve. This will ensure a clean water supply for the cattle and creates a "Micro" environment around the pond encouraging wildlife, small birds and insects to make their homes there. These are self-generating, as the plants grow, they attract insects, which in turn, attract birds and the food chain makes the connections from there on to the top, us humans who come to observe them in their everyday battle for life.

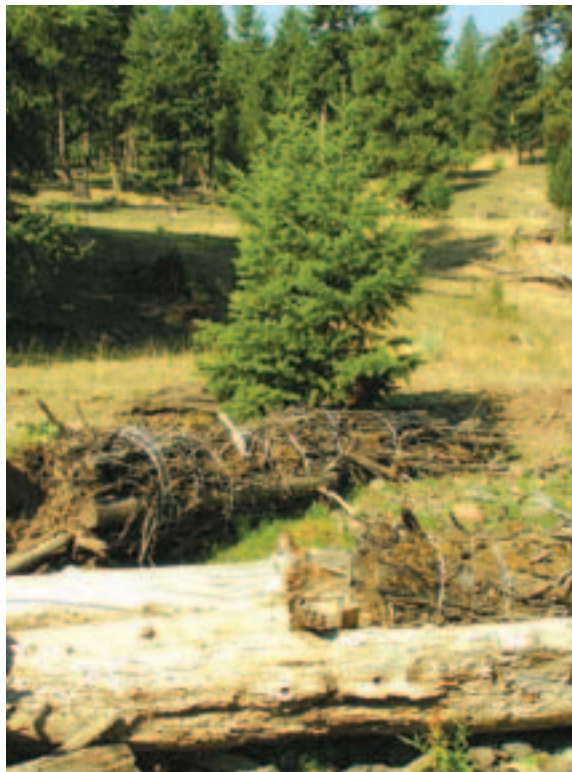
Bundles in place with large woody debris to slow water flow.

Already, in the first year after the project, there are reports of spawning steelhead, and sightings of smolt in the springtime water flow. I personally observed a fair number of above legal size trout in some of the pools that were created by the placement of the woody debris and boulders.

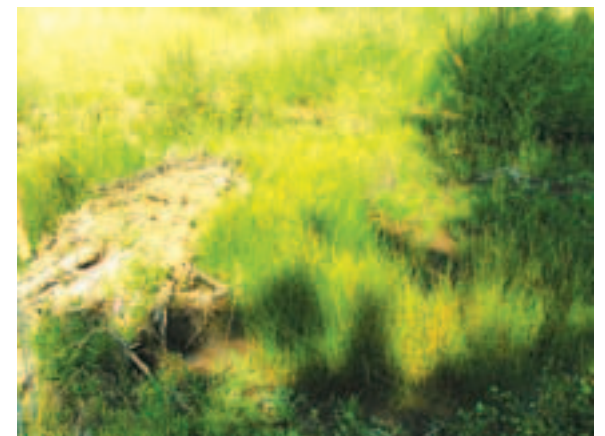
Gravel bed rejuvenation-Sighted steelhead Redd location

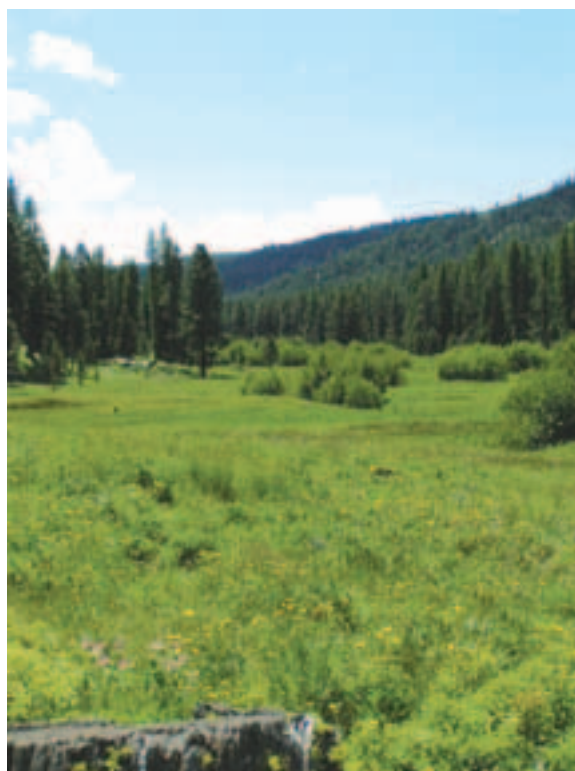
Swamp Creek-upstream view. A riparian area in the healing process.

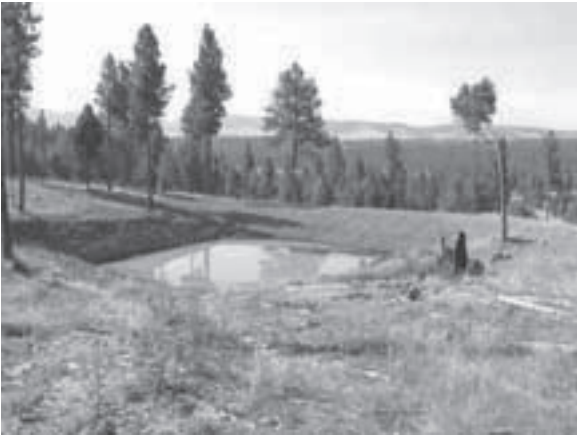
New dip / stock pond, McIntyre Creek
© Rock Rabbit Photo

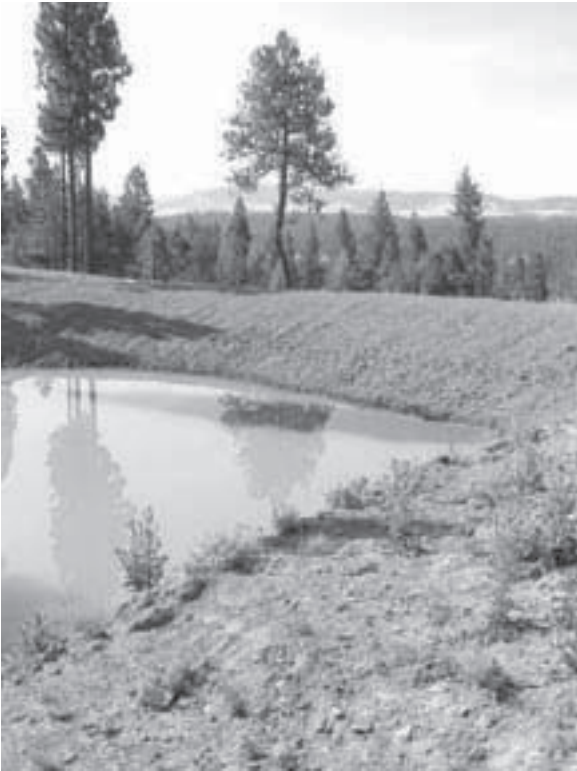
View of dam and beyond, McIntyre Creek
© Rock Rabbit Photo

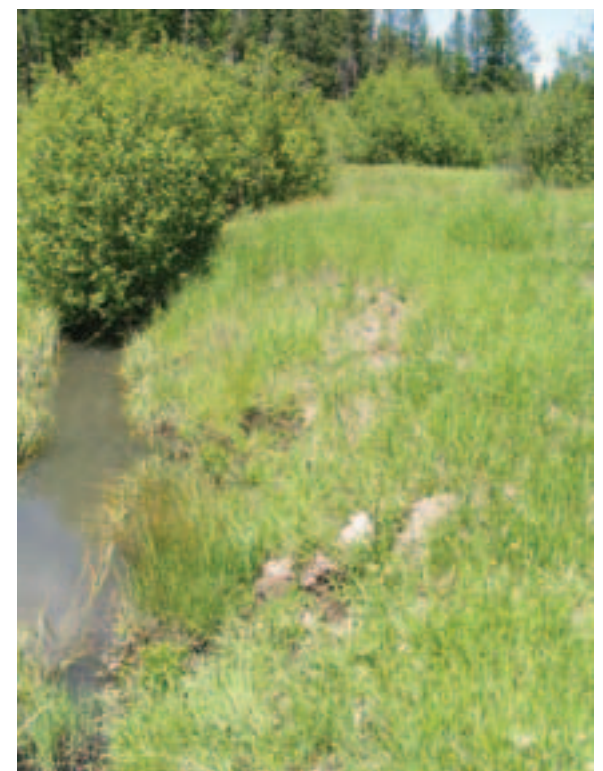
Swamp Creek restoration underway, grass and brush regrowth
© Rock Rabbit Photo
