Grande Ronde Model Watershed Project

Catherine Creek/Swackhammer Fish Passage and Erosion Mitigation

Completion Report 2004 - 2005

DOE/BP-00018635-1

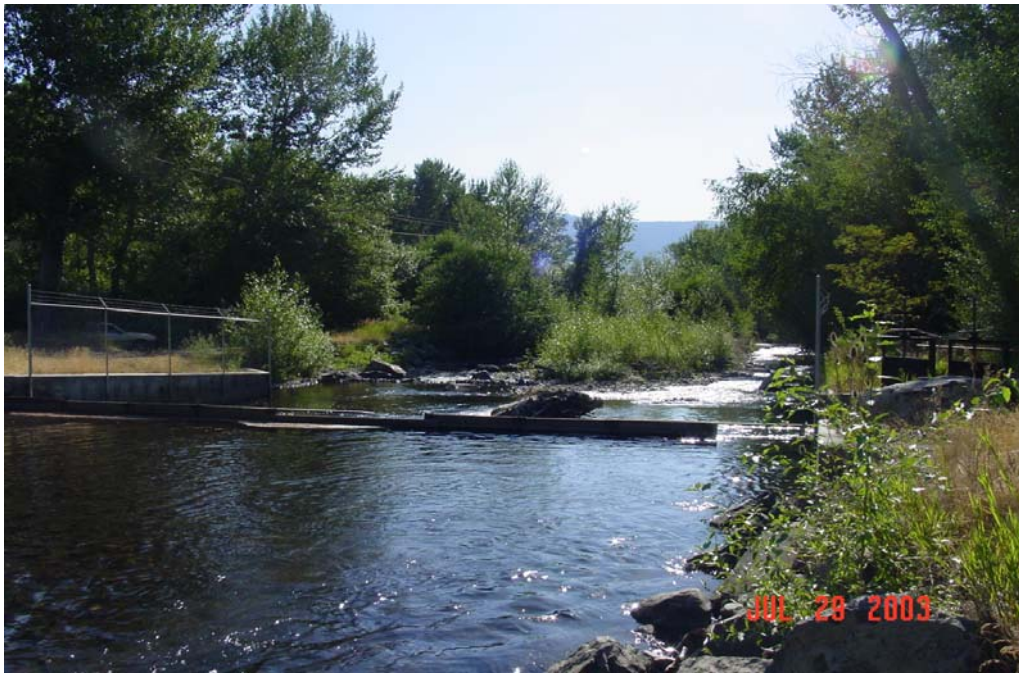
The design of the structure has caused extreme deposition of bedload in the middle of the channel downstream of the structure, resulting in a split channel. The bedload deposition in combination with the alignment of the structure has also caused the gradual migration of the channel further to the north, eroding the streambank up to 20 feet in places. Deposition and revegetation continues on the mid-channel gravel bar further aggravating the situation and putting even more pressure on the north bank (see pictures). Although the north bank is well vegetated, continued mid-channel deposition and capacity reduction could result in substantial out-of-bank flow during a future flood event. This flow would be directed toward residential areas of Union.

Mid-channel gravel bar - Pre-construction

- Remove the mid-channel gravel bar and use material to rebuild streambank along the north side of the channel.
- Install two J-hook structures and one cross channel vane to direct flow through the middle of the structure and down through the middle of the channel below the structure (see drawings).

The initial design called for the removal of the mid-channel gravel bar and the placement of that material along the north side of the channel. One J-hook structure, approximately 75 feet above the concrete weir and one J-hook structure below the weir were designed to center the flow and allow the structure to more efficiently pass bedload. A cross channel vane approximately 150 feet below the weirs was proposed to keep bedload moving downstream of the concrete structure.

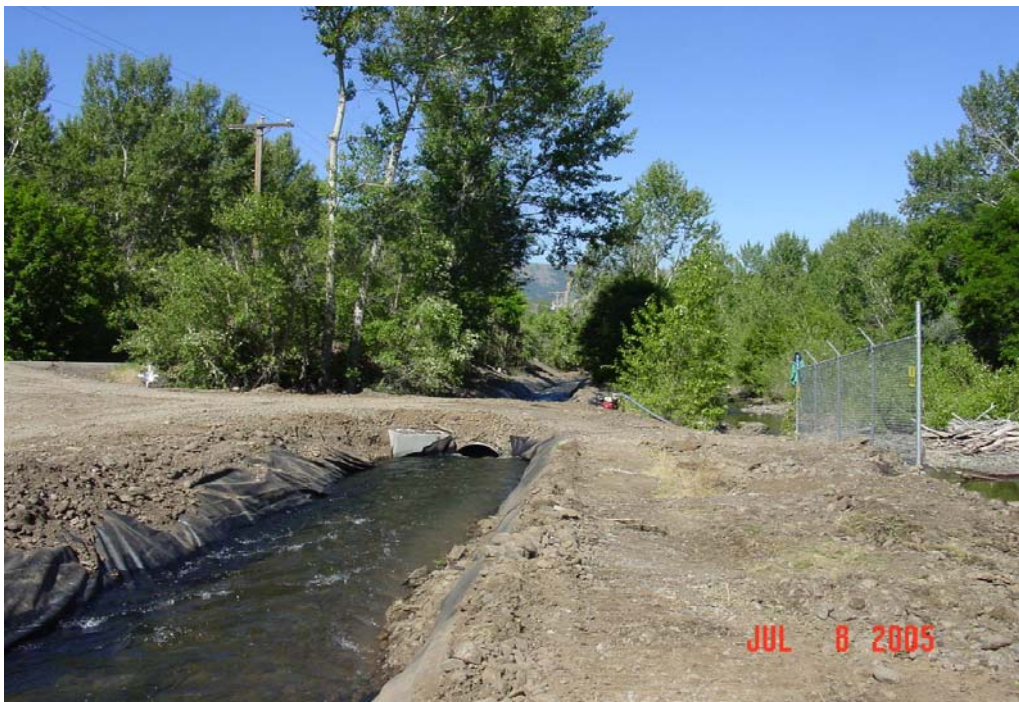
By-pass Channel

Becker Contracting moved equipment to site and began bypass construction. Met with Lee Ricker (construction superintendent) and Brett Moore (AP). Discussed required bypass channel capacity. Shad Hattan (OWRD Watermaster) estimated current Catherine Creek flow at 65 cfs at upper gauge but will be dropping as upstream irrigators increase withdrawals. Capacity should not be an issue barring intensive rain storm. Contractor requested the go-ahead to remove the large cottonwood adjacent to SW side of structure, bypass construction will cut half of root system, it would be susceptible to windthrow. OK'd removal. Met Howard Postivite (ODOT) on-site, he inquired about plant and CR clearance, all have been done. Lee inquired about truck access and ramp construction off of highway, he will need to work with ODOT. PM, inspected work site, bypass construction to about lower end of diversion structure.

Advised Lee that fish salvage could occur Friday, I am coordinating personnel and equipment for that day. PM inspection, bypass channel construction has progressed to about 30 feet from outlet to stream channel, will likely be completed tomorrow. Native material being placed in bottom of bypass as per BO requirements. Contractor will pump water into ditch to settle out sediment.

Site inspection, 1000 hrs. Some water leaking into bypass and passing through to outlet. Ecoblock cofferdam partially placed at approx. 1200, about 20% of stream flow passing through bypass. Fines washing out of bypass, turbidity standards exceeded from 1200 to 1345, water cleared.

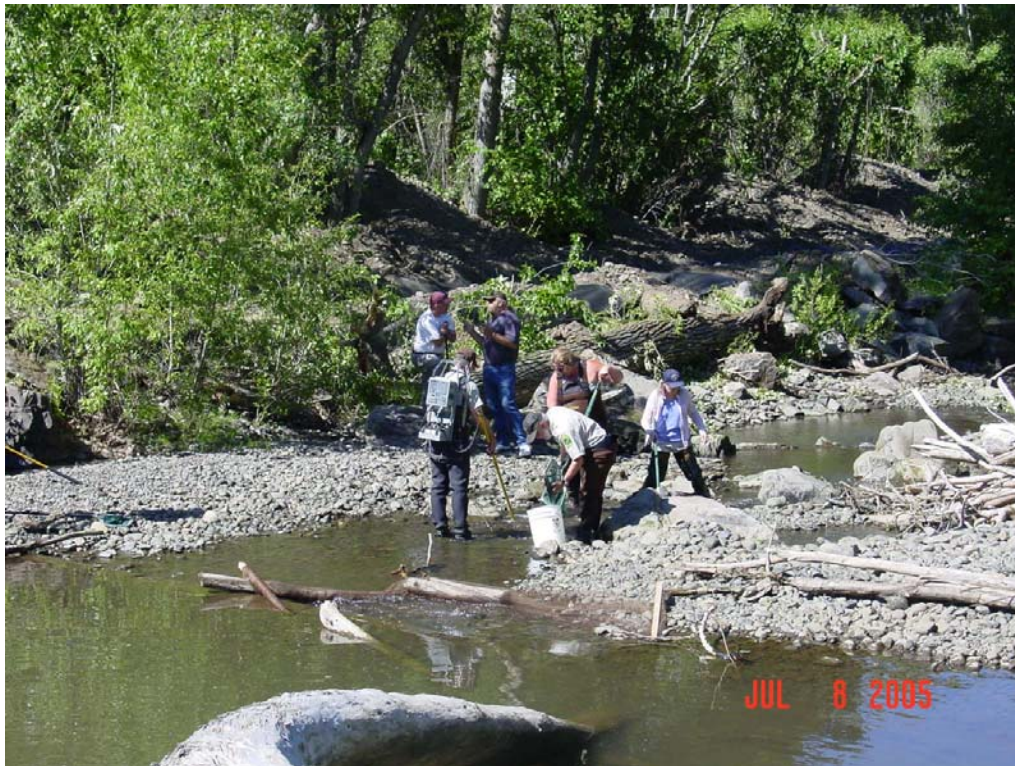
Fish Salvage – Electro-shocking

Arrived on-site for fish salvage 0530. Crew of 13 ready to begin at 0630. ODFW Research crew, Nadine Craft, CTUIR crew conducted operation. ODFW fish transport truck used to hold and transport fish. Contractor placed remaining ecoblocks at upstream end, we placed block net. About 20% of flow maintained throughout stream reach during fish salvage. Crew made multiple passes through upper reach to diversion structure with 3 shockers. Contractor sealed off cofferdam with tarps, about 1 cfs maintained. Lower end block netted off. Crew made multiple passes through lower two channels up to 1100. Bob Becker (ODFW) tallying fish and recording water temperature. Temperature reached 64 degrees at 1330. Crew made multiple seine passes through diversion structure pools. Large #'s of fish were found in the weir pools. Fish salvage concluded by about 1400. Salvaged fish were transported to an upstream location by ODFW's fish hauling tanker truck.

Final fish numbers: 620 steelhead, 240 chinook, 120 sculpin, 45 whitefish, 200 misc. Mortalities from initial salvage: 1 steelhead, 2 chinook, 2 whitefish. I observed 2 additional steelhead mortalities in dewatered channel at 1800.

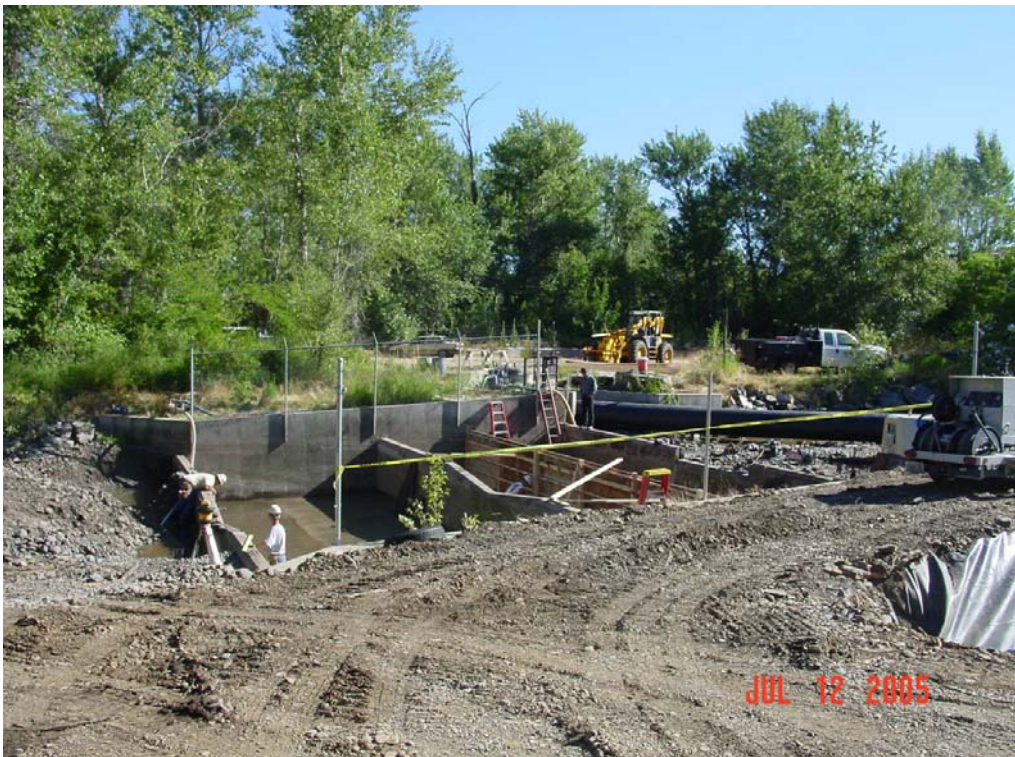
Concrete Weir-wall Construction

Contractor poured concrete walls. All work and materials inspected by Brett Moore. Concrete watering and curing over the weekend.

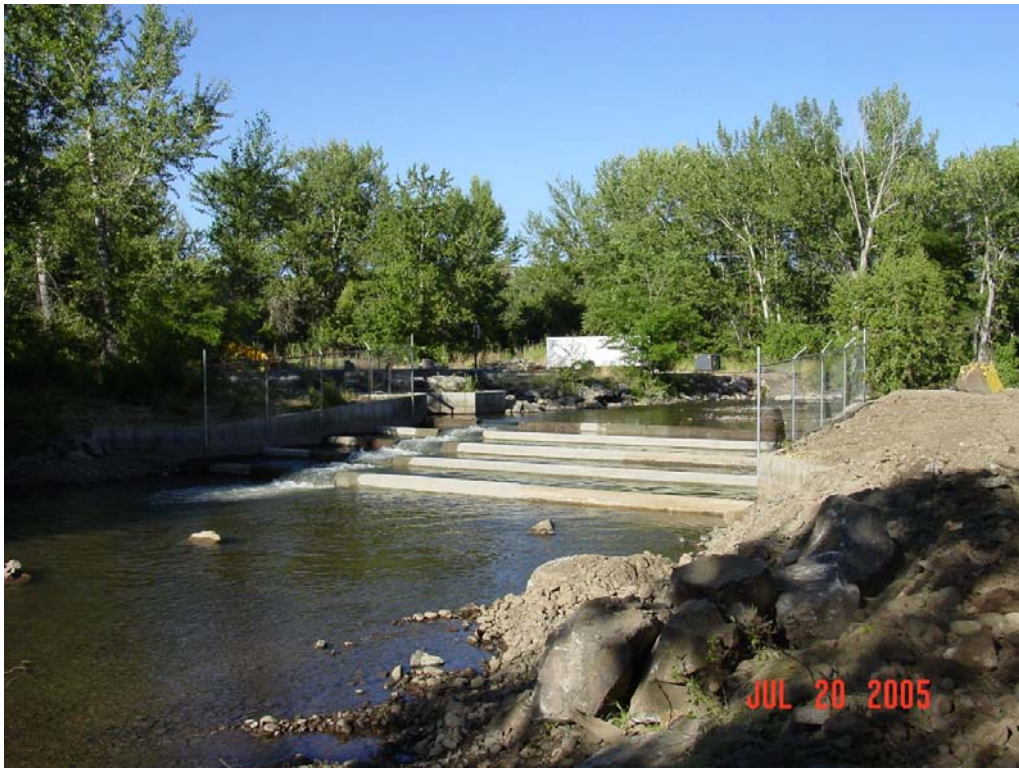
Completed Weir-wall Modifications

The BOR began working on the design during the summer of 2003. The GRMW applied for and received BPA funds in early 2004. The design called for the installation of two additional concrete weir walls within the existing structure to reduce drop at each weir to approximately 8 inches. Three existing weirs walls were modified by filling in existing 17' wide flow notches and re-cutting 6' wide flow notches for fish passage closer to the headgate.

Had telecom discussions with Jeff McLaughlin (BOR designer), ref. moving 6-foot notches progressively toward center of structure. Brett felt this would better direct thalweg toward left channel and aid bedload transport. Consensus at this time was that in-line design was OK (later adjusted one foot left at each wall).
