U.S. Fish and Wildlife Project Completion Report

Catherine Creek-Baum Habitat Improvement Project

Biological Opinion – FWS Reference 01EOW00-2012-0025

September 30, 2013

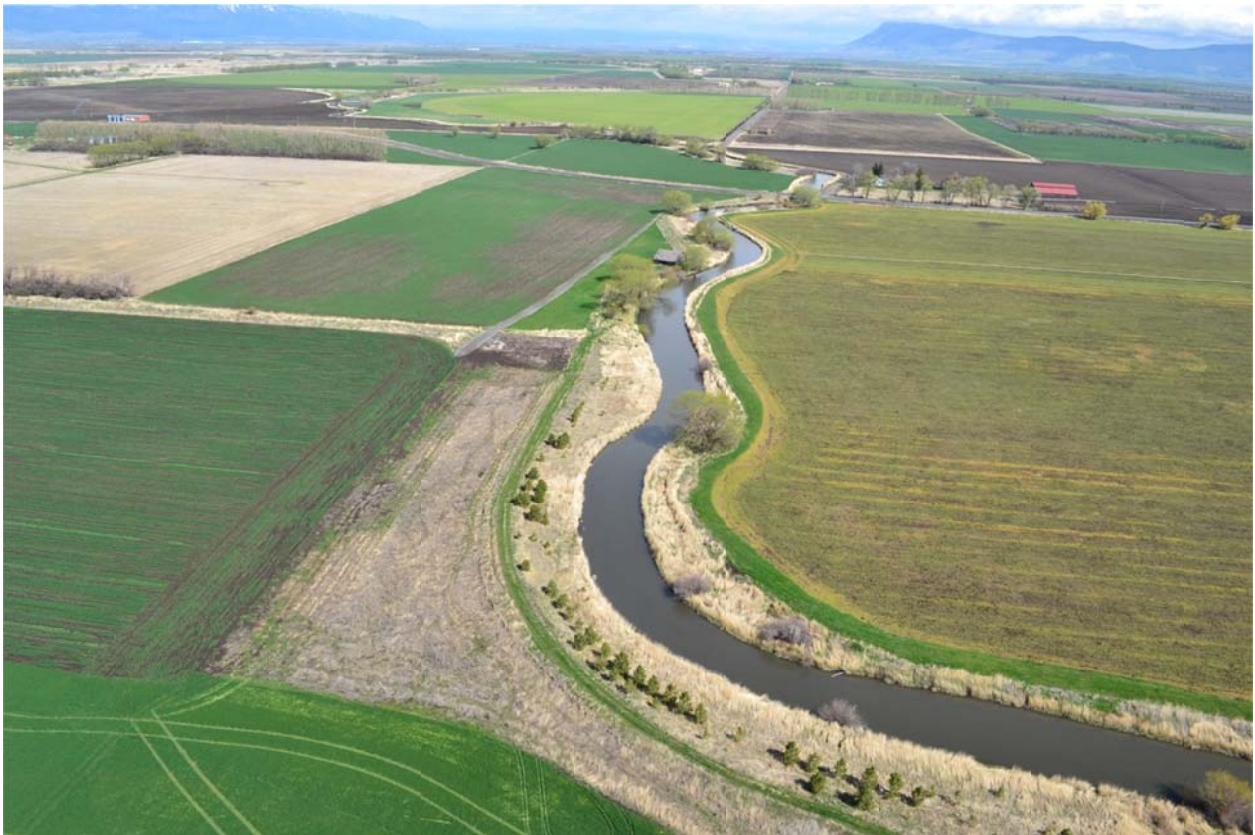
Catherine Creek-Baum Habitat Improvement Project – April 20, 2012 at 10:22am by Allen Childs (CTUIR)

Pre-Project habitat conditions-aerial

This is an aerial photo of the Catherine Creek-Baum Habitat Improvement Project site before construction. The view is looking north and flow direction is from the bottom right of the photo to the upper left.

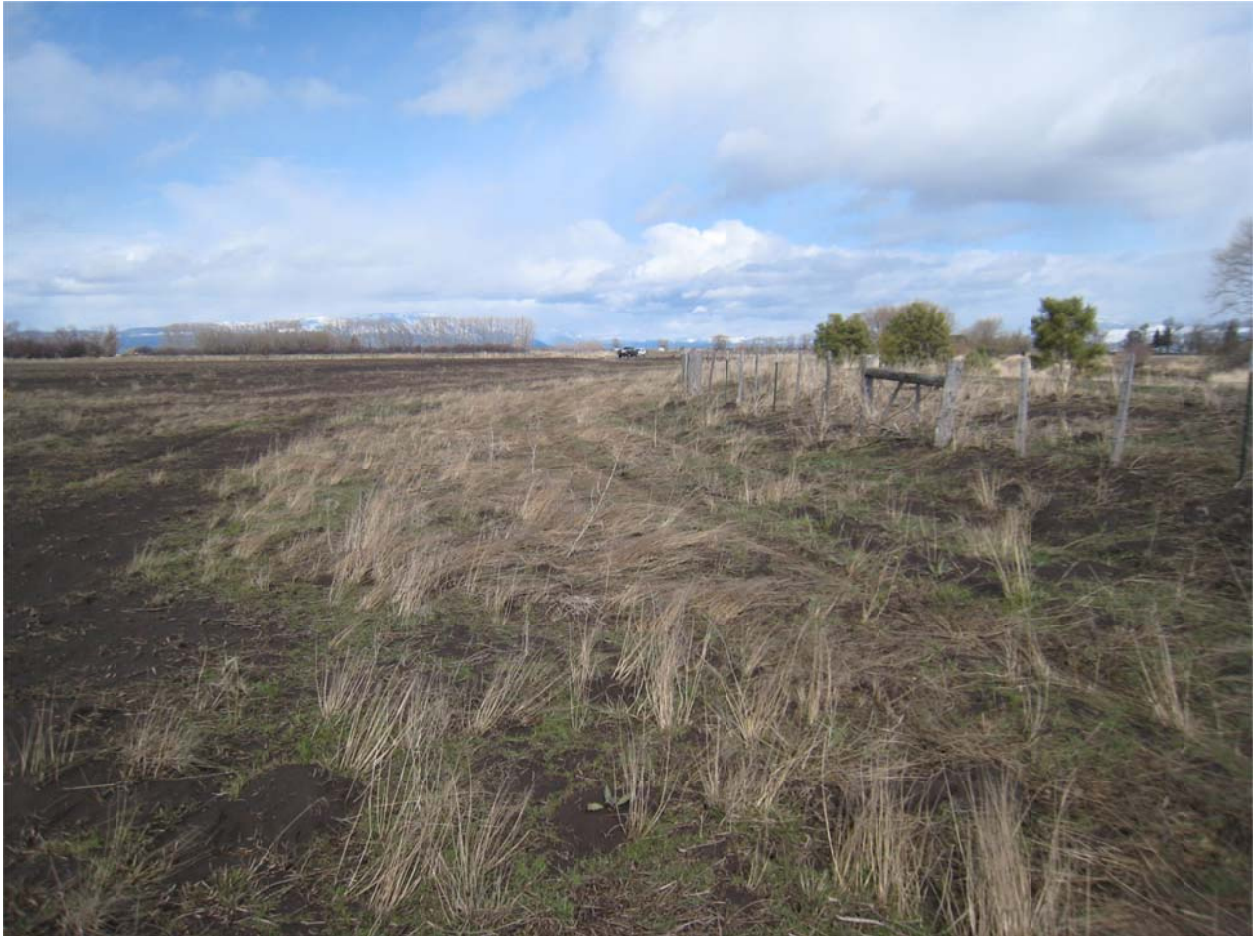
Catherine Creek-Baum Habitat Improvement Project - March 22, 2011 at 10:48am by Jesse Steele (GRMW)

Pre-project habitat conditions

This is an on the ground photo of the Catherine Creek-Baum Habitat Improvement Project site before construction. The view is looking north and taken from the southeast corner of the project site. The photo shows the pre-project location of the levee and the fence. It also shows the vegetation conditions of the project site prior to construction.

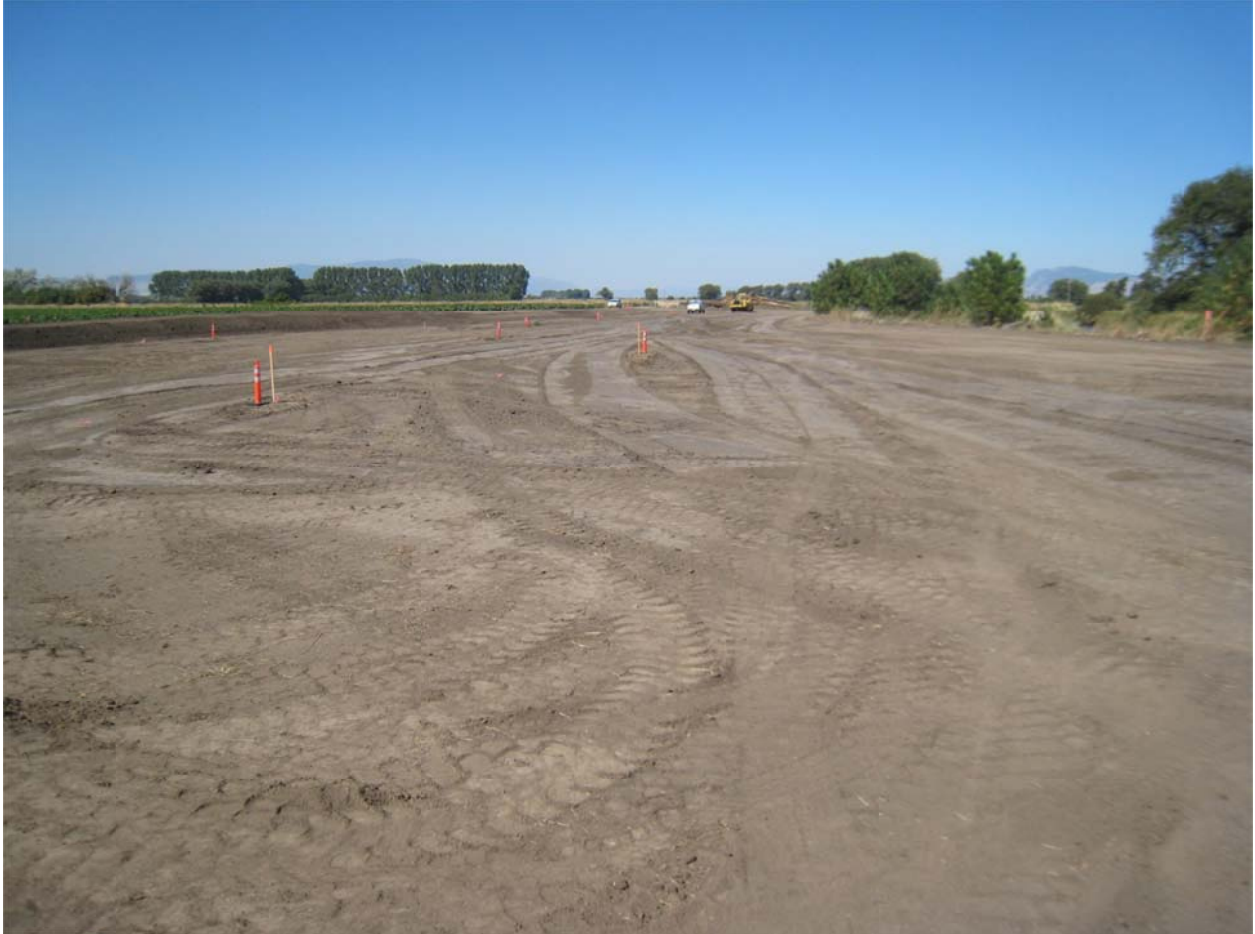
Catherine Creek-Baum Habitat Improvement Project - September 11, 2012 at 1:01pm by Jesse Steele (GRMW)

Project Construction – Levee set-back

This photo was taken from the same location as the previous photo but during construction. The fence and levee have been removed. The far left side of the photo shows the new levee being built. Notice the young pine trees on the right side of the photo were left undisturbed. Side channel location is flagged in the middle of photo.

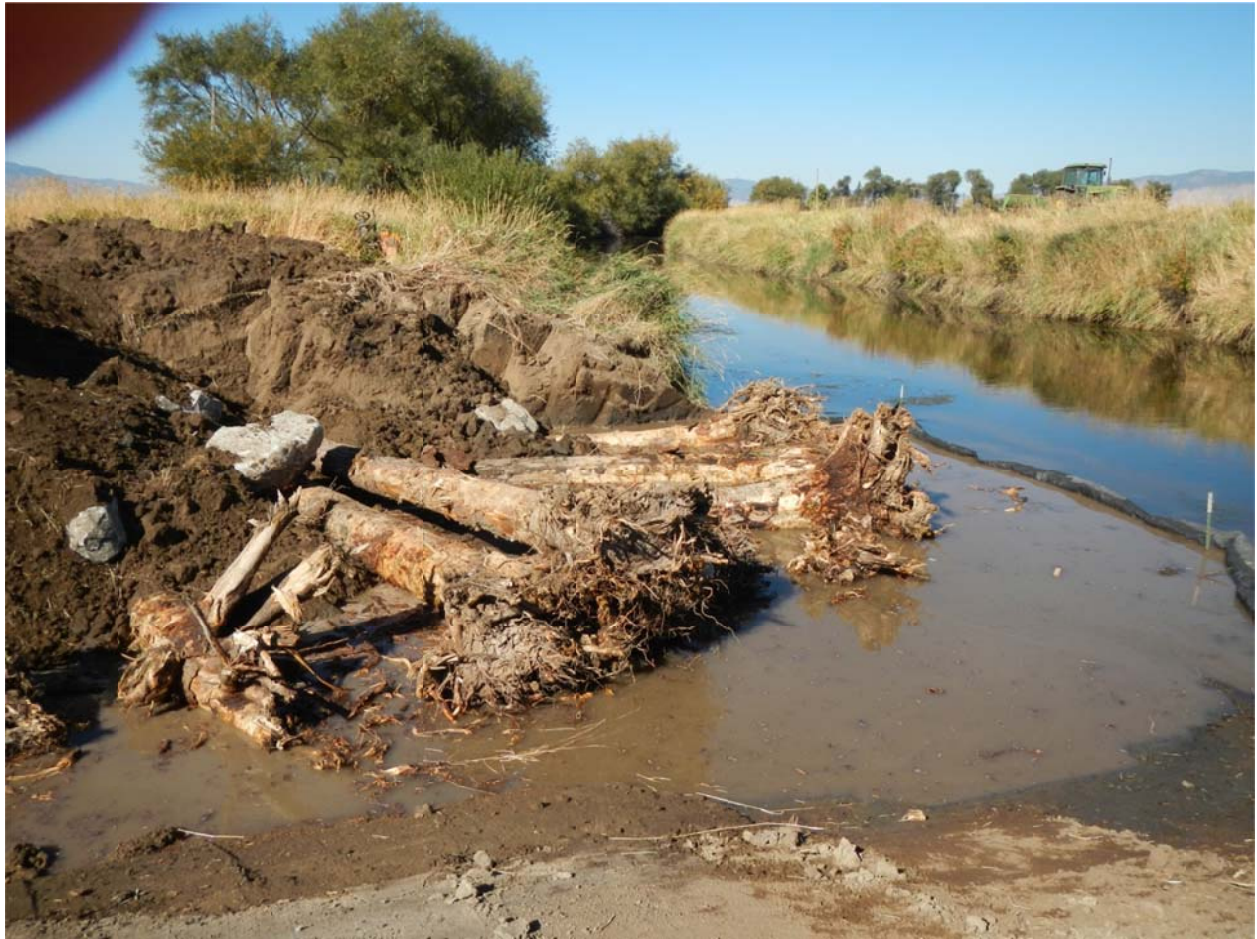
Catherine Creek-Baum Habitat Improvement Project - October 1, 2012 at 2:22pm by Jesse Steele (GRMW)

Project Construction – Large woody debris

This photo shows the large wood structure being installed at the outlet of the side channel. It shows how effective the silt curtain is at preventing suspended sediment from entering Catherine Creek.

- 1) The turbidly plume was not visible outside of the isolation work area during construction. Even during installation of large wood structures the suspended sediment was held within the isolation areas (see Large woody debris photo). Isolation barriers were removed after sediment had settled and a faint plume could be seen for approximately 100 feet downstream of the work area. The plume was monitored again during high spring flows but there was no detectable plume because Catherine Creek contained a lot of suspended sediment at the time.

- 1) The contractor isolated both work areas using a silt curtain that was sealed on the bottom and sides to prevent any fish from coming in and out of the work area.
- 2) Once isolated the work areas were electroshocked to remove all fish. Four sculpin, two red-sided shiners, one sucker and one crayfish were removed with two passes each at both sites. Fish were held in an aerated five gallon bucket for less than 10 minutes before being released.
- 3) As anticipated no listed fish species were present in the work isolation areas.
- 4) All fish were observed to be in good health at the time of release just upstream of the project site.
- 5) No mortality was observed.

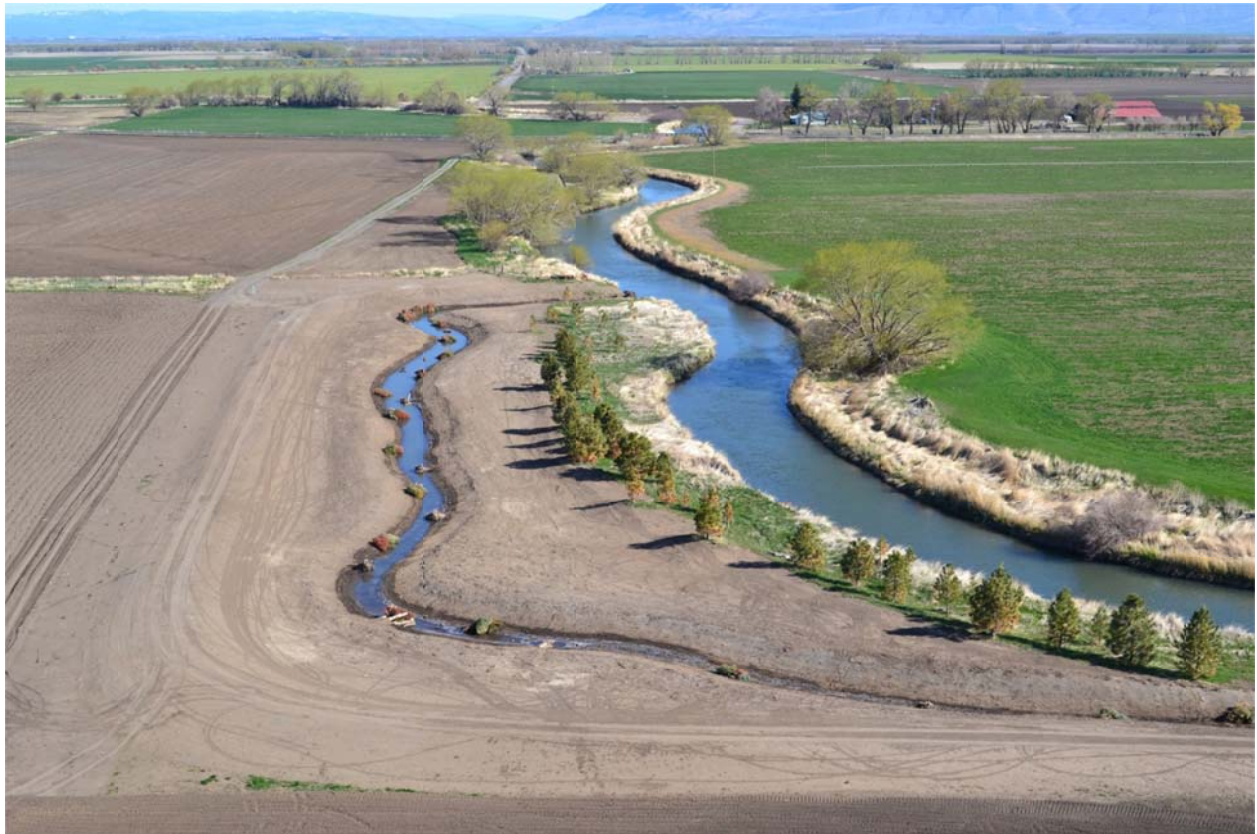
Catherine Creek-Baum Habitat Improvement Project – April 17, 2013 at 9:17am by Allen Childs
(CTUIR)

Post-construction – Aerial view of project site

This post-construction aerial photo shows the layout of the new side channel, wood structures, and the new levee location.

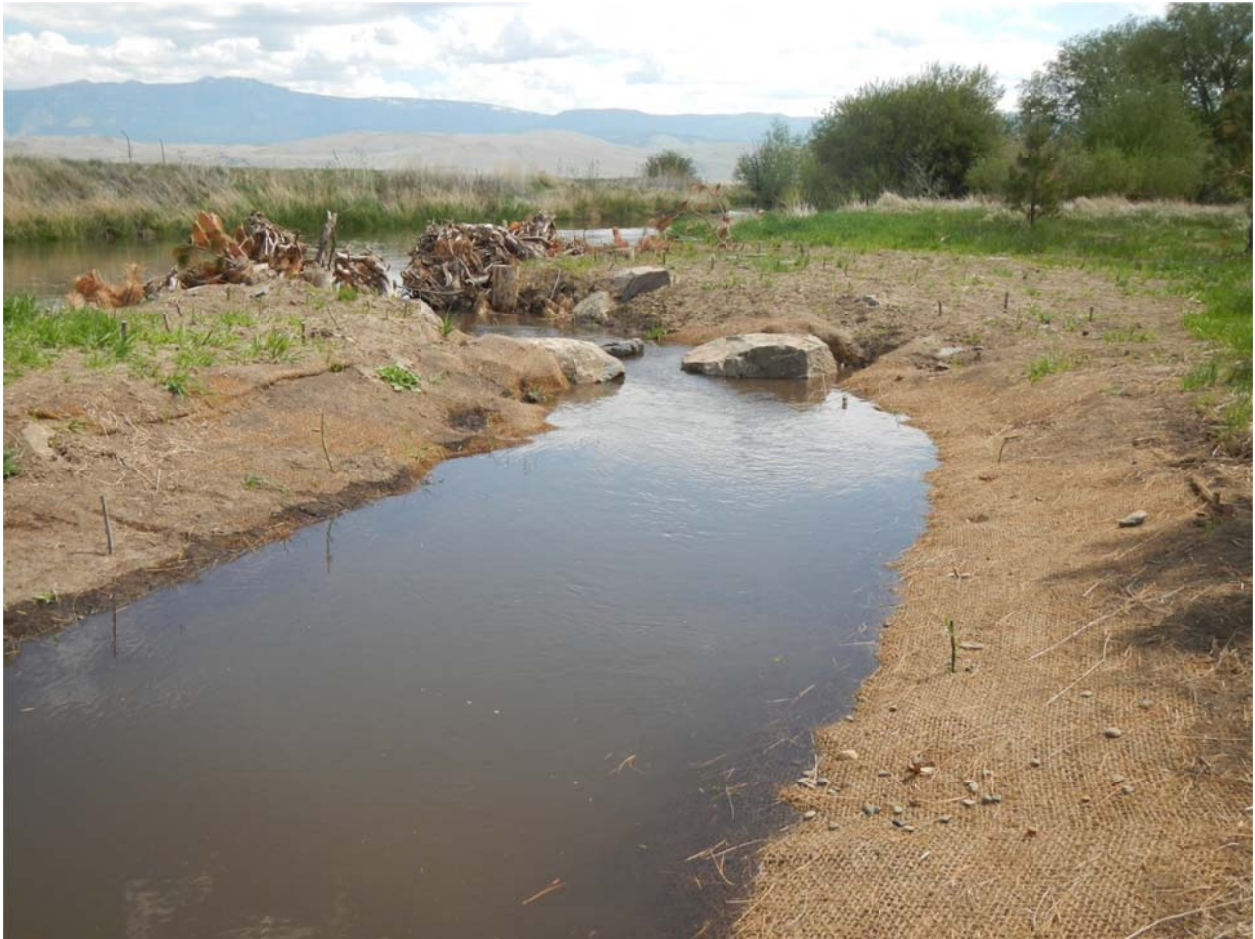
Catherine Creek-Baum Habitat Improvement Project – March 12, 2013 at 11:30am by Jesse Steele (GRMW)

Post-construction – Side channel entrance

This photo shows the upstream extent of the side channel with the large wood structure built at the entrance. Also note the coconut fiber erosion fabric used on the side channel to reduce erosion until vegetation becomes established. Also visible in the photo are the willow stakes planted along the waters edge.

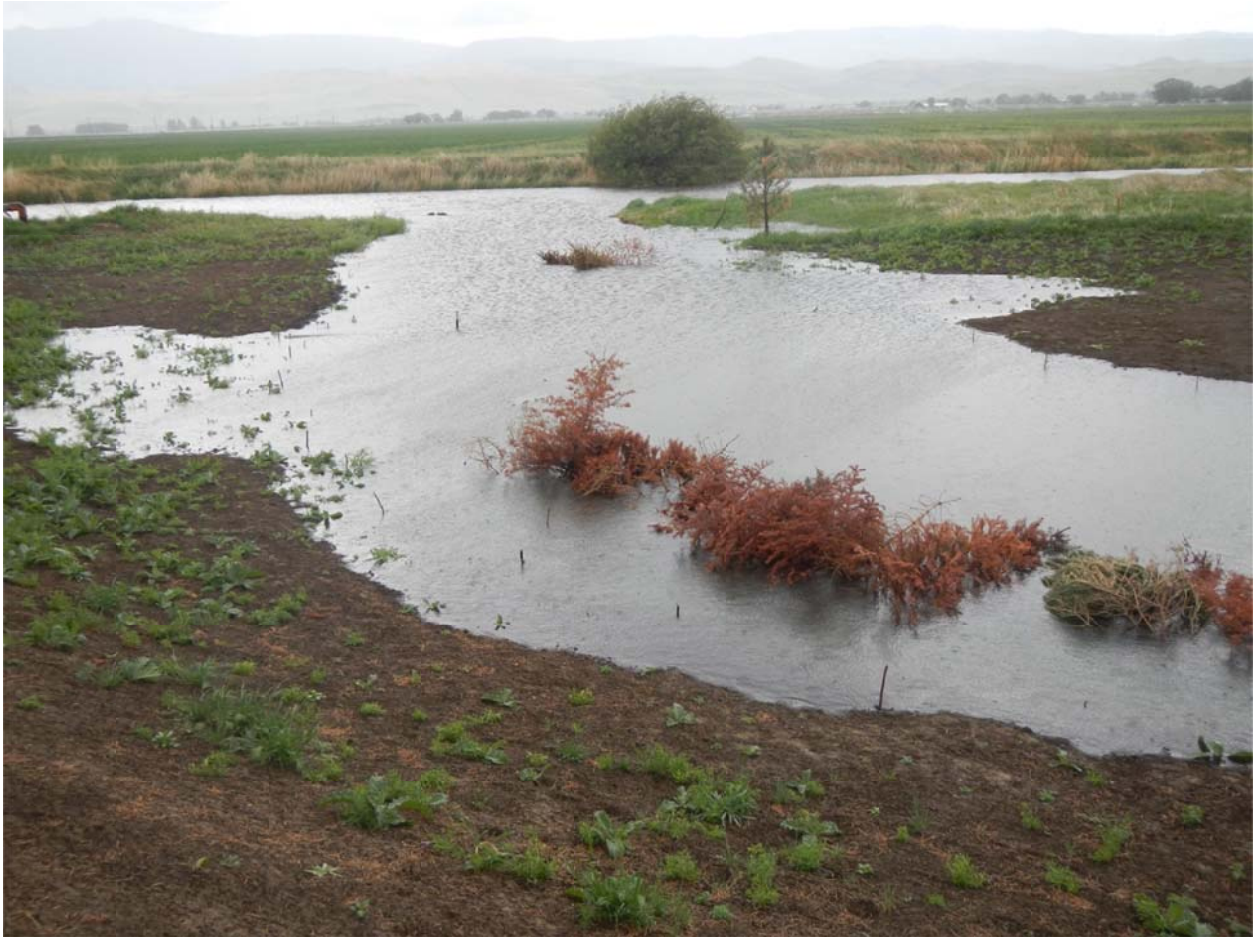
Catherine Creek-Baum Habitat Improvement Project – May 12, 2013 at 1:46pm by Jesse Steele
(GRMW)

Post-construction – Side channel exit at high flows

This photo shows the side channel exit back into Catherine Creek at high spring flows. Wood structure at exit of side channel is completely submerged.

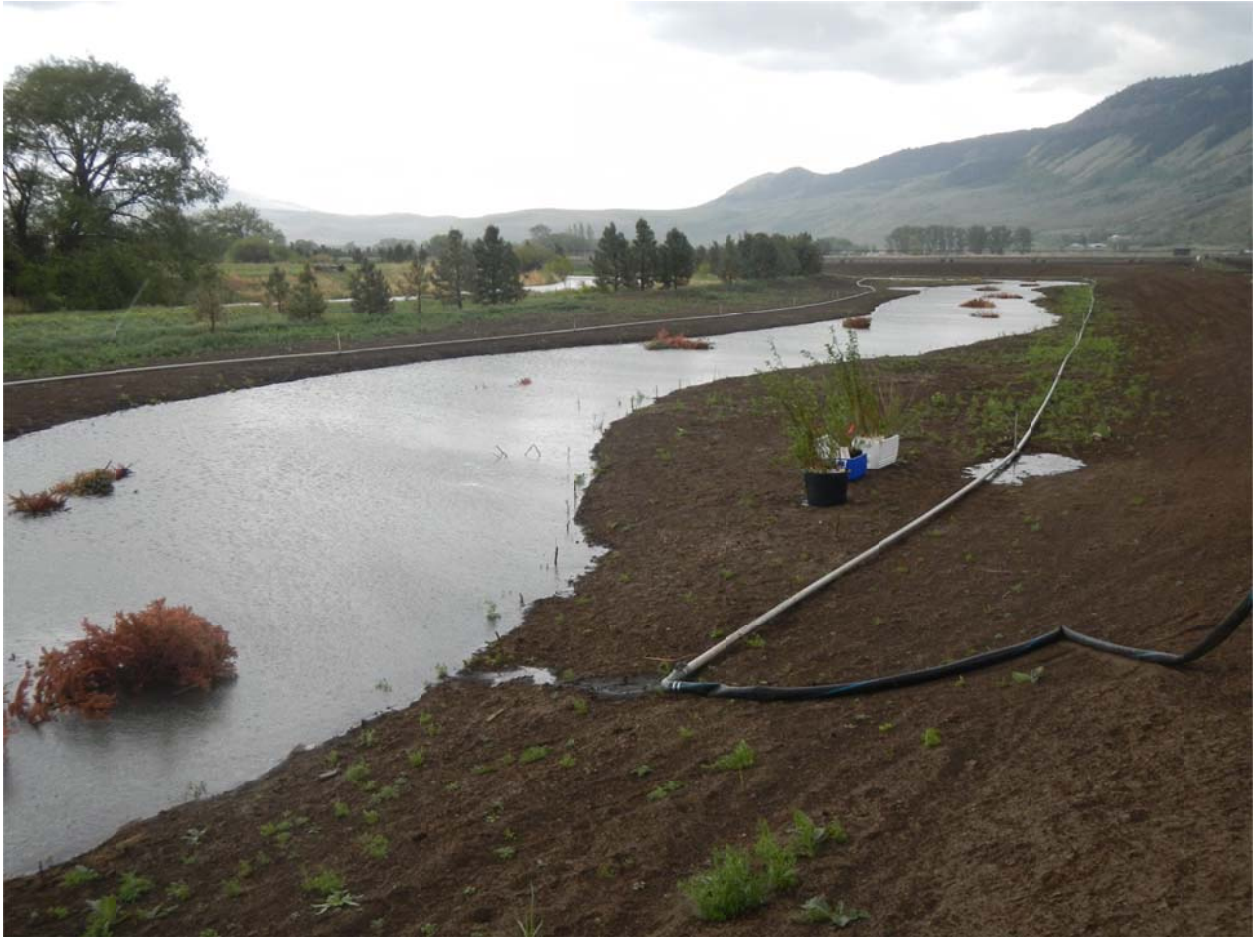
Catherine Creek-Baum Habitat Improvement Project – May 12, 2013 at 1:47pm by Jesse Steele (GRMW)

Post-construction – Side Channel at high flows

This photo shows the side channel at high flows. The containerized brush species are on site and ready to be planted. Species planted include Elderberry, Red osier Dogwood, Snowberry, and Golden Currant. This photo also shows the irrigation system that was used to water the project site during the first season.

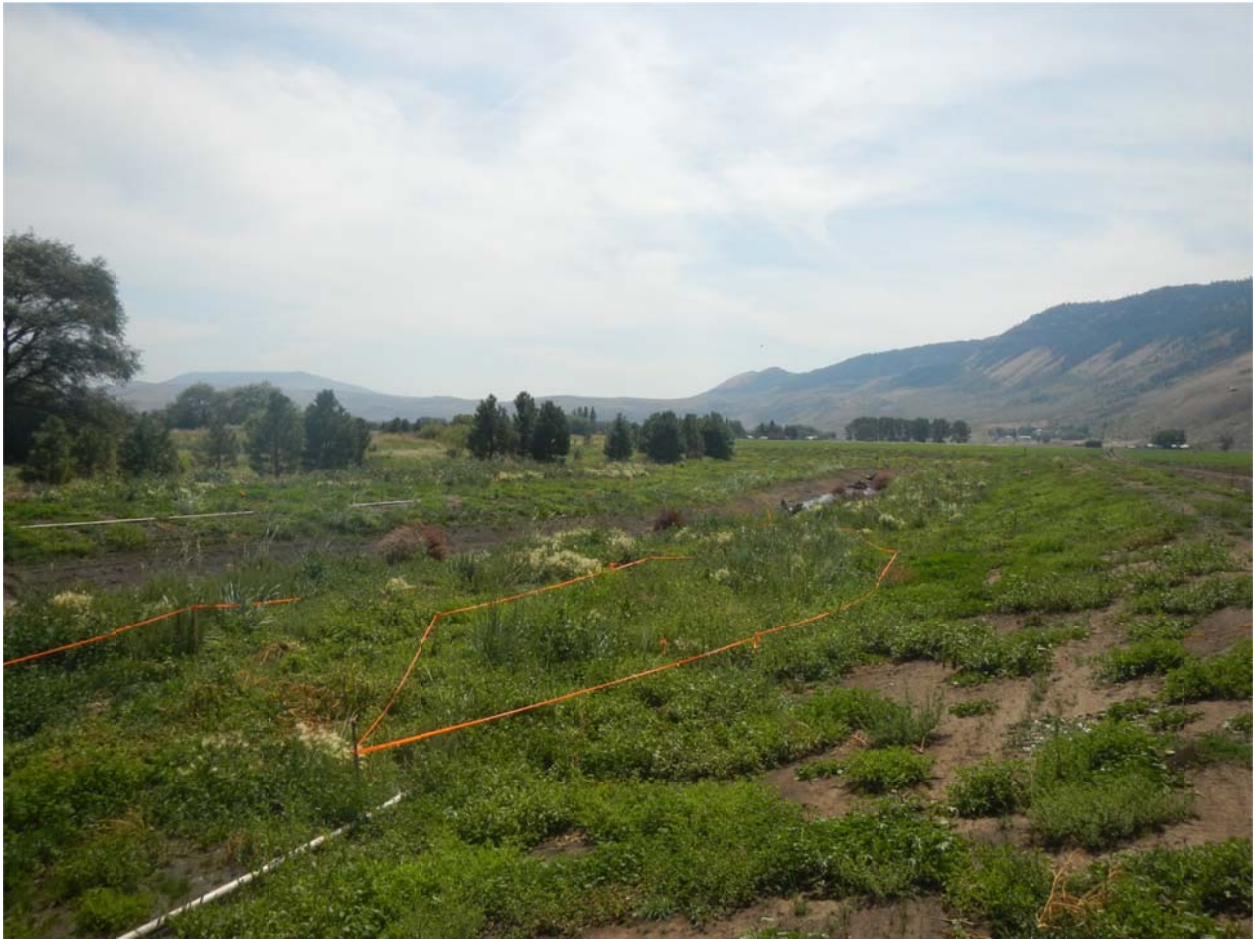
Catherine Creek-Baum Habitat Improvement Project – August 7, 2013 at 12:27pm by Jesse Steele (GRMW)

Post-construction – Project vegetation

This photo shows the project site vegetation. Areas surrounded by orange flagging indicate some of the wetland areas where we had good survival on rush and sedge species. Up to this point weeds have been controlled by hand pulling and mowing.

- 1) An In-water work extension was approved for this project from October 1st through October 12th. The extension was needed to complete the large wood structures at the inlet and outlet of the side channel.
- 2) Seeding of the project site took place immediately after construction. The grasses grew up nicely the first fall but were desiccated by harsh cold winds during the winter. The following spring when it was apparent the grass had died we reseeded using the specified native mix. Grass species have grown in well now and we don't anticipate loss this winter since it is much more established.
