Grande Ronde Model Watershed Project

Catherine Creek Swim-thru Fishway Field Test

Completion Report 2005

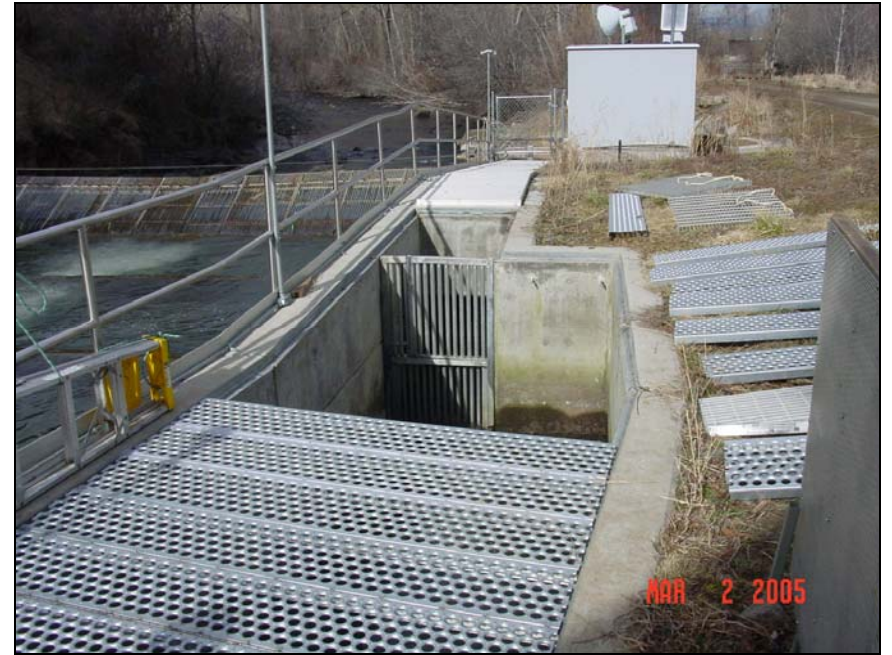
CTUIR Fish Trap, STF Placed in this structure

The rotary valve equipment was to be placed in the fish ladder immediately above where the fyked headgate is normally positioned. The fyked headgate was installed just above the upstream outlet of the STF valve. Five tests were planned for periods as described below. Start time depended on how soon permits could be obtained and equipment manufactured and delivered to the site. Between test periods the equipment would be completely removed from the stream. At any time during testing if the migration of fish appeared to be impeded (no fish in trap above equipment), the equipment would be removed from the stream and attempts made to modify and correct the configuration of the entrance.

Upon delivery, the rotary valve had to be adapted to fit inside the fishway. A plywood wall was attached on the upstream side to the device to build up a head of water and to control the flow of water through the machine. Attractant flow was provided by screened pipes, regulated by knife gates. Water entered the pipes on the upstream end and exited near the downstream entrance to the valve. The upstream valve exit had three, one-inch diameter pickets acting as a one-way door, so once fish swam through they were unable to return downstream. Installation of the device in this configuration could only test upstream capabilities for adult fish, although fish smaller than the space between the fyke bars could enter the valve from the upstream side.
