SWAMP CREEK HARDWOOD AND WETLAND RESTORATION PROJECT, FY05

BPA Contract #00022522

BPA Project #1992-026-01

Completion Report January 2006

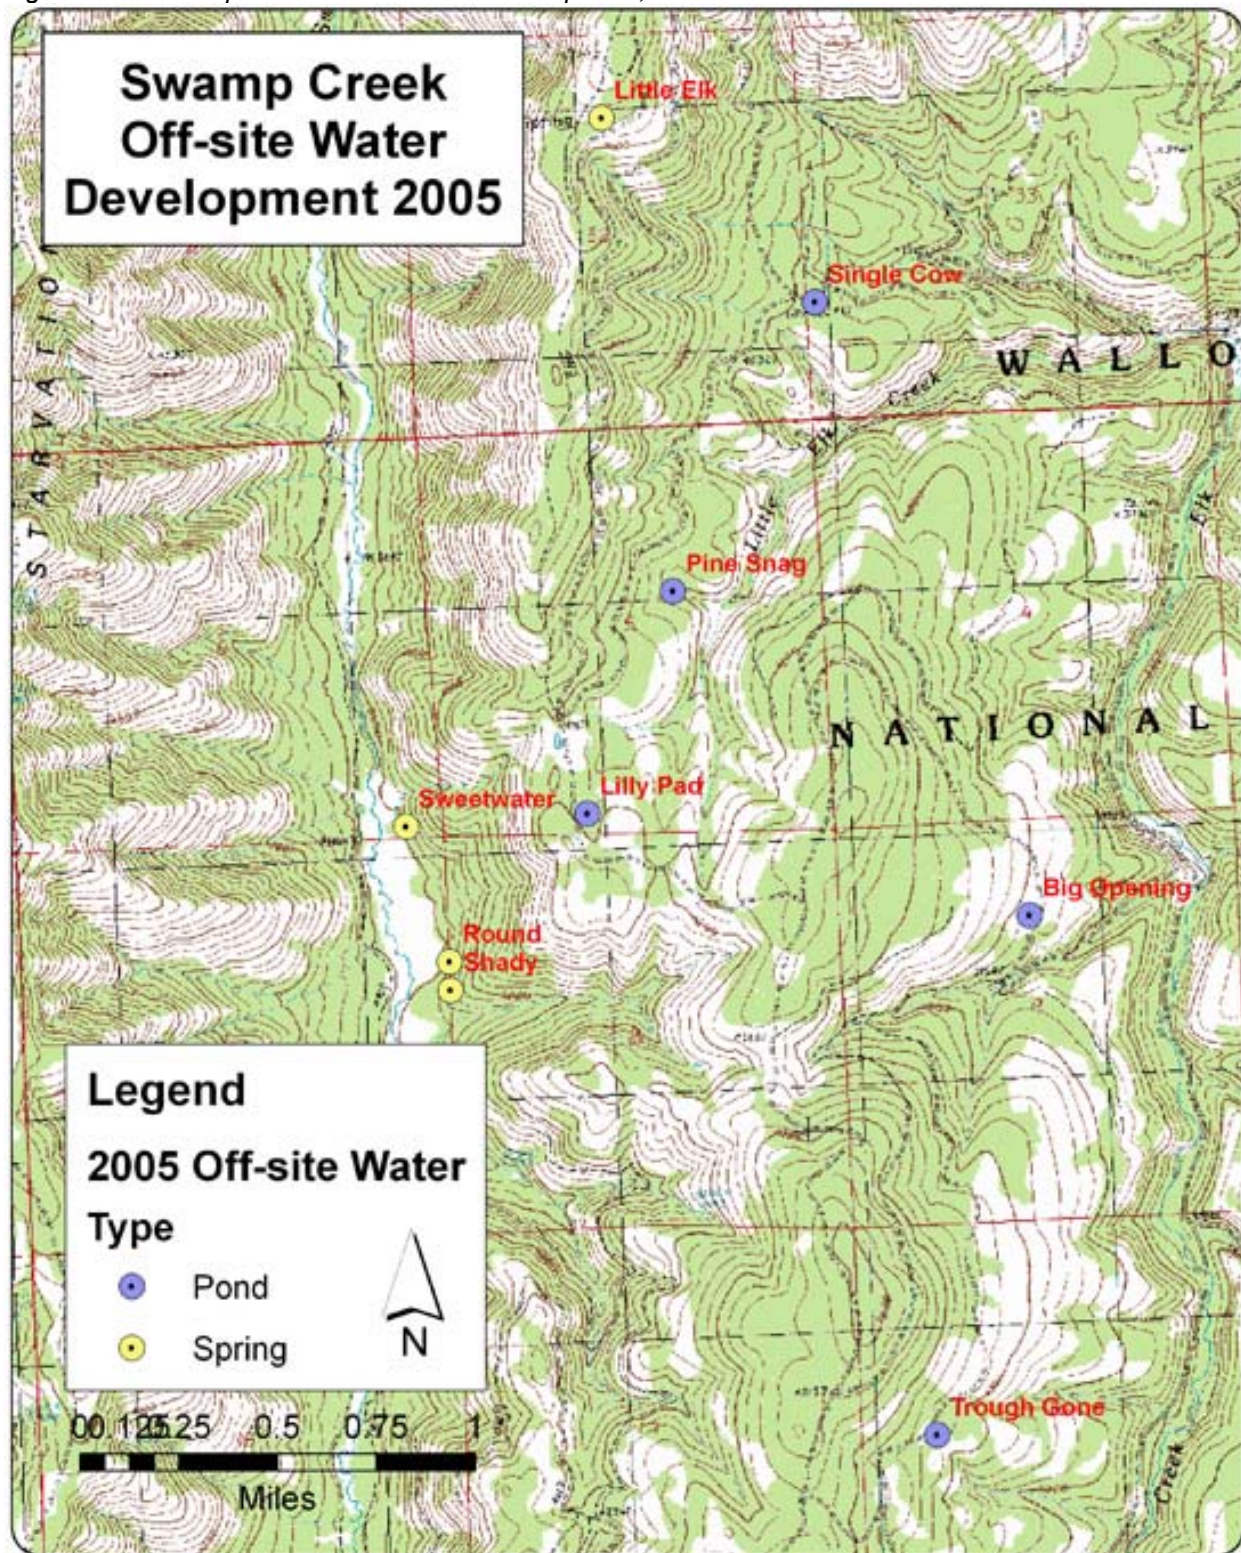
Figures 1a. Swamp Creek off-site water development, 2005.

**Swamp Creek
Off-site Water
Development 2005**

Off-Site Water Development Five upland pond sites were developed on the west side of Swamp Creek during the summer of 2005. These sites were identified by an on-the-ground upland water inventory completed by Forest Service personnel, using existing maps of developed and undeveloped water, and soliciting permittee knowledge of water sources in 2004. These ponds were selected over developing new spring sites because they are expected to need less maintenance over time and were preferred by the permittees. They are expected to help relieve pressure in the riparian zone, pulling cattle into the uplands and decreasing their impact on the creek. Their names are: Single Cow, Pine Snag, Lilly Pad, Big Opening and Trough Gone.

In addition to the ponds, eleven troughs and eleven springboxes were also installed or replaced at 12 spring locations in the Joseph Watershed by FS personnel assisted by the Training & Employment Consortium (TEC) youth crew. Spring sites were protected with 2,265 total ft of fence. Their names are: Strayley, Sweetwater, Nells, Willow, Little Elk, Fence, Round, Shady, Vawter, Boner and Sumac.

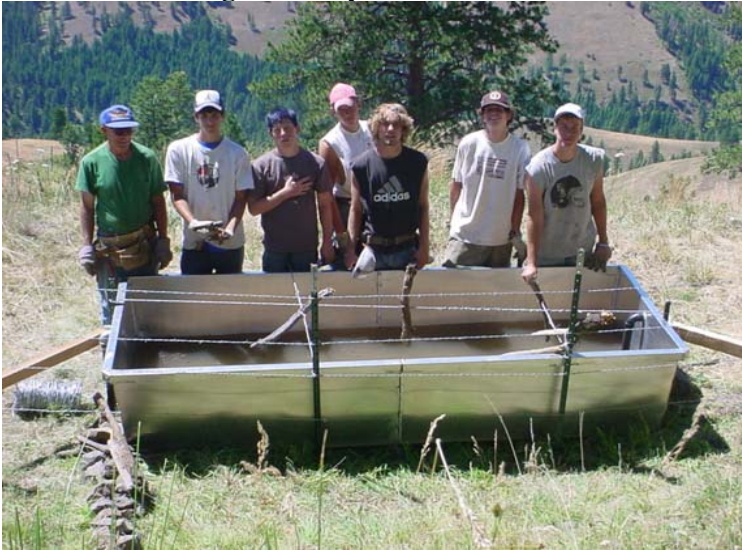
PP#1: Willow spring with TEC crew; 2005

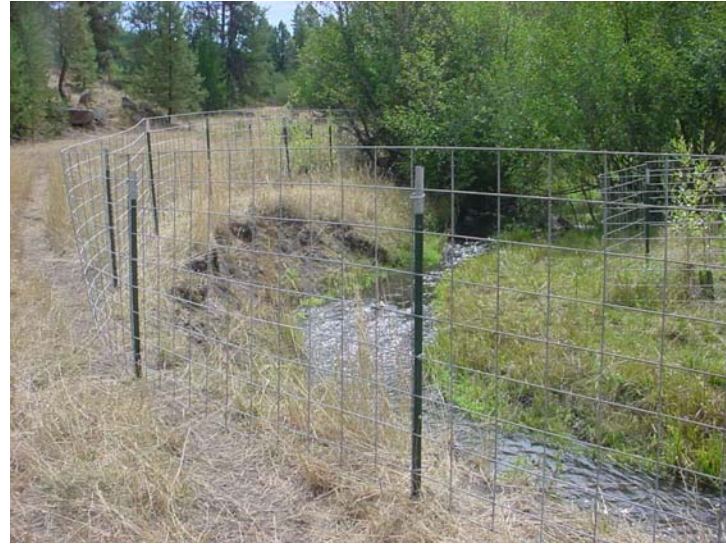
PP#2: Swamp Cr chronic sediment source #4

Chronic Sediment Source Treatment Five chronic sediment source sites along 2 miles of Swamp Creek were protected with cow panel cages by FS employees. The five water gaps did not get hardened due to a timing issue when a law suit late September froze all project work being completed under Categorical Exclusions until November, 2005. The original proposal described proposed work at 12 chronic sediment sources with a separate treatment of 5 water gaps. This was in error, and the water gaps are included as part of the original 12 chronic sediment sources.

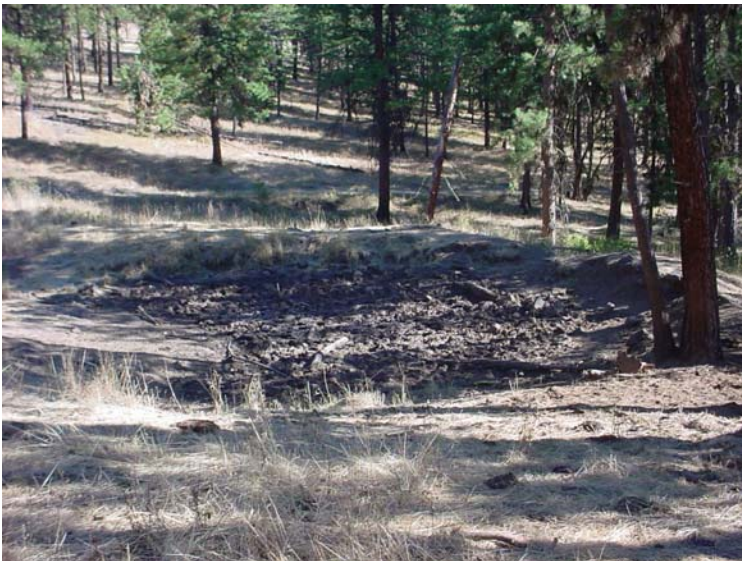
PP3: Trough Gone Pond, pre-work; 2005

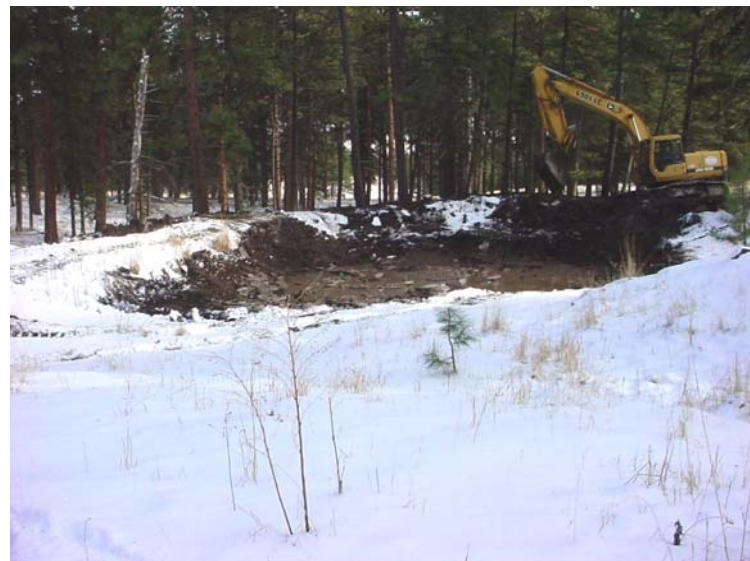
PP#3: Trough Gone Pond, post-work; 2005

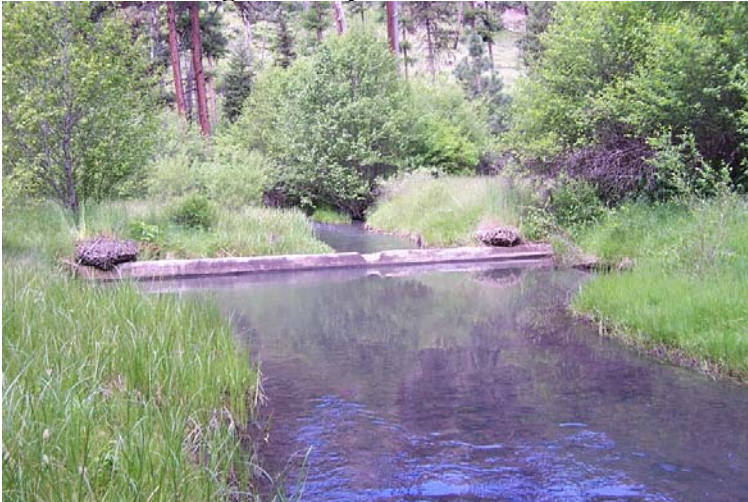
PP#4: Swamp structure #1 pre-work, 2005.

Instream Structure Modification Forty-one instream structures were modified along 4 miles of Swamp Creek in July and August, 2005. Four log boles were left in place when they did not promote bank-edge scour downstream, were not a juvenile fish passage barrier, or had shifted or blown out since installation. One bole was removed and reburied in the bank at an upstream angle. Twenty-one boles were removed and placed on the bank angling down into the stream at an upstream or downstream angle. Fifteen boles were removed and reburied in the bank or placed on the bank and had a tree placed on top of them to create a foundation for miniature log jam development.

Every structure modification involved removing the gabion baskets (with the exception of a basket or two that were hard to get and were completely covered with vegetation) and as much geo-textile material and wire mesh that could be recovered. Some geo-textile was left buried in a few banks when the removal of the material was deemed secondary to preserving the integrity of the bank. Much of the wire mesh was rusty and broke apart easily, thus making it difficult to remove. High turbidity at each site during modification prevented visual identification of lost pieces of wire or fabric. Because of this, some geo-textile material and wire mesh pieces were undoubtedly missed at each site and will be left there to decompose or rust naturally.

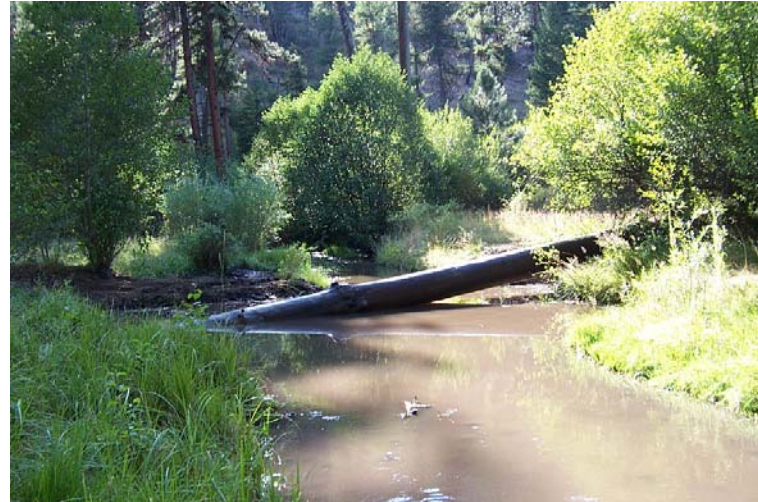
PP#4: Swamp structure #1 post-work, 2005.

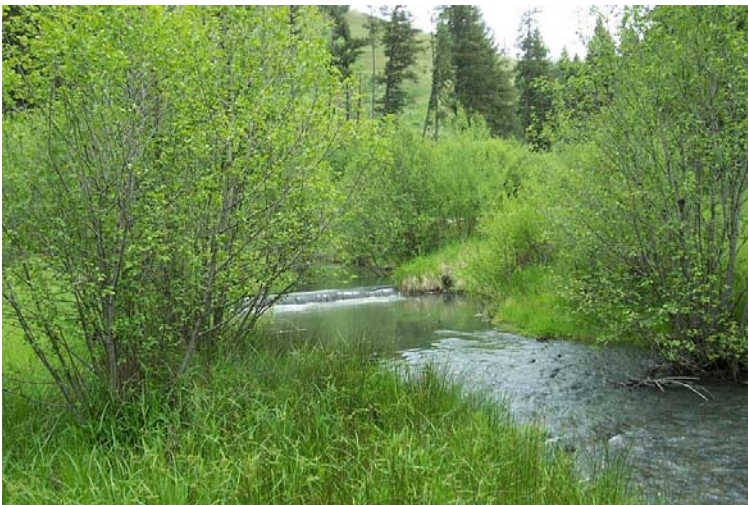
PP#5: Swamp structure #35 pre-work, 2005.

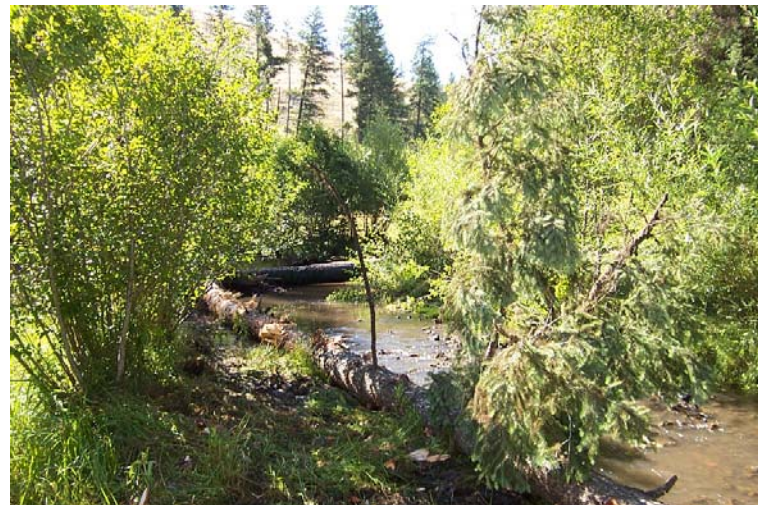
PP#5: Swamp structure #35 post-work, 2005.
