Completion Report January 29, 2007

Fly Creek Stream Restoration Project Phase I

BPA Contract #: 27853

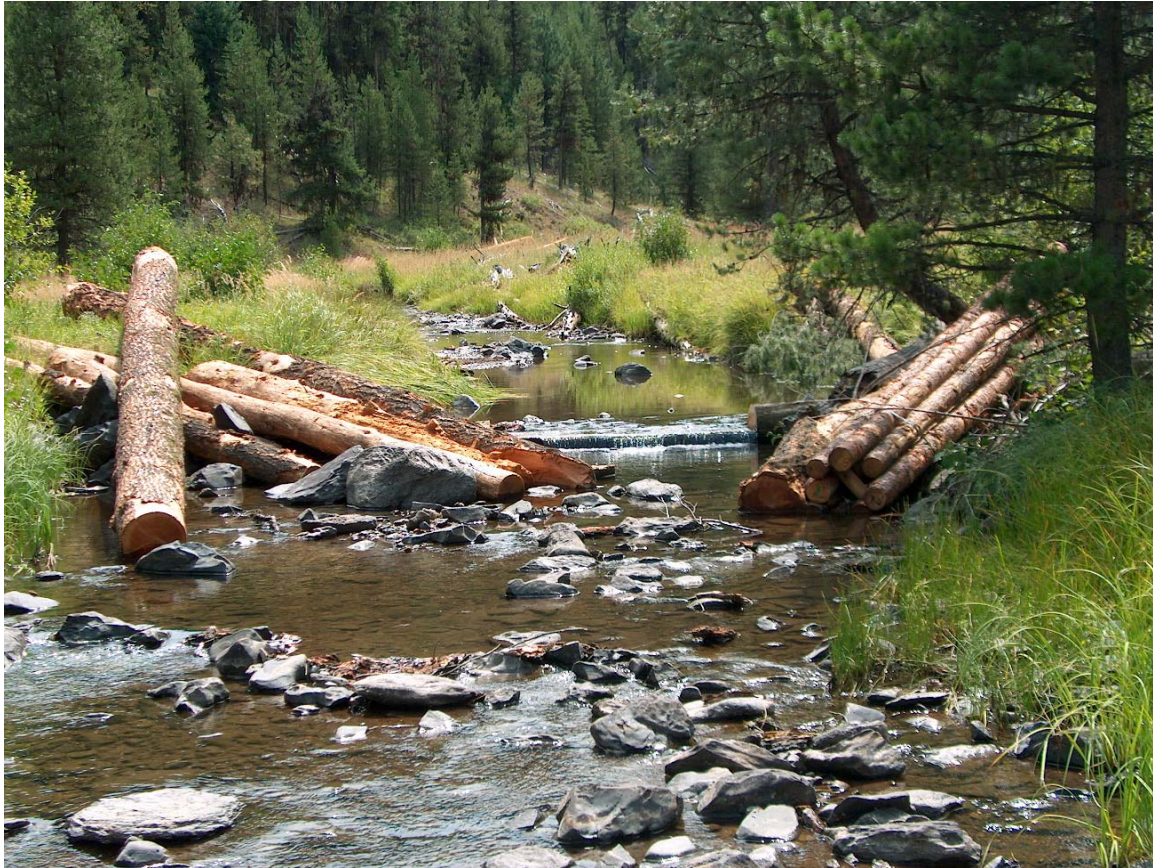
Photo 1. Fly Creek - Upstream view of site 7. Note ELWD on right and larger notch created in log weir (center of photo).

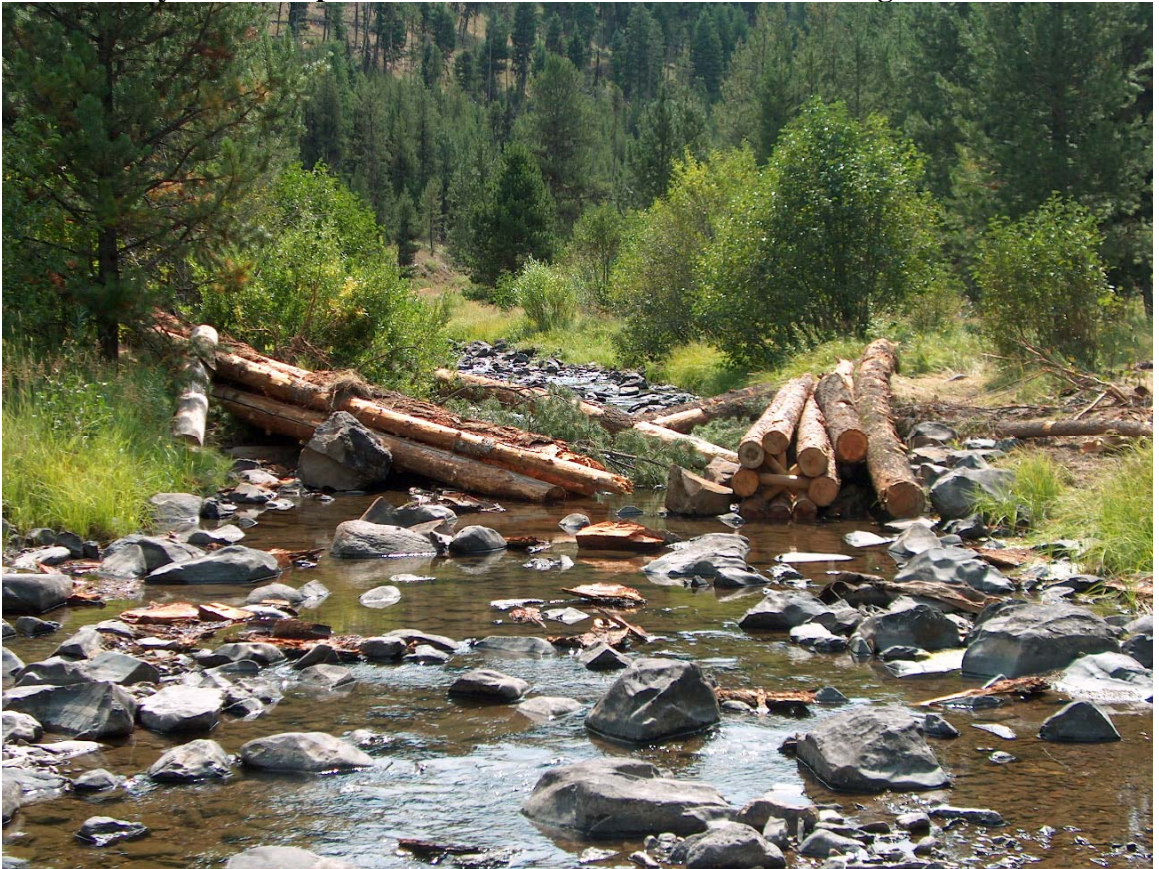
Photo 2. Fly Creek - Upstream view of site 8. Note ELWD on right.

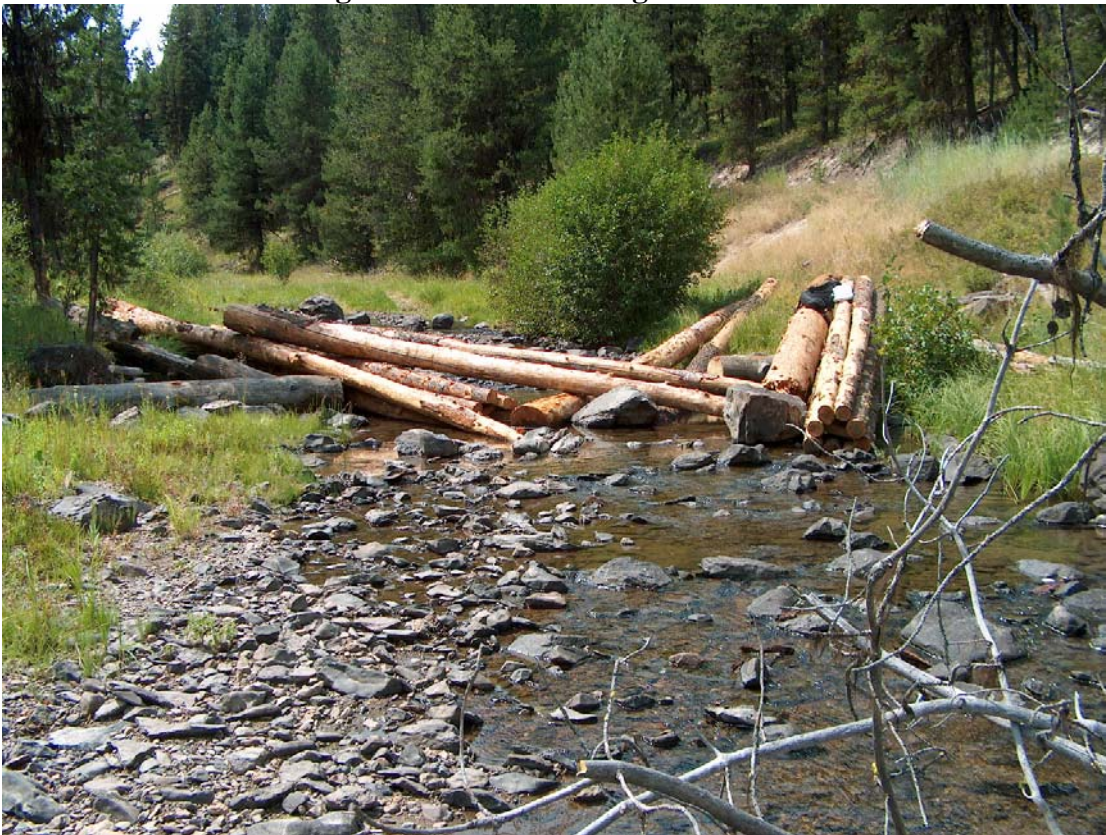
Photo 3. Fly Creek - Upstream view of site 9. Note ELWD on right and left in combination of other large wood. Center of log weir has been removed.

Two ELWD were used at the following site: 9

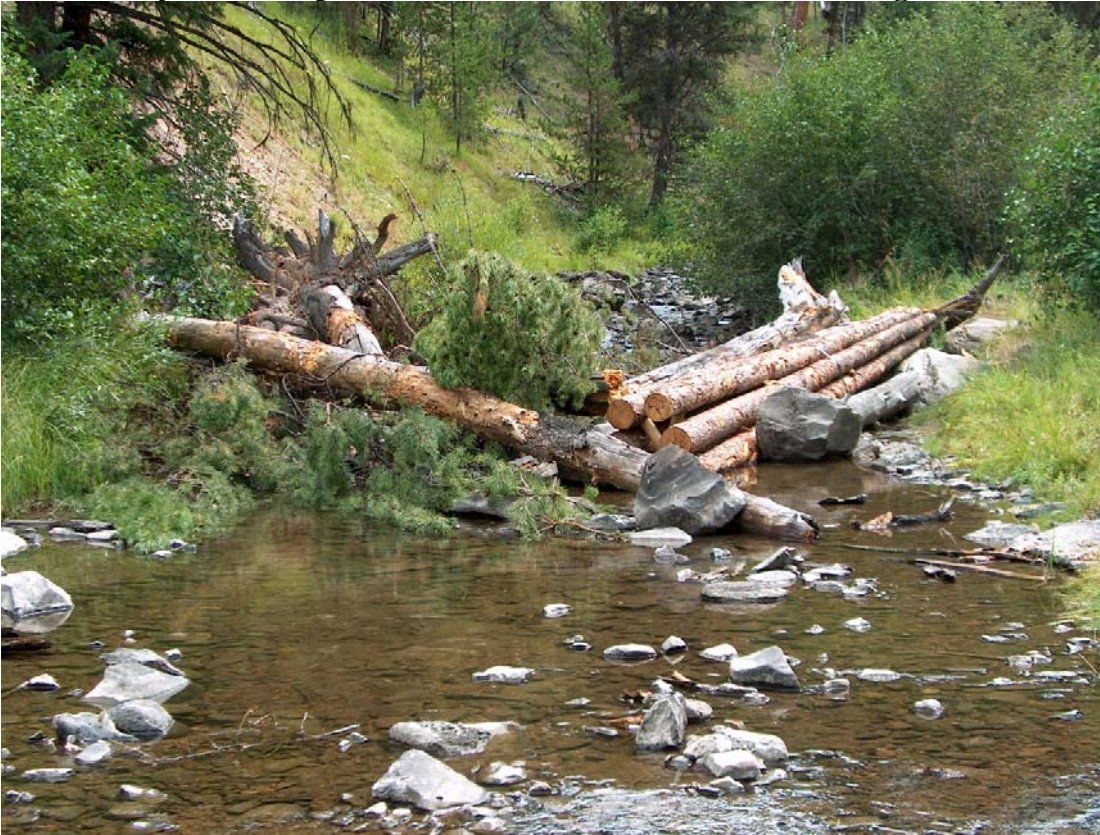
Photo 4. Fly Creek - Upstream view of site 72. Note ELWD on right.
