**WILDCAT and WALLUPA BRIDGE REPLACEMENTS**

**Completion Report**

Project No. 1992-026-01  
Contract No. 37387

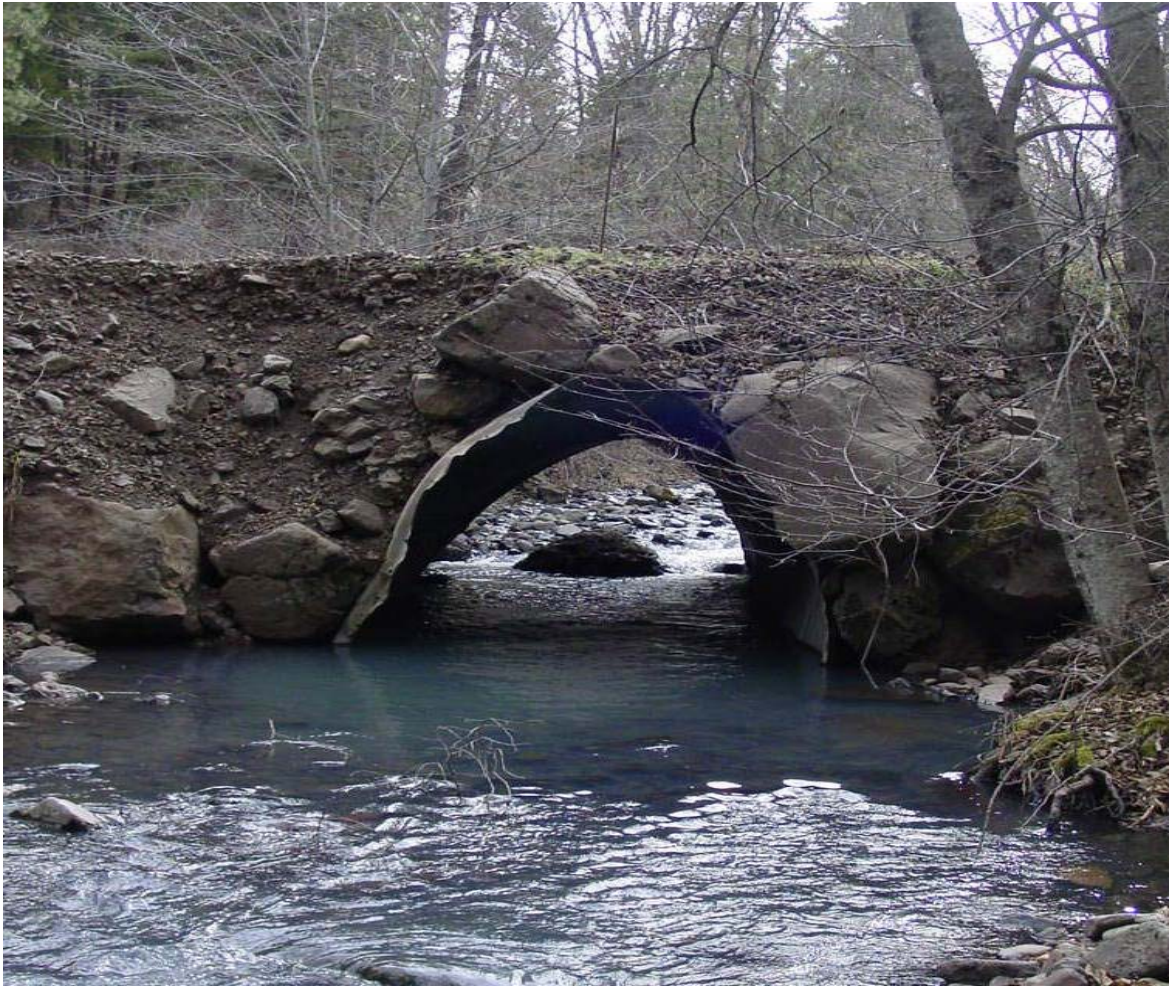
## Wildcat Pre-Project

Upstream view, March 2005. Note the large rock partially blocking the entrance and the partially collapsed condition of the pipe. The width of the structure at the base is just under ten feet, severely undersized for the area of the Wildcat drainage.

The Wildcat crossing has failed multiple times over the years, each time introducing large quantities of road fill, surface gravel and soil into the system. The prior crossing, an undersized arch, last failed in 1997. The damaged arch was salvaged and put back in place. It was partially collapsed, reducing capacity. The arch was 9.8 feet wide at the bottom. Average bankfull width through this reach is twenty six feet. The risk of future failure was high due to its size and collapsed condition. The arch was a velocity barrier to migrating adult steelhead and juveniles during peak flows. There are approximately 12 miles of available spawning and rearing habitat above this crossing.

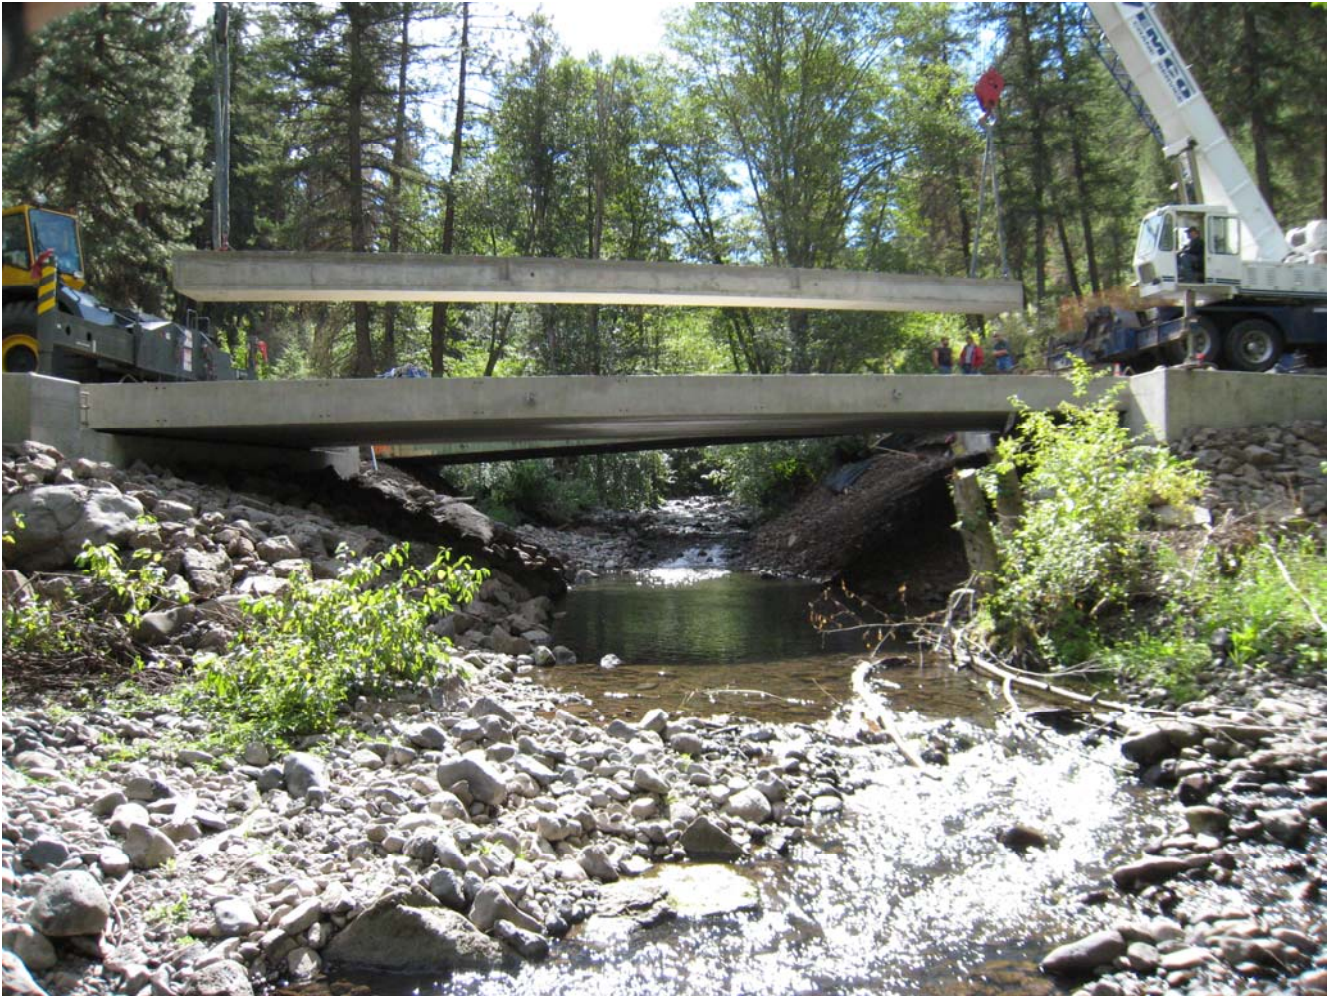
## Wildcat During Construction

Upstream view, August 2008. The bridge foundation is in place. Riprap has been placed on the north side of the stream. Riprap was planned but not necessary on the south side due to very solid basalt rock from the waterline up to the foundation. The precast concrete slabs are being placed with cranes stationed on either side of the bridge.

Structure construction was completed as per the design specifications, with a few minor exceptions. Concrete barriers at Wildcat were used on the southeast corner of the bridge in place guardrails due to shallow solid rock which prevented driving posts for the guardrails. Riprap was not needed to protect the south foundation, also due to rock. An in-water work period extension from September 15 to October 15 was requested, but was not actually needed.

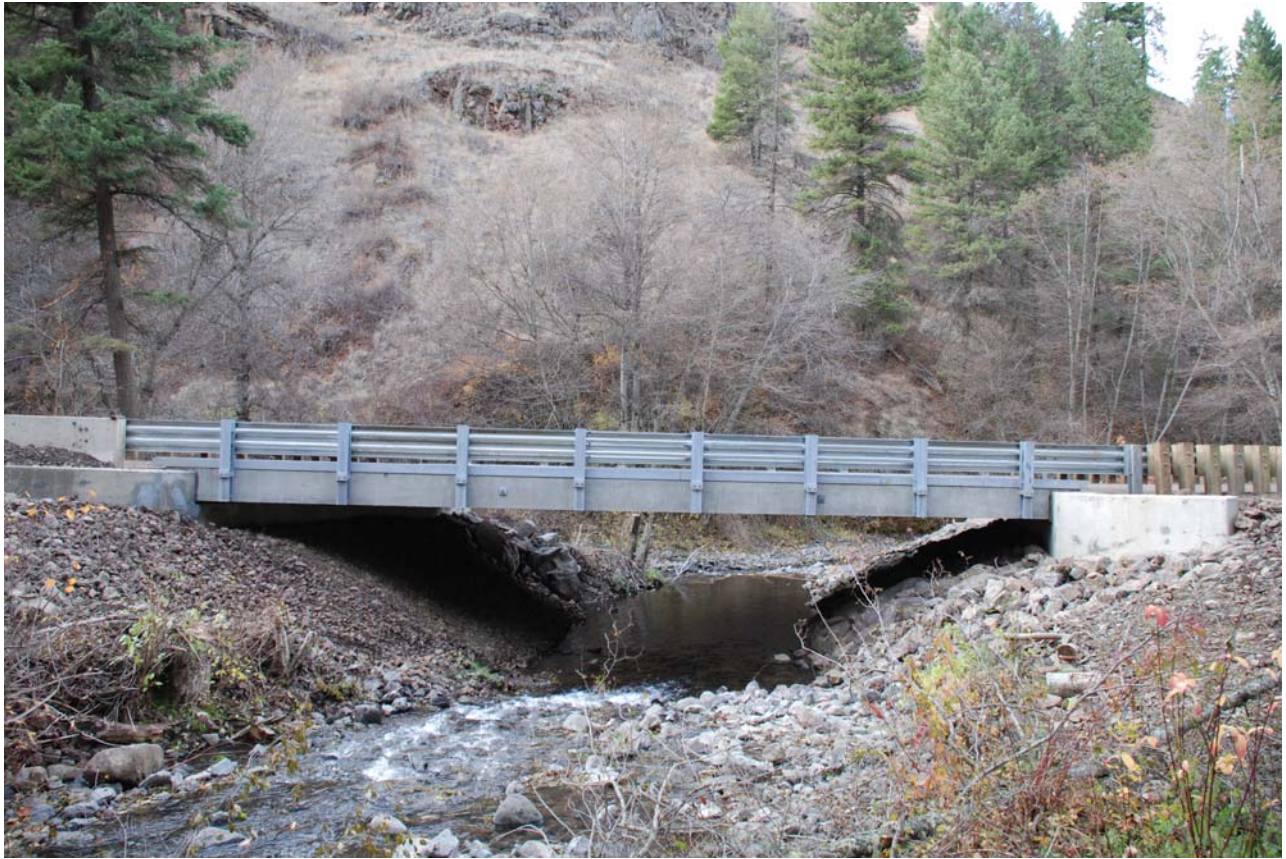
## Wildcat Post-Project

Downstream view, November 2008. Completed bridge. Note riprap was only necessary on the right streambank. Flow capacity is nearly four times pre-project.

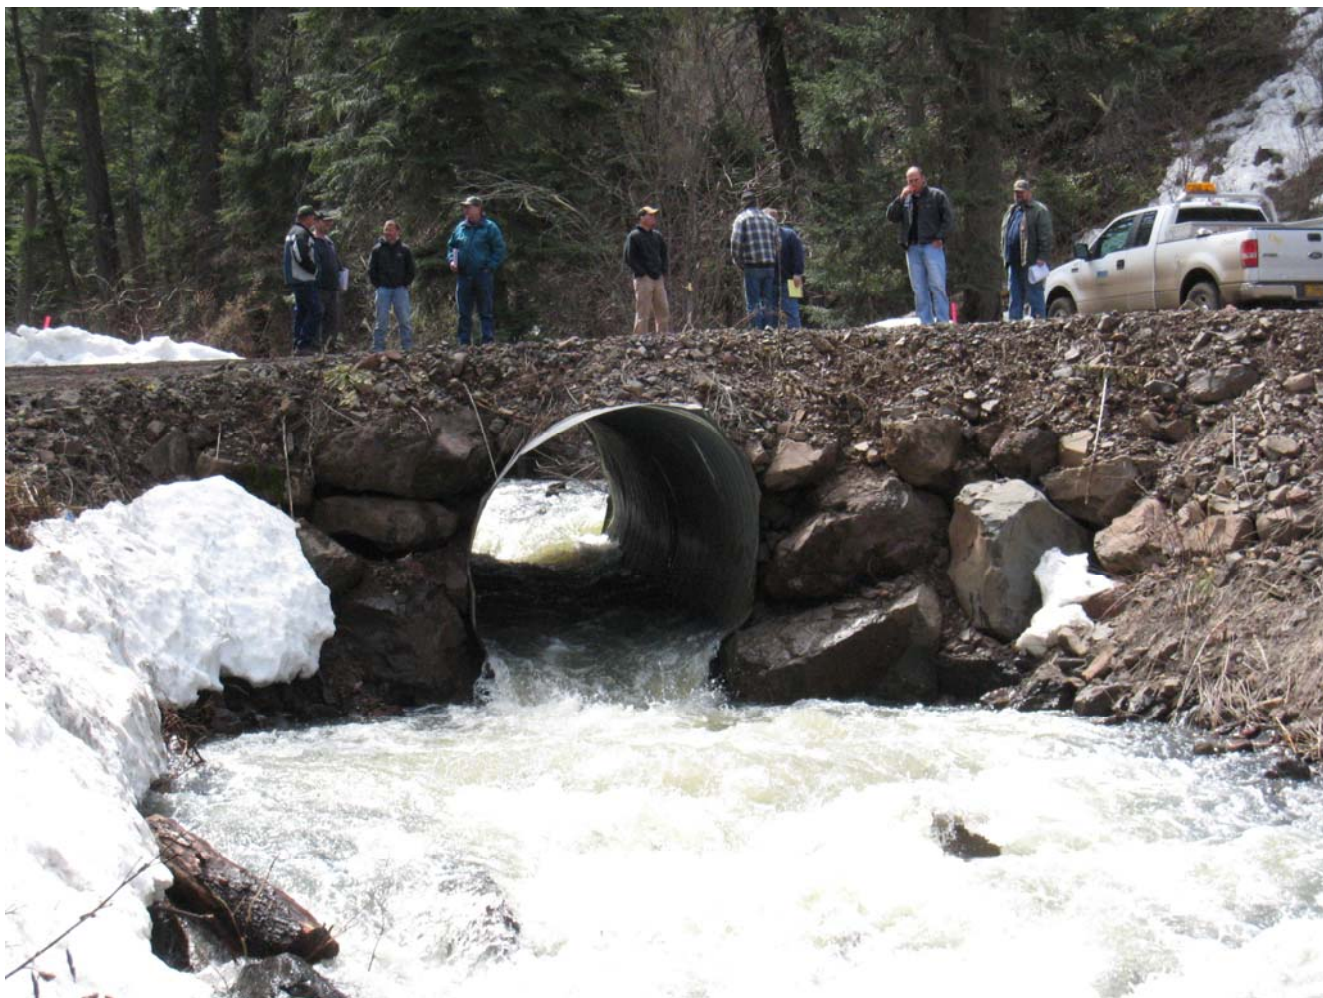
## Wallupa Pre-Project

Upstream view, May 2008. Velocity through the pipe, pipe slope and pipe length, and drop at the outlet combined to restrict adult migration as well as prohibit any upstream juvenile passage.

The Wallupa crossing also has failed multiple times. The prior crossing, an 8-foot round culvert last failed in 2002. The culvert was a velocity barrier to adult steelhead and blocked all juvenile steelhead and resident fish passage. There are 1.5 miles of spawning and rearing habitat above the crossing.

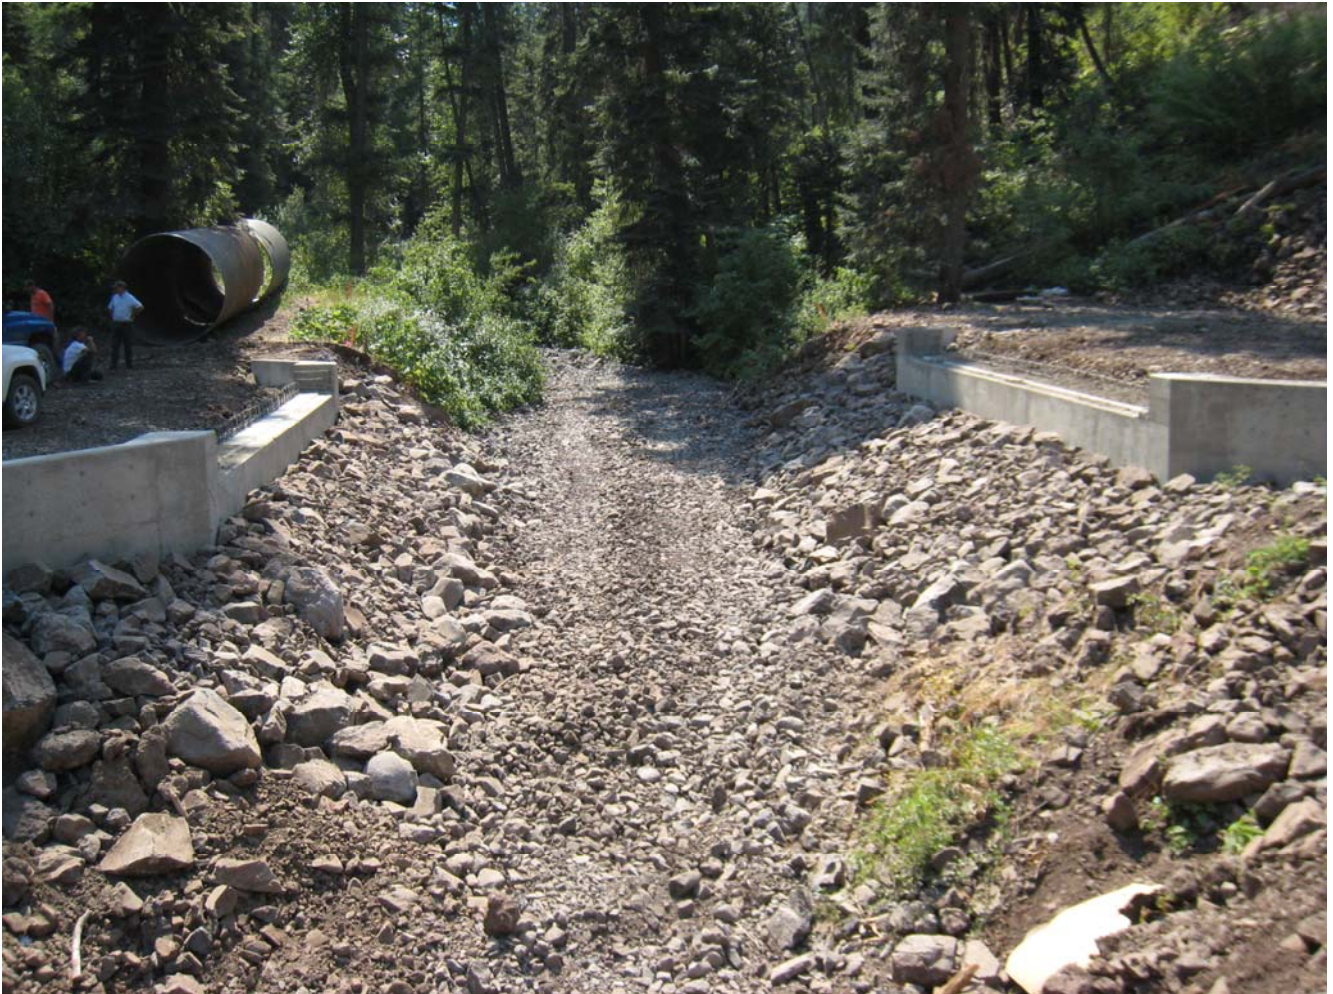
## Wallupa During Construction

Upstream view, August 2008. The bridge foundation is in place. Riprap has been placed to armor the bridge footings. Accumulated bedload from above the site has been placed throughout the channel bed.

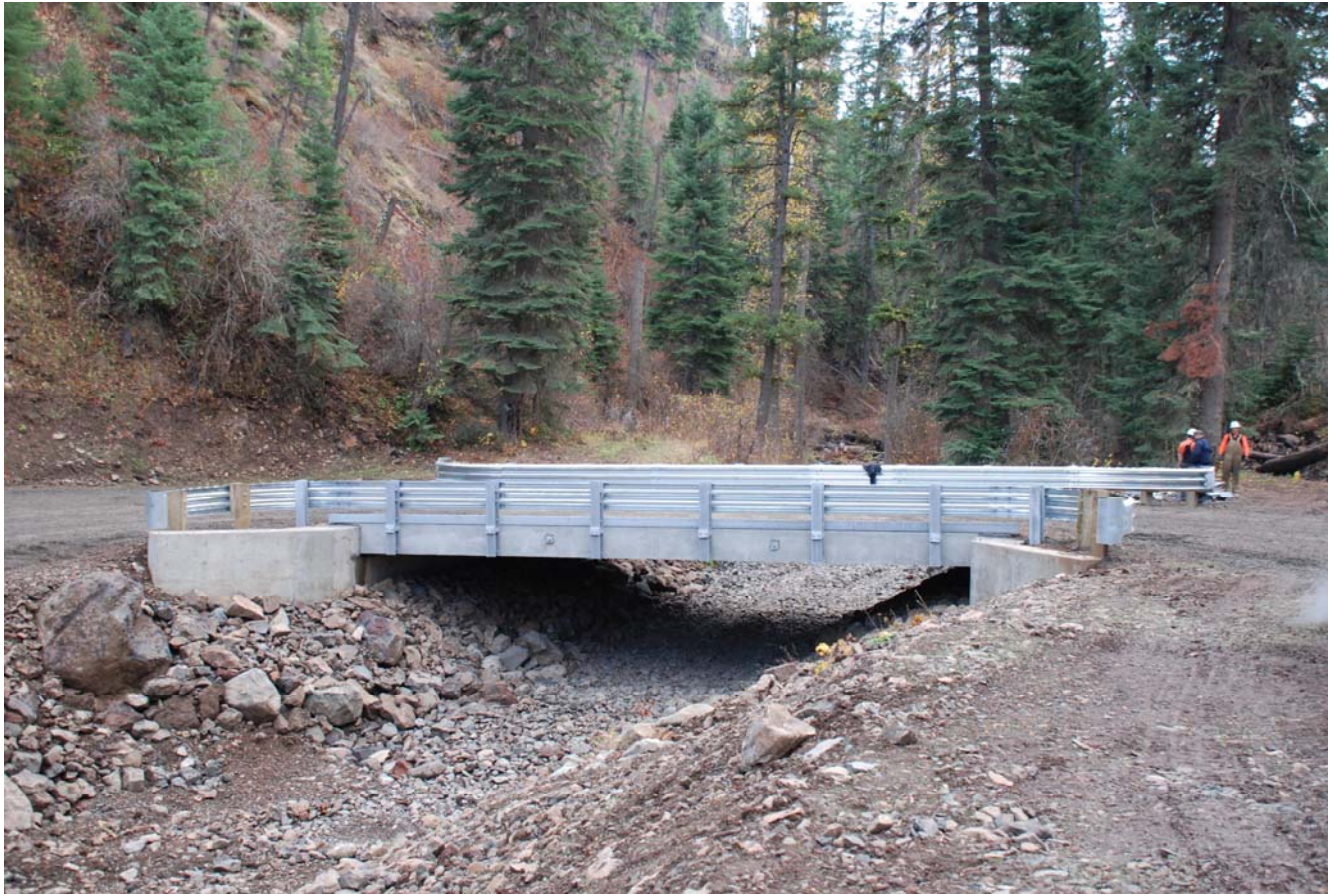
## Wallupa Post-Project

Upstream view, November 2008. Completed bridge. Live stream flow is perennial higher in the drainage. Flow at the project site normally resumes in December. Flow capacity is nearly four times pre-project.
