# **Butte Creek/Hampton Bridge Crossing**

Project Completion Report

BPA Project # 1992-026-01

Grande Ronde Model Watershed

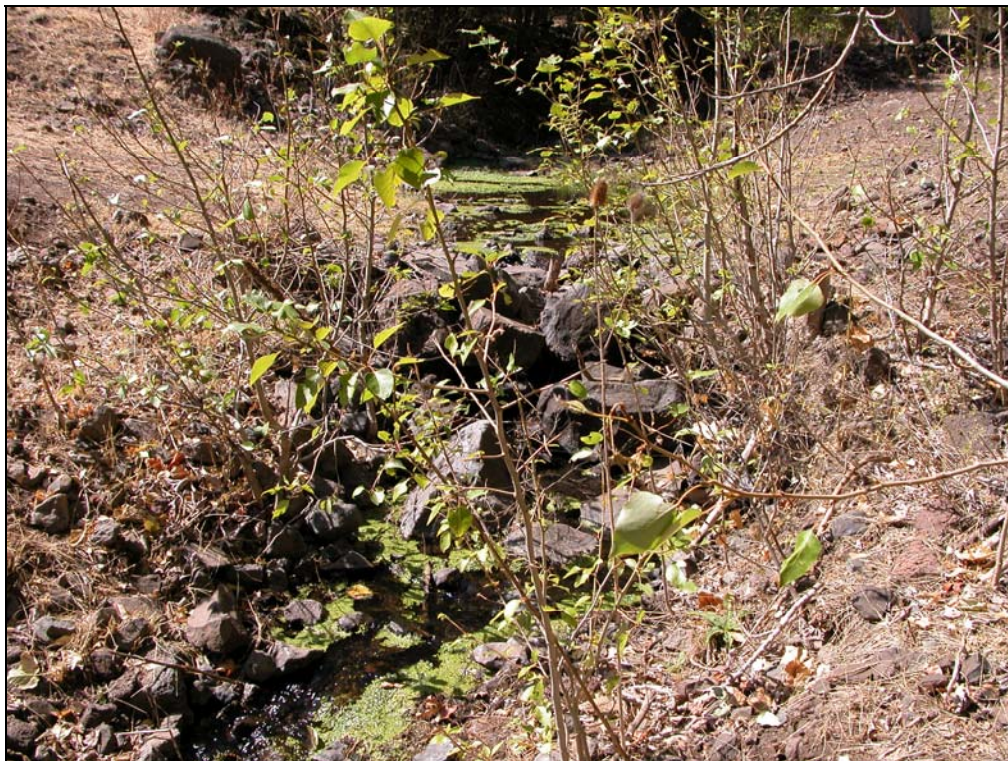
**Photo 1: Photo taken September 8, 2005 looking upstream at perched ford and road crossing.**

Perched Ford: The ford was held in place in Butte Creek by a three foot tall nearly vertical rock crib wall. The crib wall maintained road elevation through the creek and was consequently a barrier to juvenile fish and disrupted bedload transport processes. To remove the crib wall less than two cubic yards of material were removed. All of the substrate above the crib wall has been left in place and is expected to mobilize in coming high flow events. The accumulated substrate is expected to move downstream and fill interstitial spaces between boulders improving passage conditions.

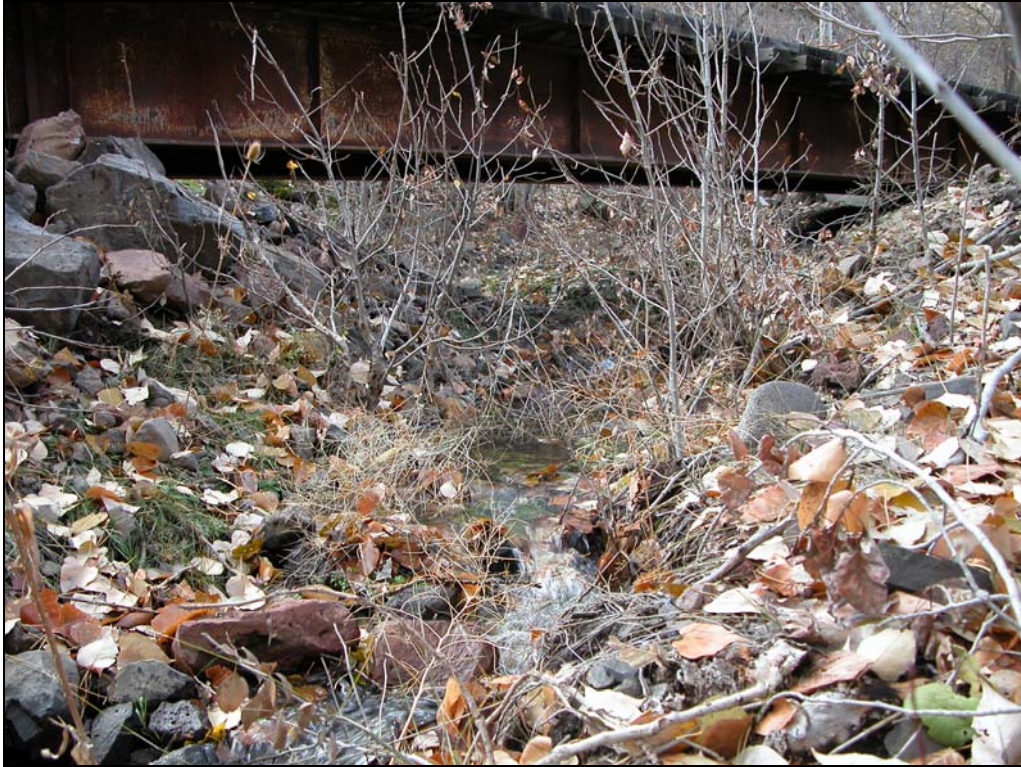
**Photo 2: Photo taken November 8, 2006 looking upstream. Perched ford has been removed, ford is no longer used to cross Butte Creek, bridge has been installed, and fish passage through the area has been accomplished.**

Objectives #1 & #5 to provide juvenile fish passage and enhance adult passage above current perched ford has been accomplished through removal of the ford and crib-wall holding it in place. Butte Creek below the project footprint is steep and characterized by medium sized boulders and step pools. The accumulated bedload at the ford site is expected to mobilize in coming high flow events and fill interstitial spaces between the boulders enhancing passage. Adult fish passage has been enhanced and juvenile passage has been restored to  $\frac{3}{4}$  of a mile of Butte Creek above the bridge site.

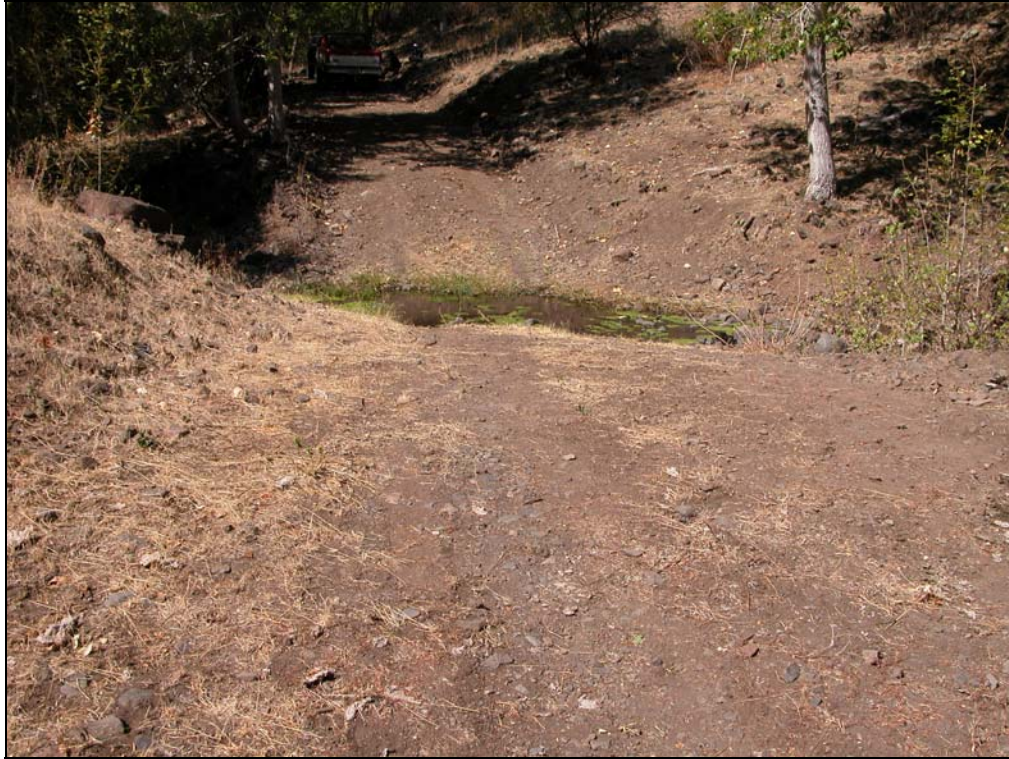
**Photo 3: Photo taken on September 8, 2005 looking up the road at ford crossing and bridge installation site. This photo demonstrates how during wet or runoff conditions sediment enters Butte Creek particularly from the up-road side of the creek.**

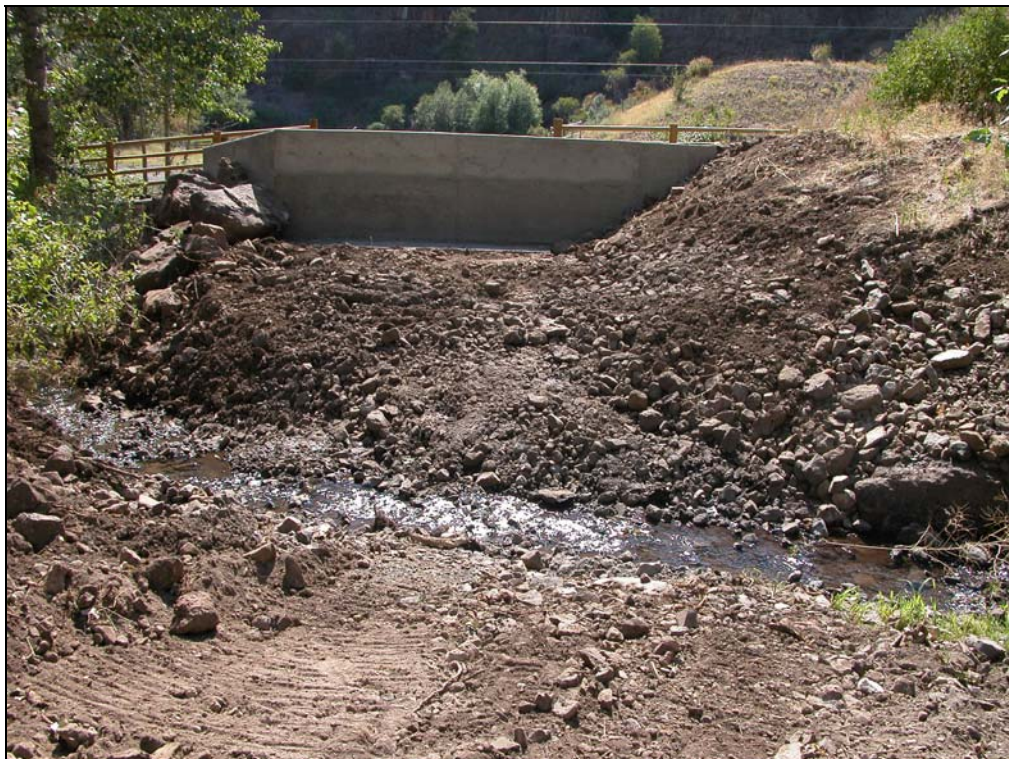
**Photo 4: Photo taken on August 14, 2006 looking at the completed and backfilled down road abutment. Some clean up and shaping is yet to be done before bridge can be set in place.**

The concrete foundation and abutment walls for the bridge were installed between July 31, 2006 and August 10, 2006. Concrete was formed and poured in two phases; phase I being form, pour, and form stripping of the foundation and phase II being the same for the abutment walls. The abutment closest to HWY 350 was poured directly from the concrete truck while the up road abutment concrete was transferred across the creek to the forms with an excavator bucket. This allowed the concrete work to be done in two instead of three phases and kept the concrete truck out of Butte Creek. Abutment backfill and rock placement was completed on August 11, 2006. All concrete was formed and poured in place at the request of the contractor. Initially we intended to pre-cast all concrete off-site, haul, and install on pre-excavated pads. Through discussion with the engineer and contractor it was decided pouring in place would be the most economical and practical way to accomplish the concrete work. The bridge was craned into place on August 19, 2006.

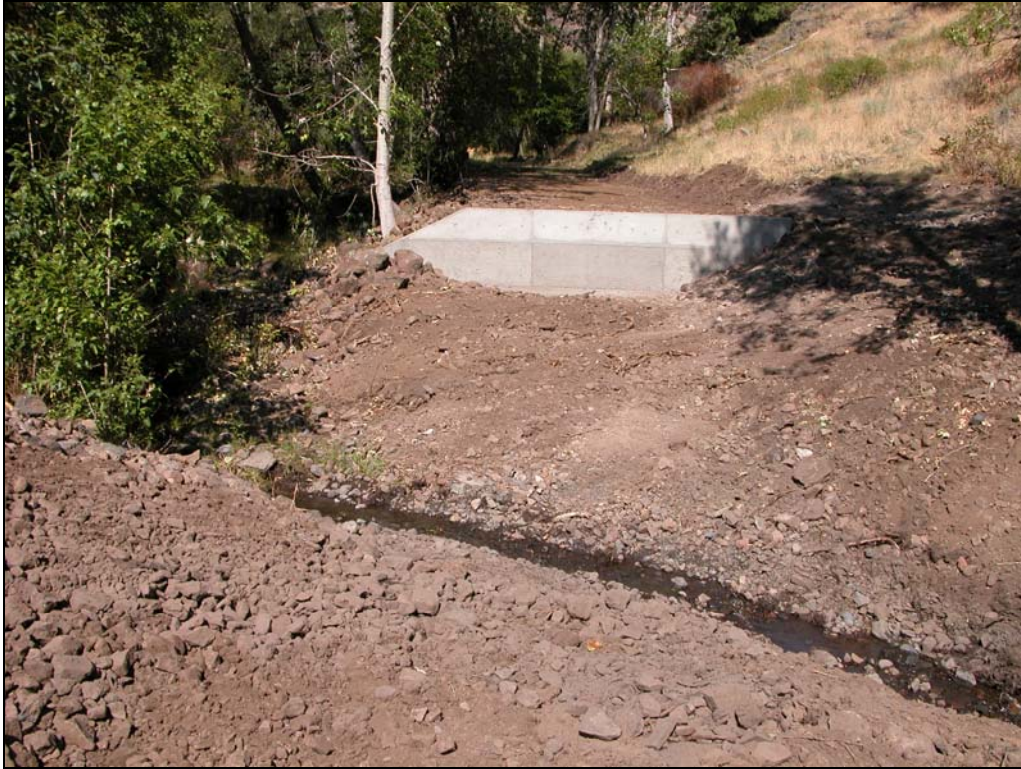
**Photo 5: Photo taken on August 14, 2006 looking at completed and backfilled up road abutment. Butte Creek is free flowing through the site as the crib wall has been removed.**

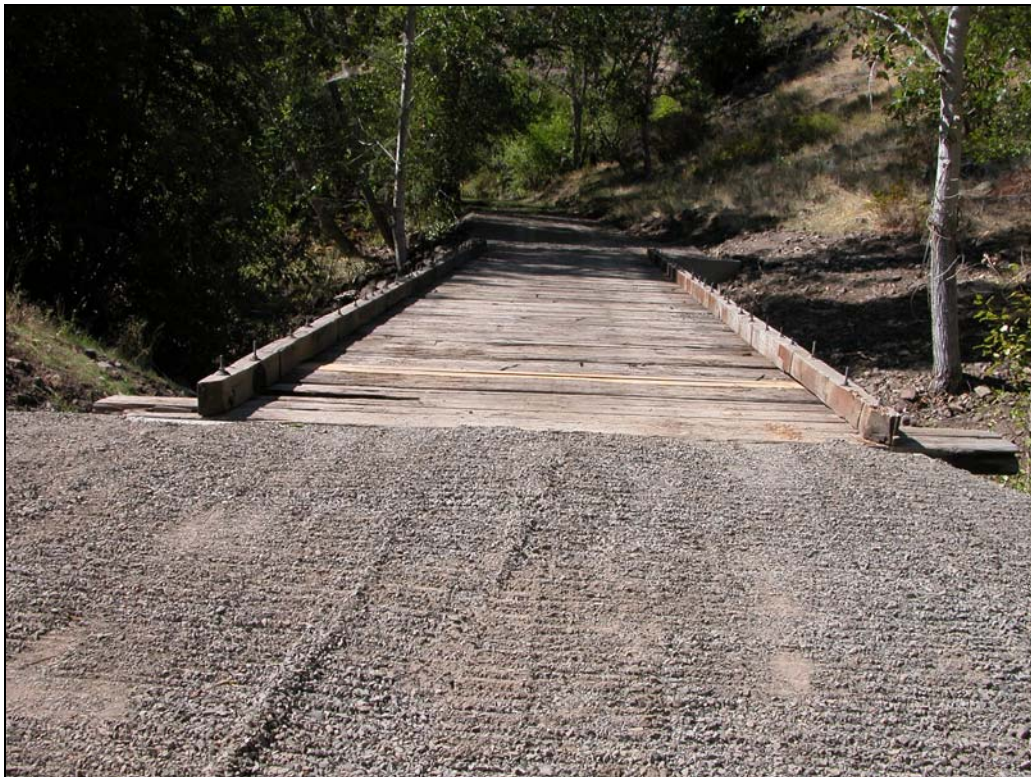
**Photo 6: Photo taken on August 31, 2006 from same location as photo # 3. Bridge has been set eliminating the need for the ford, reducing direct sediment input to the stream, & restoring passage.**

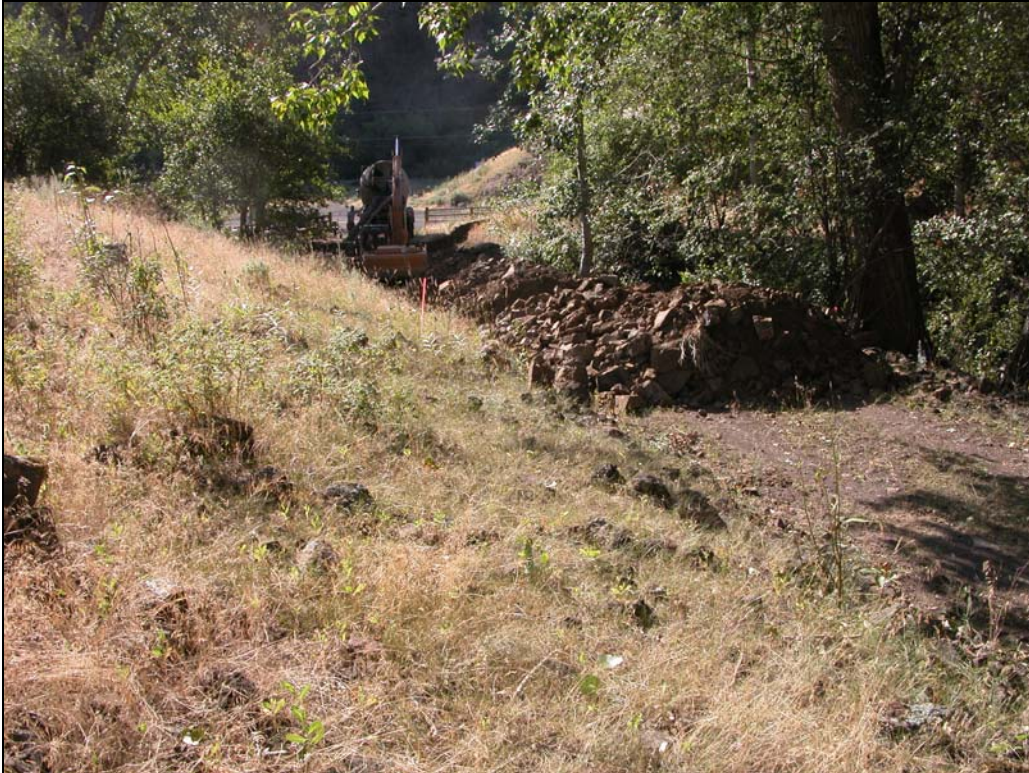
**Photo 7: Photo taken August 3<sup>rd</sup>, 2006 looking down the road through bridge installation site. Course road base material has been hauled before bridge work .**

Road: After the bridge was installed the road grade needed to be raised to meet bridge deck elevation. Before any bridge or instream work was done several truck loads of road base material was hauled across the ford to the up road side of the job. This action allowed the road to be rough graded after bridge installation providing roadbed for the dump trucks to haul subsequent loads. The down road side of the bridge was directly accessed from HWY 350. A rolling rock drainage dip was installed 40 meters above the bridge to route water from the road to an upland area between the road and creek. Course granular road base and one-inch minus crushed top dressing material was hauled, graded, and shaped during the week of August 28, 2006 and the construction portion of the project was completed on August 31, 2006.

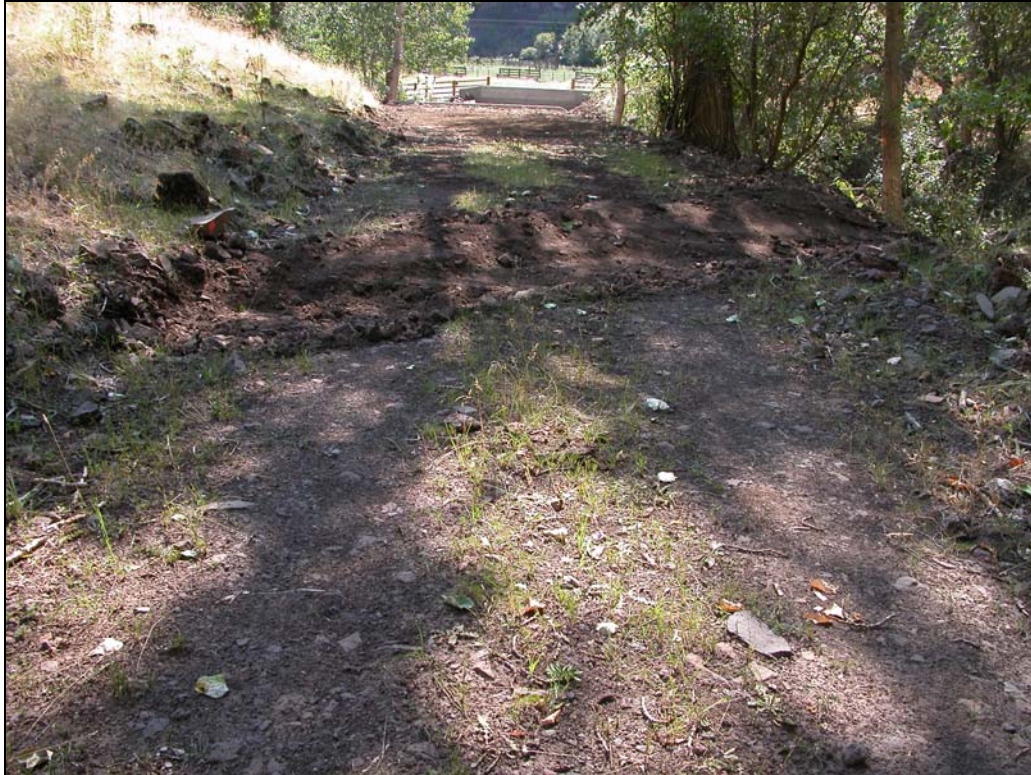
**Photo 8: Photo taken on August 14<sup>th</sup>, 2006 looking down the road. Rolling rock dip has been installed and course road base material has been graded to bridge abutment.**

Objectives #2 & #3 to reduce sediment and siltation has clearly been met through the implementation of the project. With proper road drainage and elimination of the ford sediment will no longer deposit in the creek from the road. The rolling rock drainage dip in the road above the bridge will route most water from the road to an upland setting where sediment will settle before entering Butte Creek. Vehicle traffic has been eliminated from the creek and a reduction in suspended sediment will result from this action. Creek disturbance caused by livestock at the site is expected to be reduced. Cattle will likely cross the creek on the bridge due to steep stream banks and coarse channel substrate.

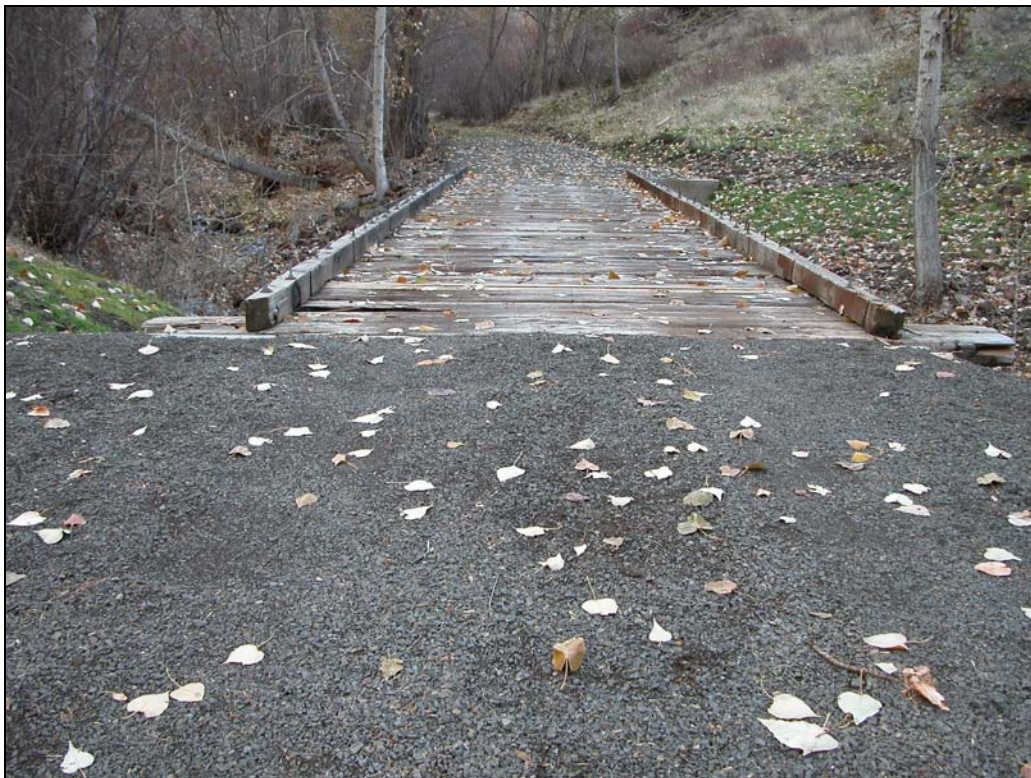
**Photo 9: Photo taken November 8<sup>th</sup>, 2006 looking up road and across bridge. All road base material has been graded and shaped with 1" minus material graded on top of the road.**

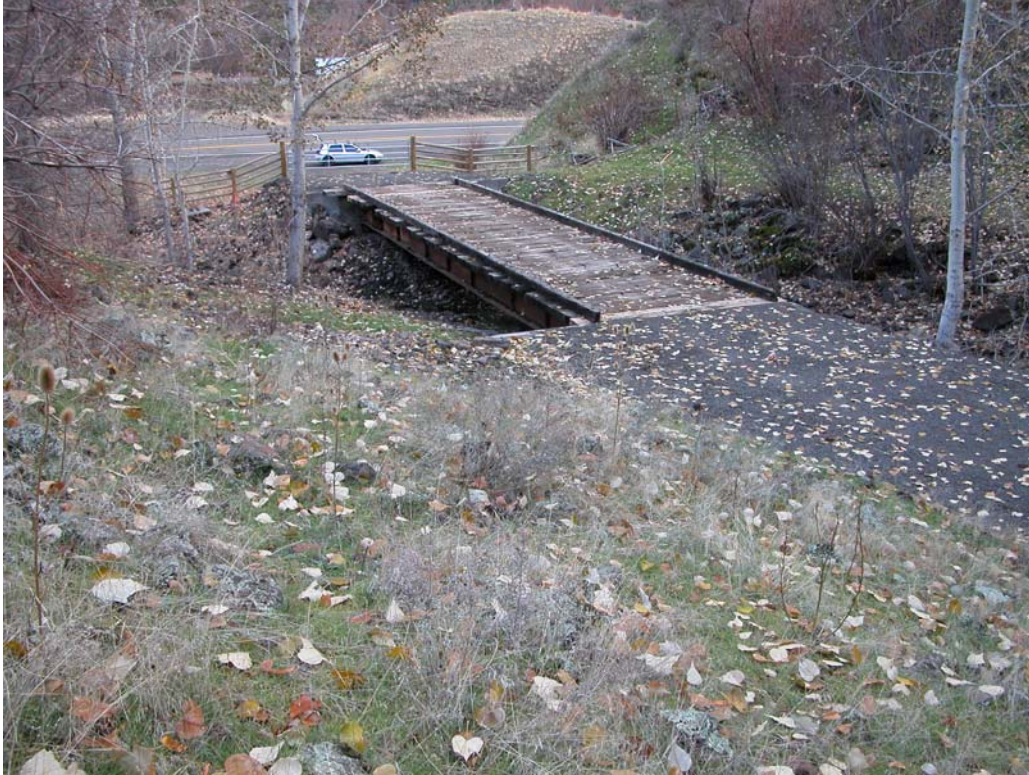
**Photo 10: Photo taken on November 8<sup>th</sup>, 2006 looking down on completed project. Fish passage, vehicle access, road work, and proper drainage have all been accomplished.**
