# Willow Creek Fish Habitat Enhancement Project (Implementation Summer-Fall 2012)

**Project Overview:**

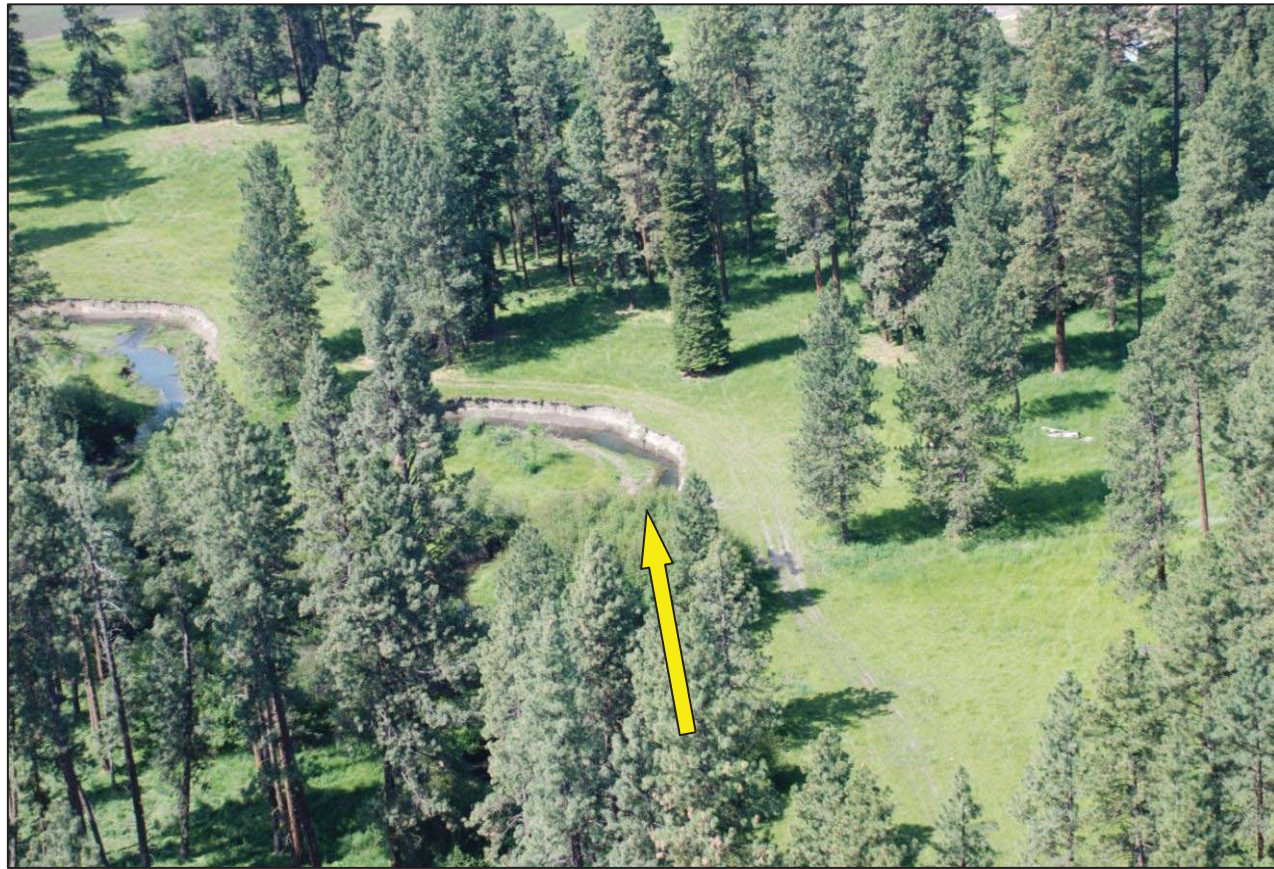
The far left aerial photo is an example of high vertical banks on Dry Creek in the upper reaches of the project area prior to construction. Exposed bank heights of the existing channel throughout the project were 6-10 ft. The yellow arrow corresponds with the location of photo point series left and below taken pre-treatment October 24, 2011 and post treatment on November 11, 2012.

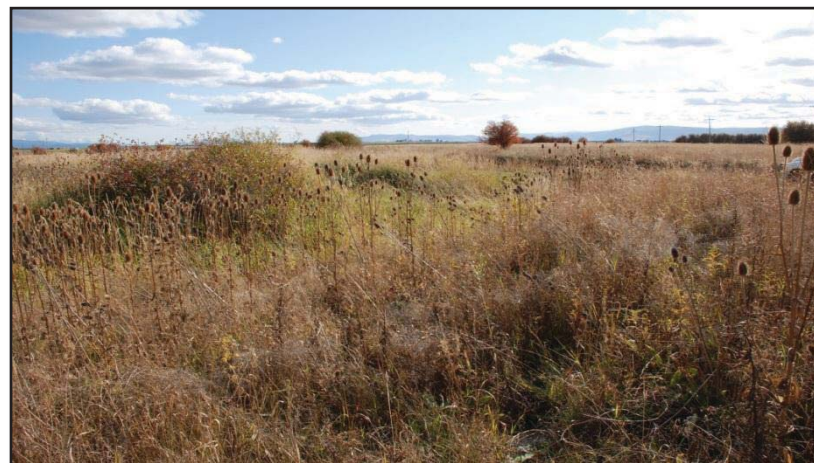
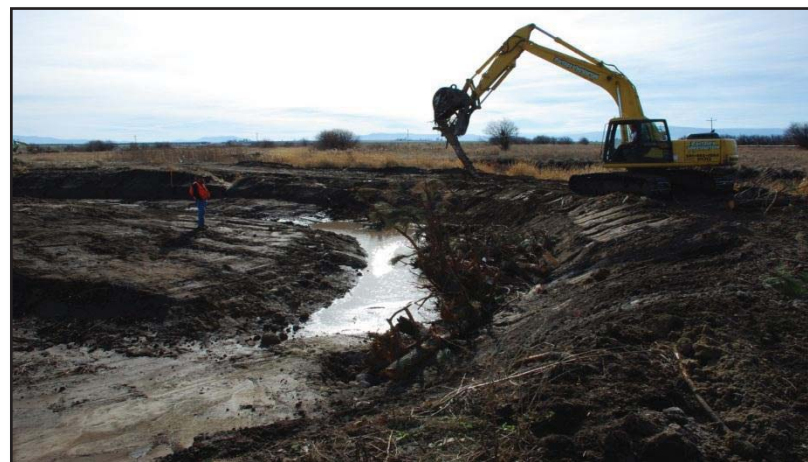
The aerial photo on the far right is looking downstream at Lower Willow Creek pre-project June 11, 2009. The immediate foreground is the McKenzie/OAF property and the recently plowed ground is the Craig property. The arrow corresponds to the location of the photo series above and right. The above photo is looking downstream towards the active channel from the right bank of the historic channel before construction October 24, 2011. The photo on the right is from the same location on November 6, 2012 during construction. The remnant channel from the 1930's was activated November 20, 2012.

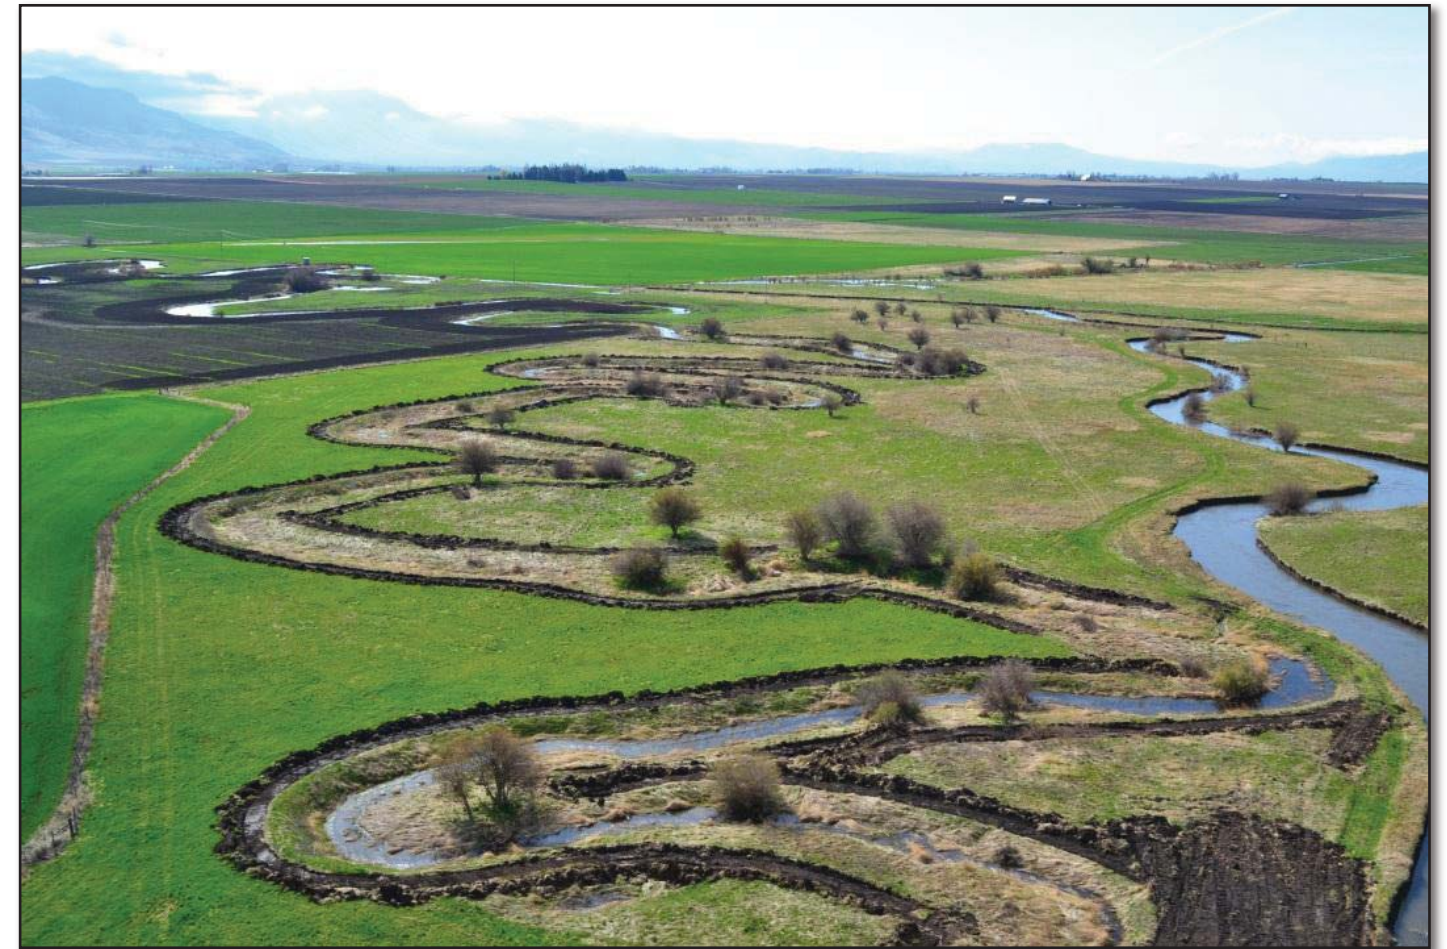
The aerial photo from April 20, 2012 to the right is looking downstream at the historic channel of Willow Creek on the Oregon Agriculture Foundation property and the Craig property shortly after the areas included in the construction zone were scarified for cultural resources.

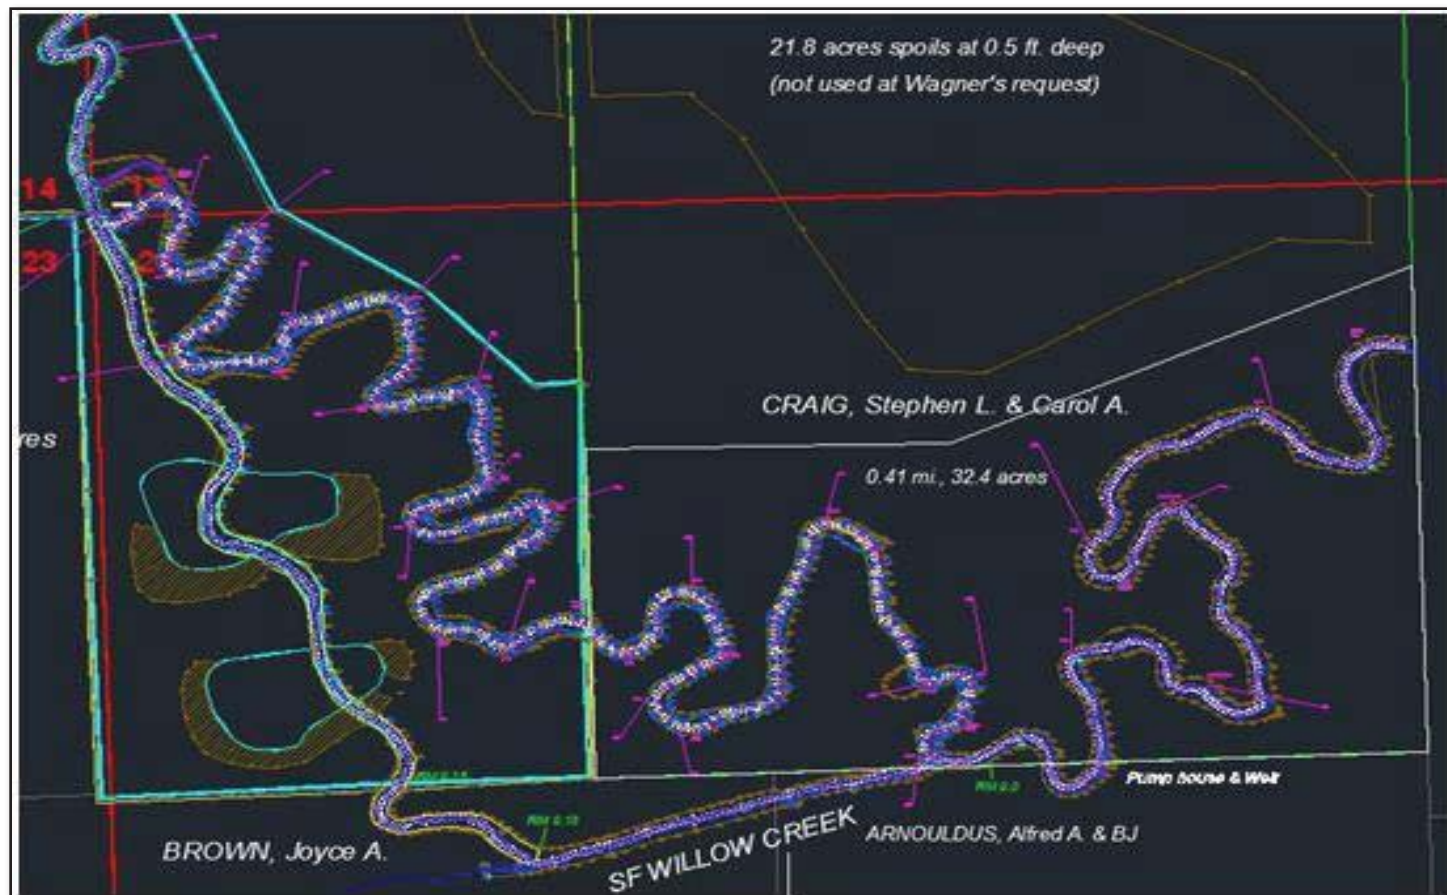
The image to the left is the plan view design by ODFW for the restoration and reactivation of the historic channel of Willow Creek on the Oregon Agricultural Foundation and Craig properties. The channel was activated November 20, 2012.
