GODLEY DITCH FISH PASSAGE

Completion Report

**Project No. 1992-026-01
Contract No. 53180**

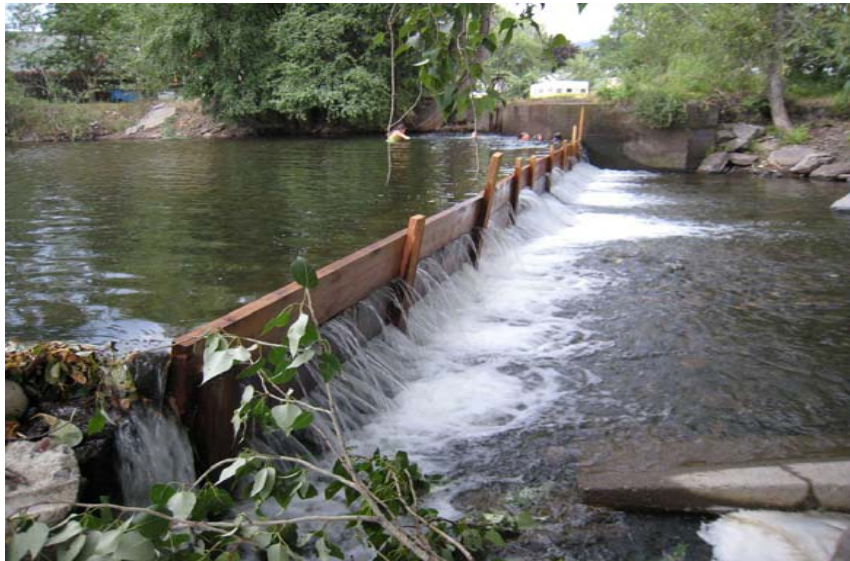
Pre-project boards fully installed

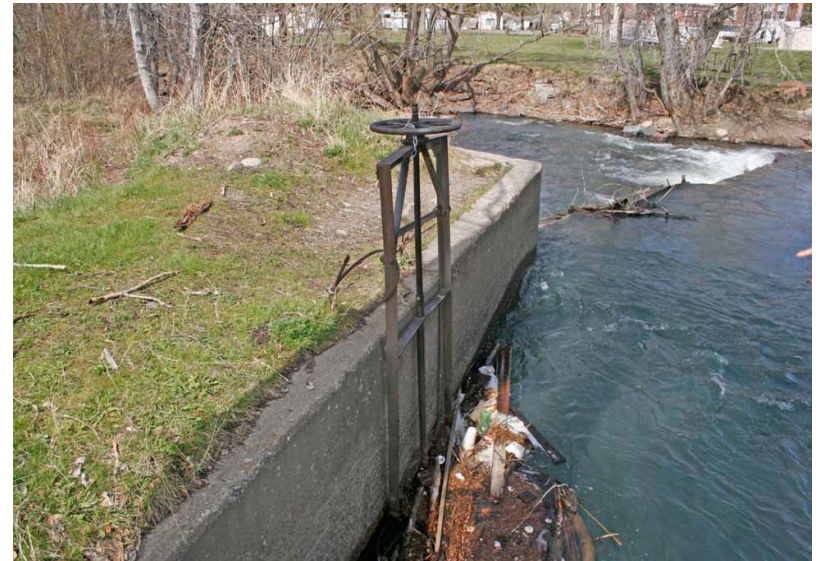
Pre-project ditch headgate

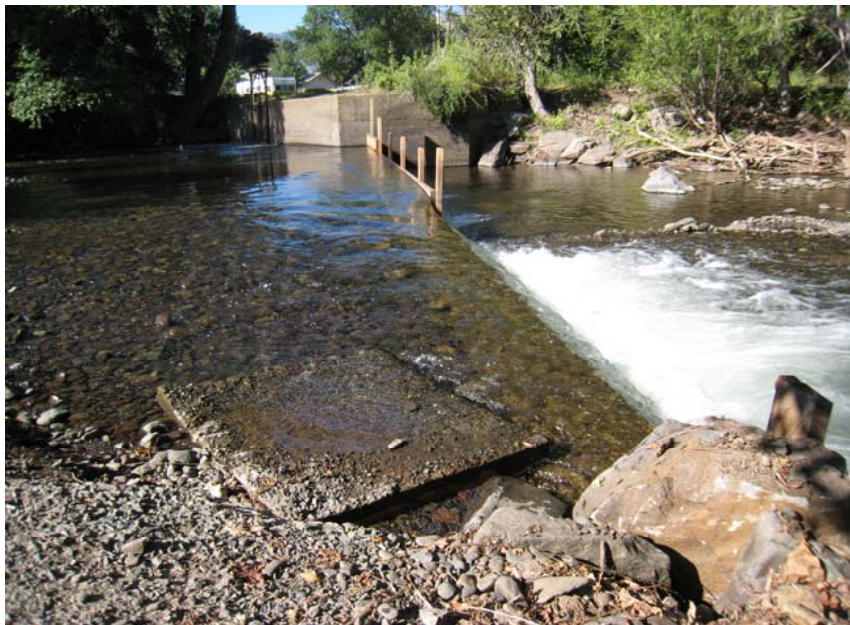
Pre-project-boards partially installed-view to south

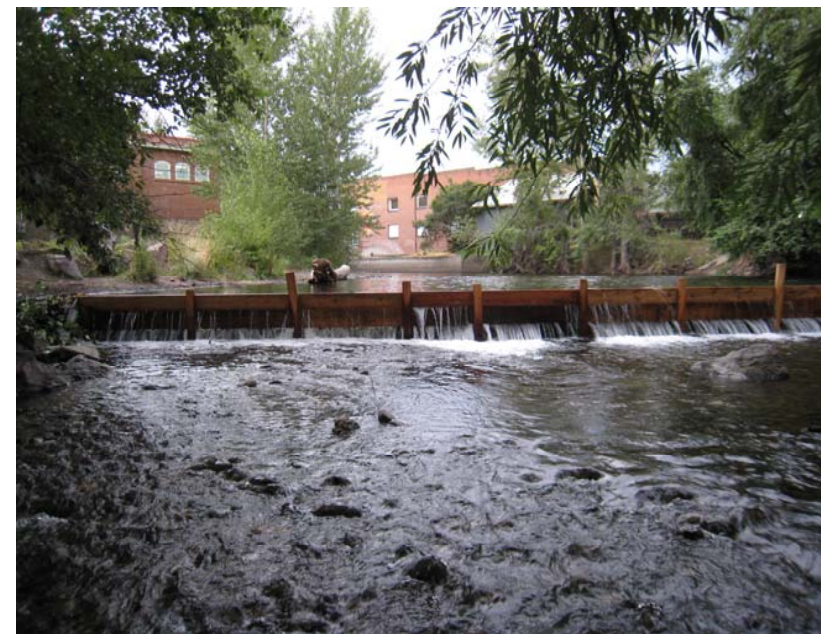
Pre-project-boards fully installed-upstream view

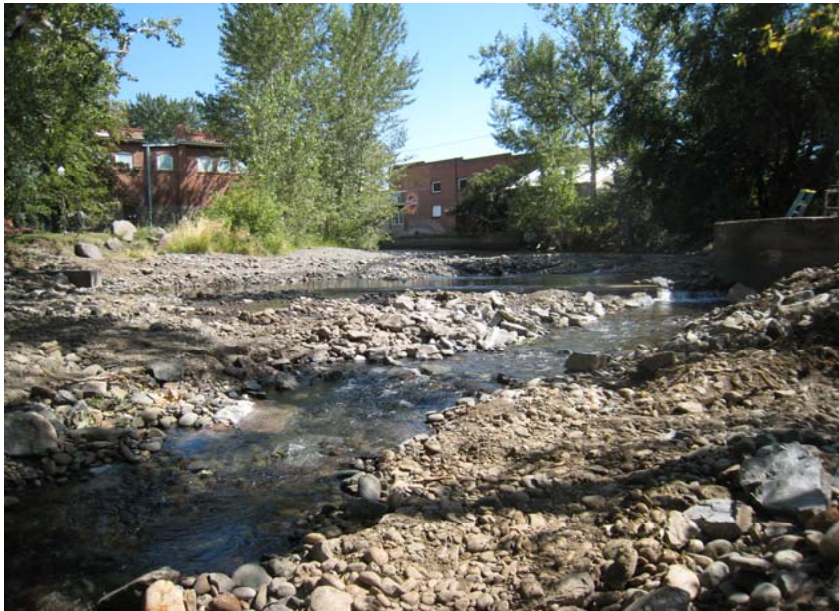
Post-construction-view upstream-low flow channel

- Constructed flow bypass channel
- Installed steel plate on top of the pre-existing concrete diversion sill
- Notched concrete sill to provide flow bypass attractant water near the inlet to the fish ladder
- Installed rock vortex channel-spanning weir for grade control below the diversion
- Placed stream simulation material below the concrete sill downstream to the weir
- Excavated for and installed the precast step-pool fish ladder with headgate
- Completed site contouring and seeding

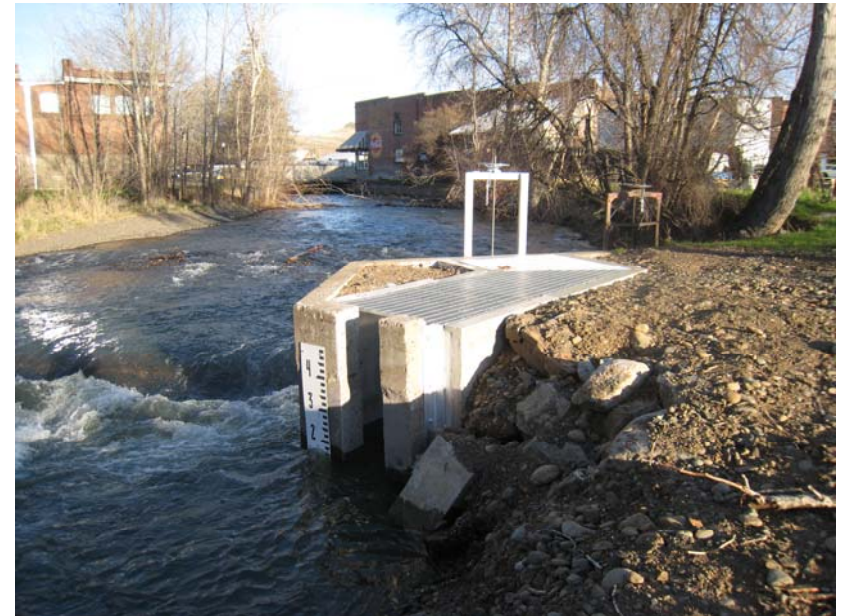
Post-construction-inlet to step-pool fish ladder

The preferred alternative, developed in consultation with ODFW and the NOAA Fish Passage engineer, was to construct a step-pool fish ladder on the south streambank adjacent to the diversion ditch headgate. Additionally some modifications to the concrete sill and installation of a rock weir below the structure were required.

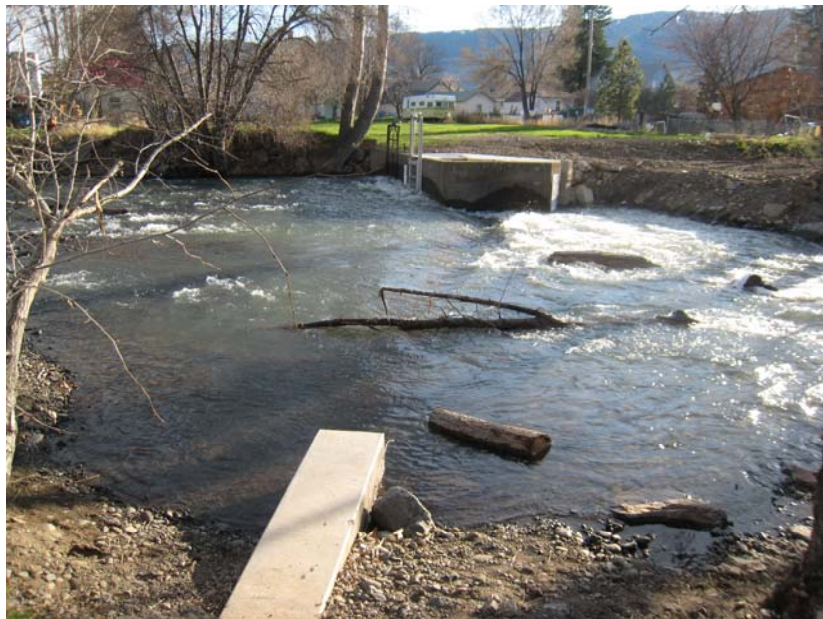
Post-project-diversion without boards-view to south

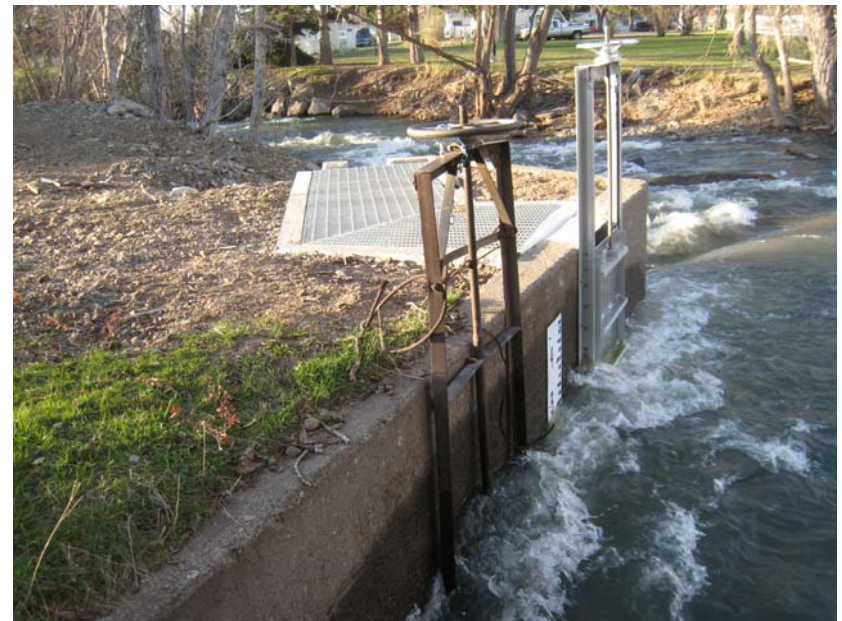
Post-project-ditch headgate and fish ladder outlet
