2020 Tampa Bay Water Quality Assessments

A Tampa Bay Estuary Program Initiative to Maintain and Restore the Bay's Seagrass Resources

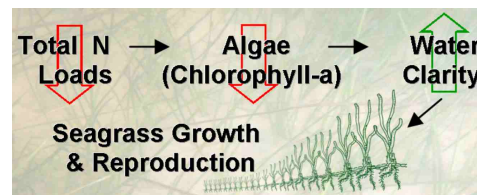
Figure 2: Seagrass restoration with N management.

Light availability to seagrass is the guiding paradigm for TBEP's Nitrogen Management Strategy. Because excessive nitrogen loads to the bay generally lead to increased algae blooms (higher chlorophyll-a levels) (Figure 2) and reduce light penetration to seagrass, an evaluation method was developed to assess whether load reduction strategies are achieving desired water quality results (i.e. reduced chlorophyll-a concentrations and increased water clarity).

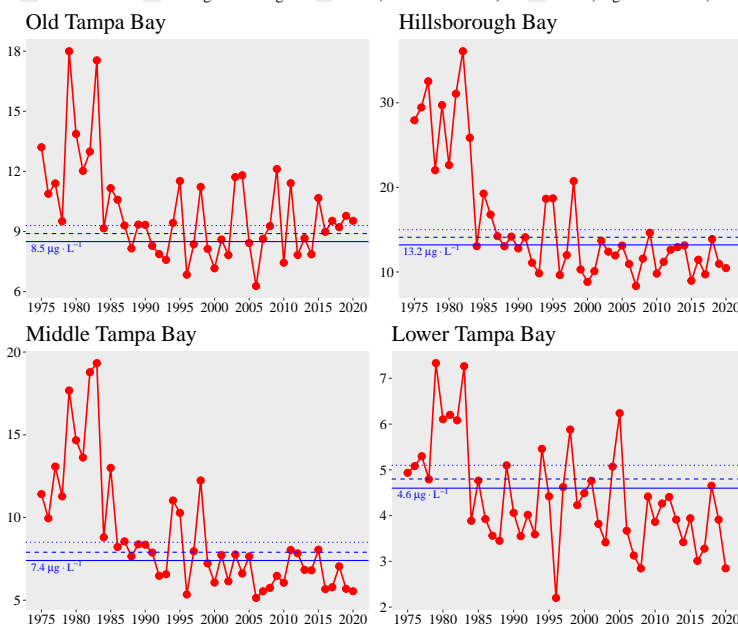
— Annual Mean — Management Target - - +1 se (small exceedance) - - +2 se (large exceedance)

Figure 3: Historic chlorophyll-a annual averages for the four bay segments.

Water quality (chlorophyll-a and light penetration) remained supportive of seagrass in Hillsborough Bay (HB), Middle Tampa Bay (MTB), and Lower Tampa Bay (LTB)(Table 1, Figure 3). The nuisance algae, *Pyrodinium bahamense*, was again reported in Old Tampa Bay (OTB) during June - Sept 2020, contributing to a large magnitude chlorophyll-a exceedance that has persisted for a long duration (6 yrs). However, it should be noted that effective light penetration was still observed to be supportive of seagrass in all bay segments, including OTB (Table 1).
