2021 Tampa Bay Water Quality Assessments

A Tampa Bay Estuary Program Initiative to Maintain and Restore the Bay's Seagrass Resources

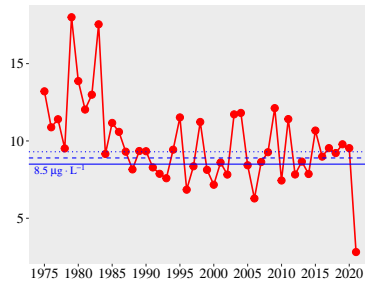
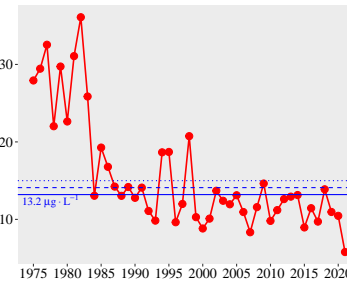
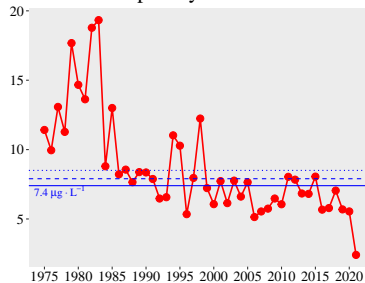
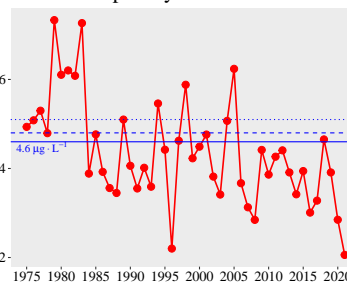
Figure 3: Historic chlorophyll-a annual averages for the four bay segments.

— Annual Mean — Management Target - - +1 se (small exceedance) - - +2 se (large exceedance)

Old Tampa Bay

Hillsborough Bay

Middle Tampa Bay

Lower Tampa Bay

Water quality (chlorophyll-a and light penetration) remained supportive of seagrass in Hillsborough Bay (HB), Middle Tampa Bay (MTB), and Lower Tampa Bay (LTB) (Table 1, Figure 3). The nuisance algae, *Pyrodinium bahamense*, was again reported in Old Tampa Bay (OTB) during June - Sept 2020, contributing to a large magnitude chlorophyll-a exceedance that has persisted for a long duration (6 yrs). However, it should be noted that effective light penetration was still observed to be supportive of seagrass in all bay segments, including OTB (Table 1).
