2021 Tampa Bay Water Quality Assessments

A Tampa Bay Estuary Program Initiative to Maintain and Restore the Bay's Seagrass Resources

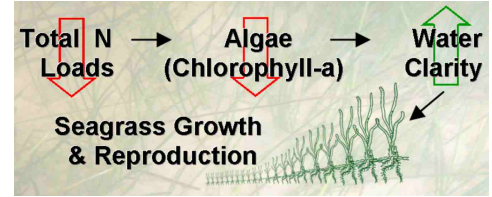
Figure 2: Seagrass restoration with N management.

Light availability to seagrass is the guiding paradigm for TBEP's Nitrogen Management Strategy. Because excessive nitrogen loads to the bay generally lead to increased algae blooms (higher chlorophyll-a levels) (Figure 2) and reduce light penetration to seagrass, an evaluation method was developed to assess whether load reduction strategies are achieving desired water quality results (i.e. reduced chlorophyll-a concentrations and increased water clarity).

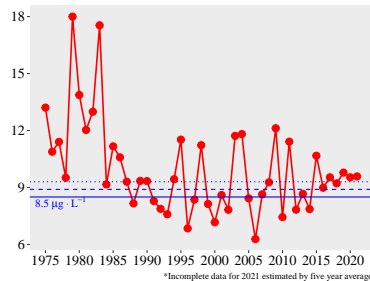
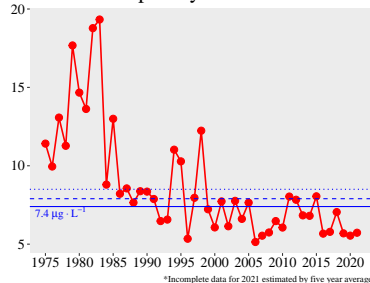
Figure 3: Historic chlorophyll-a annual averages for the four bay segments.

Water quality (chlorophyll-a and light penetration) remained supportive of seagrass in Hillsborough Bay (HB), Middle Tampa Bay (MTB), and Lower Tampa Bay (LTB)(Table 1, Figure 3). The nuisance alga, *Pyrodinium bahamense*, was again reported in Old Tampa Bay (OTB) during June - Sept 2020, contributing to a large magnitude chlorophyll-a exceedance that has persisted for a long duration (6 yrs). However, it should be noted that effective light penetration was still observed to be supportive of seagrass in all bay segments, including OTB (Table 1).

— Annual Mean — Management Target - - +1 se (small exceedance) - - +2 se (large exceedance)
