# 2020 Tampa Bay Water Quality Assessments

A Tampa Bay Estuary Program Initiative to Maintain and Restore the Bay's Seagrass Resources

# Progress Towards Meeting Regulatory Goals

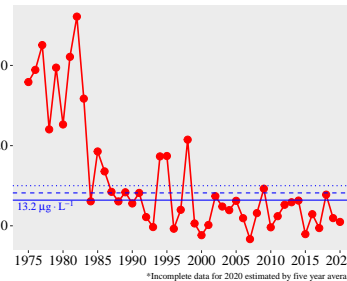
Figure 3: Historic chlorophyll-a annual averages for the four bay segments.

— Annual Mean — Management Target — +1 se (small exceedance) — +2 se (large exceedance)

Water quality (chlorophyll-a and light penetration) remained supportive of seagrass in Hillsborough Bay (HB), Middle Tampa Bay (MTB), and Lower Tampa Bay (LTB)(Table 1, Figure 3). The nuisance algae, *Pyrodinium bahamense*, was again reported in Old Tampa Bay (OTB) during May - September 2019, contributing to a large magnitude chlorophyll-a exceedance that has persisted for a long duration (5yrs). However, it should be noted that effective light penetration was still observed to be supportive of seagrass in all bay segments, including OTB (Table 1).
