2020 Tampa Bay Water Quality Assessments

A Tampa Bay Estuary Program Initiative to Maintain and Restore the Bay's Seagrass Resources

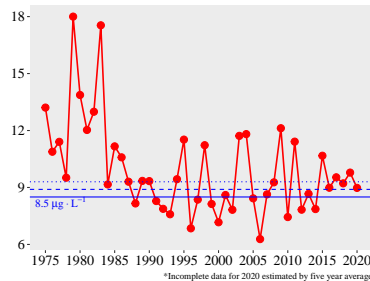
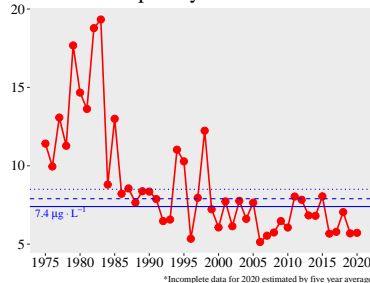
Figure 3: Historic chlorophyll-a annual averages for the four bay segments.

Water quality (chlorophyll-a and light penetration) remained supportive of seagrass in Hillsborough Bay (HB), Middle Tampa Bay (MTB), and Lower Tampa Bay (LTB) (Table 1, Figure 3). The nuisance algae, *Pyrodinium bahamense*, was again reported in Old Tampa Bay (OTB) during May - September 2019, contributing to a large magnitude chlorophyll-a exceedance that has persisted for a long duration (5yrs). However, it should be noted that effective light penetration was still observed to be supportive of seagrass in all bay segments, including OTB (Table 1).

— Annual Mean — Management Target — +1 se (small exceedance) — +2 se (large exceedance)
