2021 Tampa Bay Water Quality Assessments

A Tampa Bay Estuary Program Initiative to Maintain and Restore the Bay's Seagrass Resources

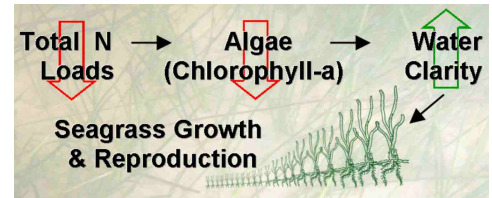
Figure 2: Seagrass restoration with N management.

Light availability to seagrass is the guiding paradigm for TBEP's Nitrogen Management Strategy. Because excessive nitrogen loads to the bay generally lead to increased algae blooms (higher chlorophyll-a levels) (Figure 2) and reduce light penetration to seagrass, an evaluation method was developed to assess whether load reduction strategies are achieving desired water quality results (i.e. reduced chlorophyll-a concentrations and increased water clarity).

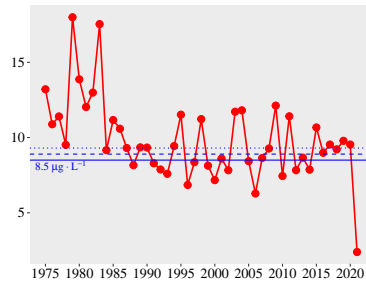
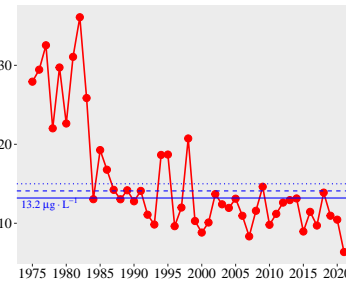
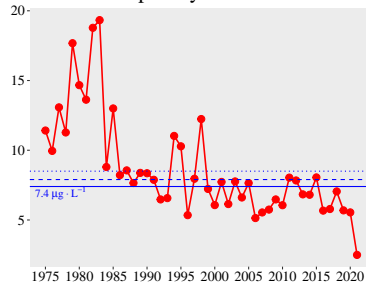
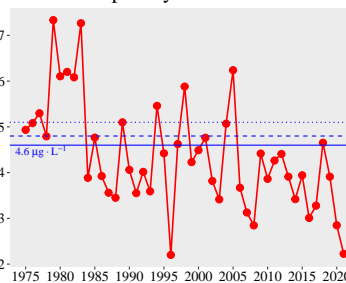
Figure 3: Historic chlorophyll-a annual averages for the four bay segments.

Water quality (chlorophyll-a and light penetration) remained supportive of seagrass in Hillsborough Bay (HB), Middle Tampa Bay (MTB), and Lower Tampa Bay (LTB) (Table 1, Figure 3). The nuisance algae, *Pyrodinium bahamense*, was again reported in Old Tampa Bay (OTB) during June - Sept 2020, contributing to a large magnitude chlorophyll-a exceedance that has persisted for a long duration (6 yrs). However, it should be noted that effective light penetration was still observed to be supportive of seagrass in all bay segments, including OTB (Table 1).

— Annual Mean — Management Target — +1 se (small exceedance) — +2 se (large exceedance)

Segment	Chl-a (ug/L)		Light Penetration (m ⁻¹)	
	2021	target	2021	target
OTB	2.4	8.5	1.03	0.83
HB	6.4	13.2	1.29	1.58
MTB	2.5	7.4	0.63	0.83
LTB	2.2	4.6	0.62	0.63
