2021 Tampa Bay Water Quality Assessments

A Tampa Bay Estuary Program Initiative to Maintain and Restore the Bay's Seagrass Resources

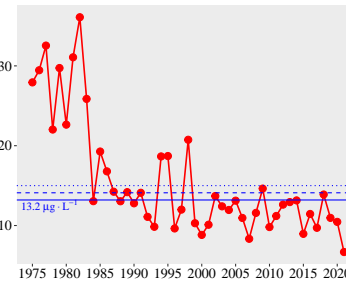
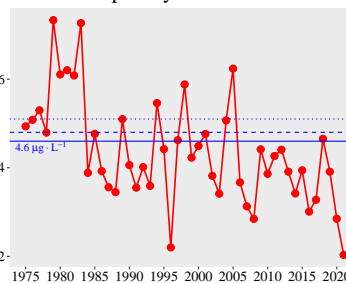
Figure 3: Historic chlorophyll-a annual averages for the four bay segments.

Water quality (chlorophyll-a and light penetration) remained supportive of seagrass in Hillsborough Bay (HB), Middle Tampa Bay (MTB), and Lower Tampa Bay (LTB)(Table 1, Figure 3). The nuisance alga, *Pyrodinium bahamense*, was again reported in Old Tampa Bay (OTB) during June - Sept 2020, contributing to a large magnitude chlorophyll-a exceedance that has persisted for a long duration (6 yrs). However, it should be noted that effective light penetration was still observed to be supportive of seagrass in all bay segments, including OTB (Table 1).

— Annual Mean — Management Target - - +1 se (small exceedance) - - +2 se (large exceedance)

Segment	Chl-a (ug/L)		Light Penetration (m ⁻¹)	
	2021	target	2021	target
OTB	3.6	8.5	1.00	0.83
HB	6.7	13.2	1.17	1.58
MTB	2.9	7.4	0.62	0.83
LTB	2.0	4.6	0.61	0.63
