# 2021 Tampa Bay Water Quality Assessments

A Tampa Bay Estuary Program Initiative to Maintain and Restore the Bay's Seagrass Resources

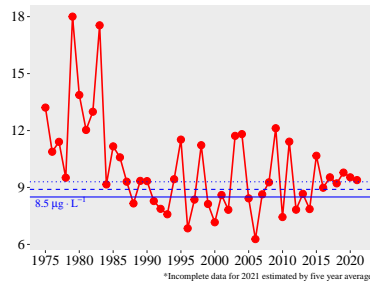
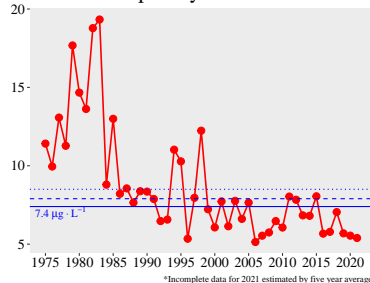
Figure 3: Historic chlorophyll-a annual averages for the four bay segments.

Water quality (chlorophyll-a and light penetration) remained supportive of seagrass in Hillsborough Bay (HB), Middle Tampa Bay (MTB), and Lower Tampa Bay (LTB)(Table 1, Figure 3). The nuisance alga, *Pyrodinium bahamense*, was again reported in Old Tampa Bay (OTB) during June - Sept 2020, contributing to a large magnitude chlorophyll-a exceedance that has persisted for a long duration (6 yrs). However, it should be noted that effective light penetration was still observed to be supportive of seagrass in all bay segments, including OTB (Table 1).

— Annual Mean — Management Target — +1 se (small exceedance) — +2 se (large exceedance)
