2021 Tampa Bay Water Quality Assessments

A Tampa Bay Estuary Program Initiative to Maintain and Restore the Bay's Seagrass Resources

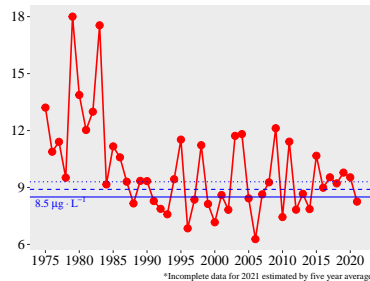
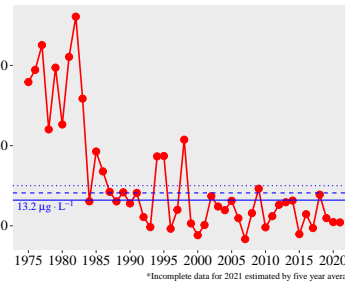
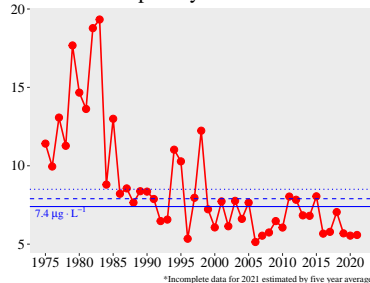
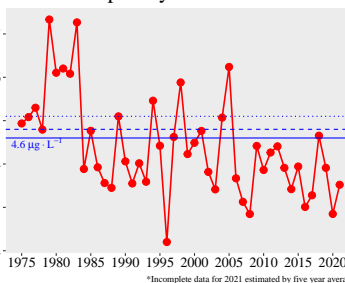
— Annual Mean — Management Target — +1 se (small exceedance) — +2 se (large exceedance)

Figure 3: Historic chlorophyll-a annual averages for the four bay segments.

Water quality (chlorophyll-a and light penetration) remained supportive of seagrass in Hillsborough Bay (HB), Middle Tampa Bay (MTB), and Lower Tampa Bay (LTB)(Table 1, Figure 3). The nuisance alga, *Pyrodinium bahamense*, was again reported in Old Tampa Bay (OTB) during June - Sept 2020, contributing to a large magnitude chlorophyll-a exceedance that has persisted for a long duration (6 yrs). However, it should be noted that effective light penetration was still observed to be supportive of seagrass in all bay segments, including OTB (Table 1).
