# 2021 Tampa Bay Water Quality Assessments

A Tampa Bay Estuary Program Initiative to Maintain and Restore the Bay's Seagrass Resources

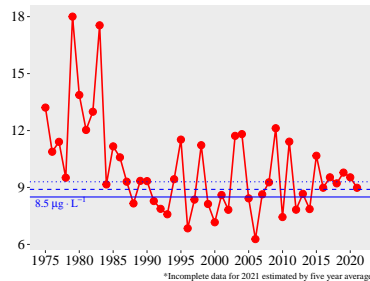
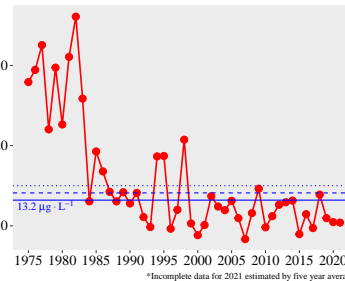
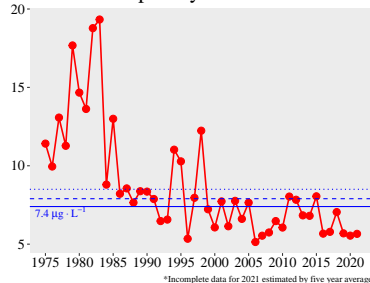
Figure 3: Historic chlorophyll-a annual averages for the four bay segments.

— Annual Mean — Management Target — +1 se (small exceedance) — +2 se (large exceedance)

\*Incomplete data for 2021 estimated by five year average

Water quality (chlorophyll-a and light penetration) remained supportive of seagrass in Hillsborough Bay (HB), Middle Tampa Bay (MTB), and Lower Tampa Bay (LTB)(Table 1, Figure 3). The nuisance alga, *Pyrodinium bahamense*, was again reported in Old Tampa Bay (OTB) during June - Sept 2020, contributing to a large magnitude chlorophyll-a exceedance that has persisted for a long duration (6 yrs). However, it should be noted that effective light penetration was still observed to be supportive of seagrass in all bay segments, including OTB (Table 1).
