# 2022 Tampa Bay Water Quality Assessments

A Tampa Bay Estuary Program Initiative to Maintain and Restore the Bay's Seagrass Resources

# Progress Towards Meeting Regulatory Goals

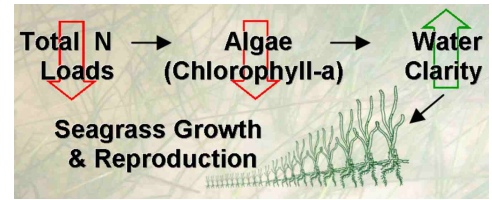
Figure 2: Seagrass restoration with N management.

Light availability to seagrass is the guiding paradigm for TBEP's Nitrogen Management Strategy. Because excessive nitrogen loads to the bay generally lead to increased algae blooms (higher chlorophyll-a levels) (Figure 2) and reduced light penetration to seagrass, an evaluation method was developed to assess whether load reduction strategies are achieving desired water quality results (i.e. reduced chlorophyll-a concentrations and increased water clarity).
