# 2021 Tampa Bay Water Quality Assessments

A Tampa Bay Estuary Program Initiative to Maintain and Restore the Bay's Seagrass Resources

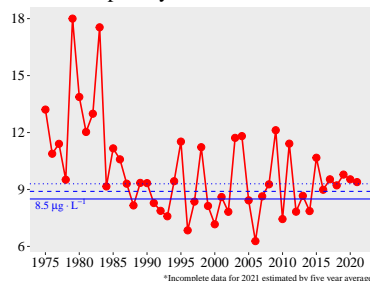
Figure 3: Historic chlorophyll-a annual averages for the four bay segments.

Water quality (chlorophyll-a and light penetration) remained supportive of seagrass in Hillsborough Bay (HB), Middle Tampa Bay (MTB), and Lower Tampa Bay (LTB)(Table 1, Figure 3). The nuisance alga, *Pyrodinium bahamense*, was again reported in Old Tampa Bay (OTB) during June - Sept 2020, contributing to a large magnitude chlorophyll-a exceedance that has persisted for a long duration (6 yrs). However, it should be noted that effective light penetration was still observed to be supportive of seagrass in all bay segments, including OTB (Table 1).

— Annual Mean — Management Target - - +1 se (small exceedance) - - +2 se (large exceedance)
