2020 Tampa Bay Water Quality Assessments

A Tampa Bay Estuary Program Initiative to Maintain and Restore the Bay's Seagrass Resources

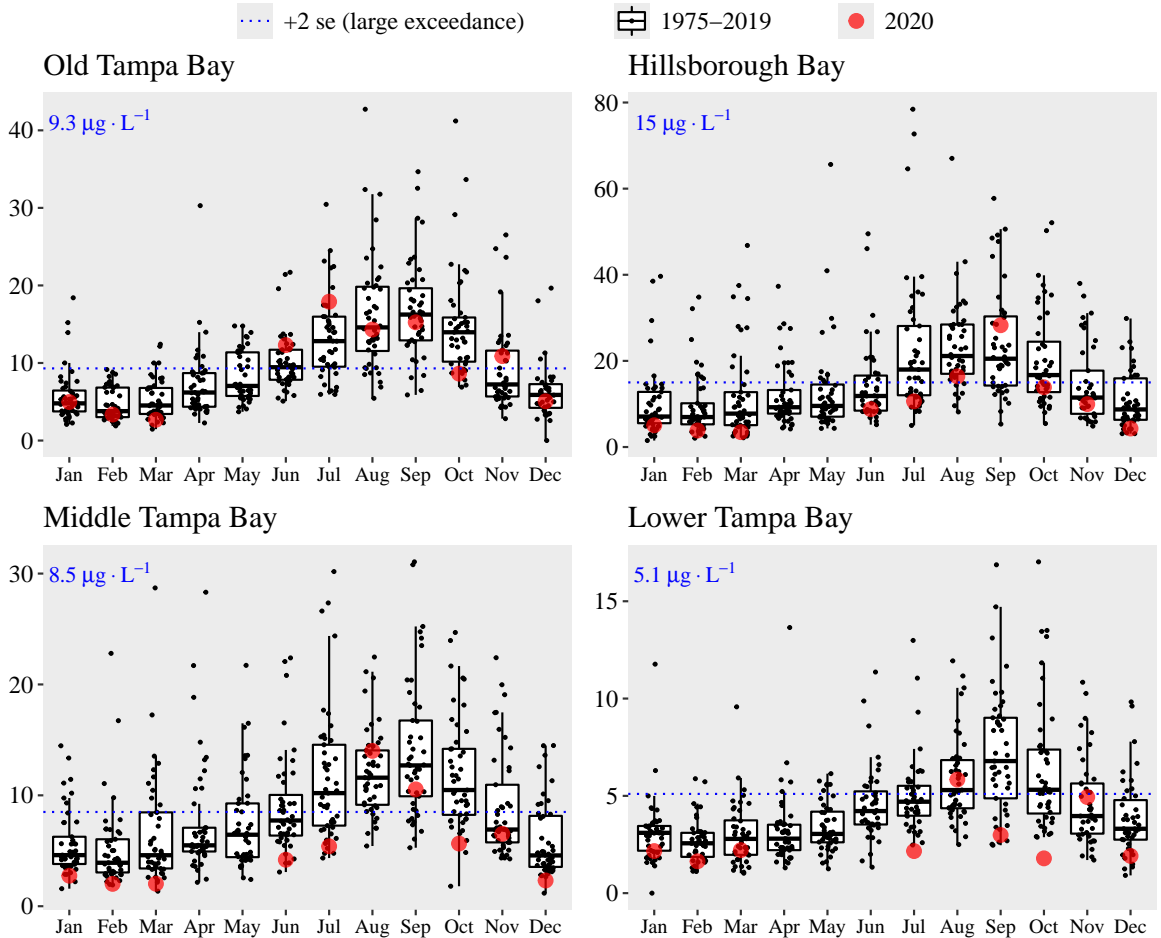
Figure 6: Chlorophyll-a monthly averages from 1975-2019 for the four bay segments. The monthly averages for 2020 are shown in red.

Chlorophyll-a concentrations were evaluated within the bay on a monthly basis during 2020 and compared to prior years' levels (Figure 6). Elevated concentrations in Old Tampa Bay were primarily due to *Pyrodinium bahamense* during the late summer months.
