**From:** Brian Donahoe <bdonahoe@goldmanenvironmental.com>  
**Sent:** Monday, January 04, 2021 12:16 PM  
**To:** Karon Catrone  
**Subject:** FW: additional review material  
**Attachments:** Combined Attachments Reduced.pdf

**From:** Brian Donahoe  
**Sent:** Monday, December 14, 2020 2:23 PM  
**To:** [kcatrone@townhall.westwood.ma.us](mailto:kcatrone@townhall.westwood.ma.us)  
**Subject:** additional review material

42 Mill St  
Westwood, MA  
GEC Project Number 1826-5010

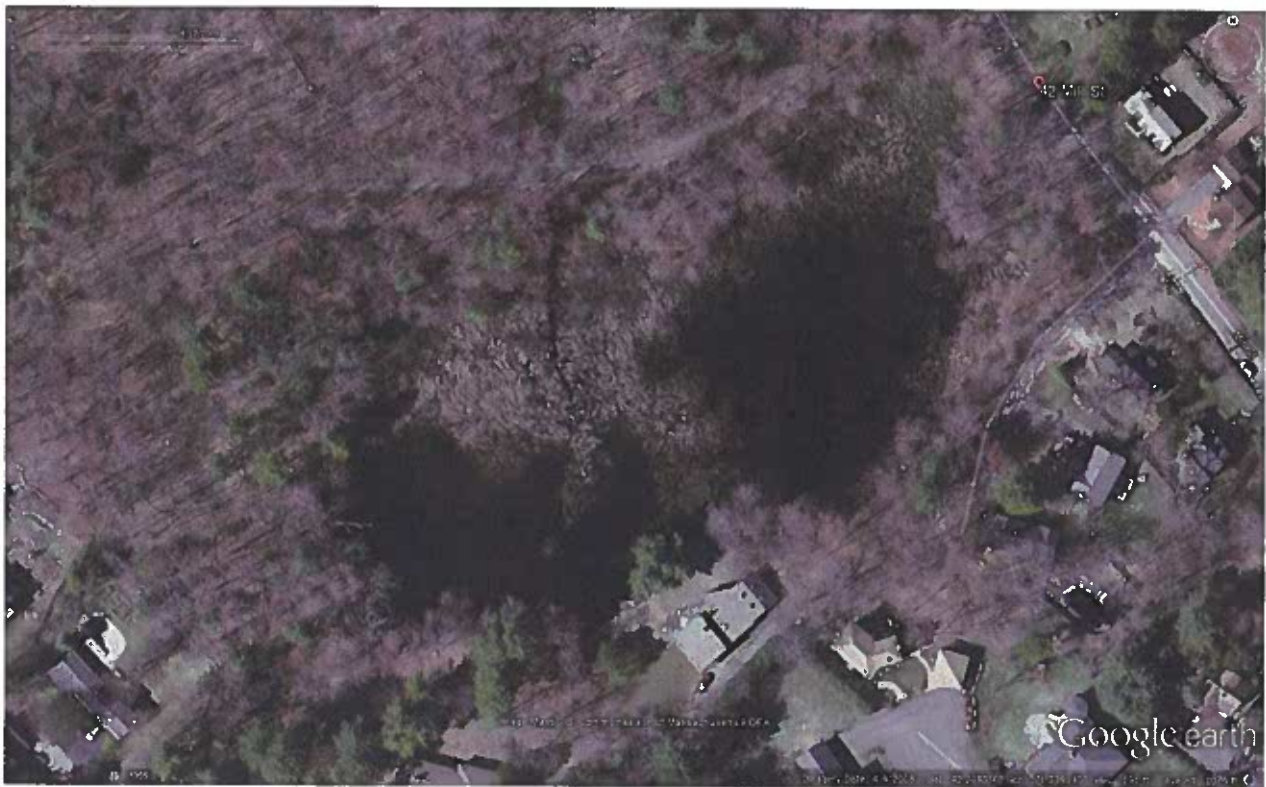
**Figure 6**

- A. Figure 6 from original report – indicating the stream channel flows approximately 140 feet through a vegetated wetland before entering the ‘pond’.

Pond at Mill Brook behind old dam. Note riverine characteristics flowing through the area from north to southwest.

Attachment A is Figure 6 from the original report in January 2016 show the Brook following a channel for more than 140 feet south into the area of the 'pond' and therefore extends the bank of the perennial stream for that distance. The corresponding river front setbacks will also change due to that condition. The second attachment, B, shows the concrete dam and the dry stream channel in October 2020. Debris of the beaver dam can be seen upstream of the concrete dam. Also note the stream channel in the foreground is approximately 35-40 feet wide. The bank of this channel seems to be shown on the submitted plan following contour 184 whereas the channel that was measured is only 5 feet wide. (See Attachment I) This changes the riverfront setback by about 25 feet closer to the proposed house. The third attachment, C, shows the channel flowing at the same time the concrete dam was dry indicating that it now is the likely perennial stream due to the beaver dam. These two photos were taken during an official drought monitoring period. (see attachment G) The fourth photo D, shows the same channel on December 2 2020 after a 2.5 inch rain fall event from December 1. The fifth picture E, shows the same channel looking downstream. Based on this picture the level of the water at the main channel is approximately elevation 188 using the plan of record. This further expands the point of the perennial stream edge, 25 +/- feet closer to the project site because the edge if the perennial stream is the annual high water mark per the regulations. We continue to maintain as well that this stream is the perennial stream due to the changed condition of the beaver dam and the resulting pathway for the water is this channel as documented here. See attachment J. Furthermore based on this information the Commission has the right to consider the pond to not exist if it is not named on the u USGS plan and if the characteristic of the steam can be documented through the impoundment. Attachment F is the latest FEMA flood map for the 100- and 500- year elevations from the MASS GIS system. Note that the entire site is within the 100 year flood plain including the house location. In fact the entire lot as shown is within the 100 year flood plain.

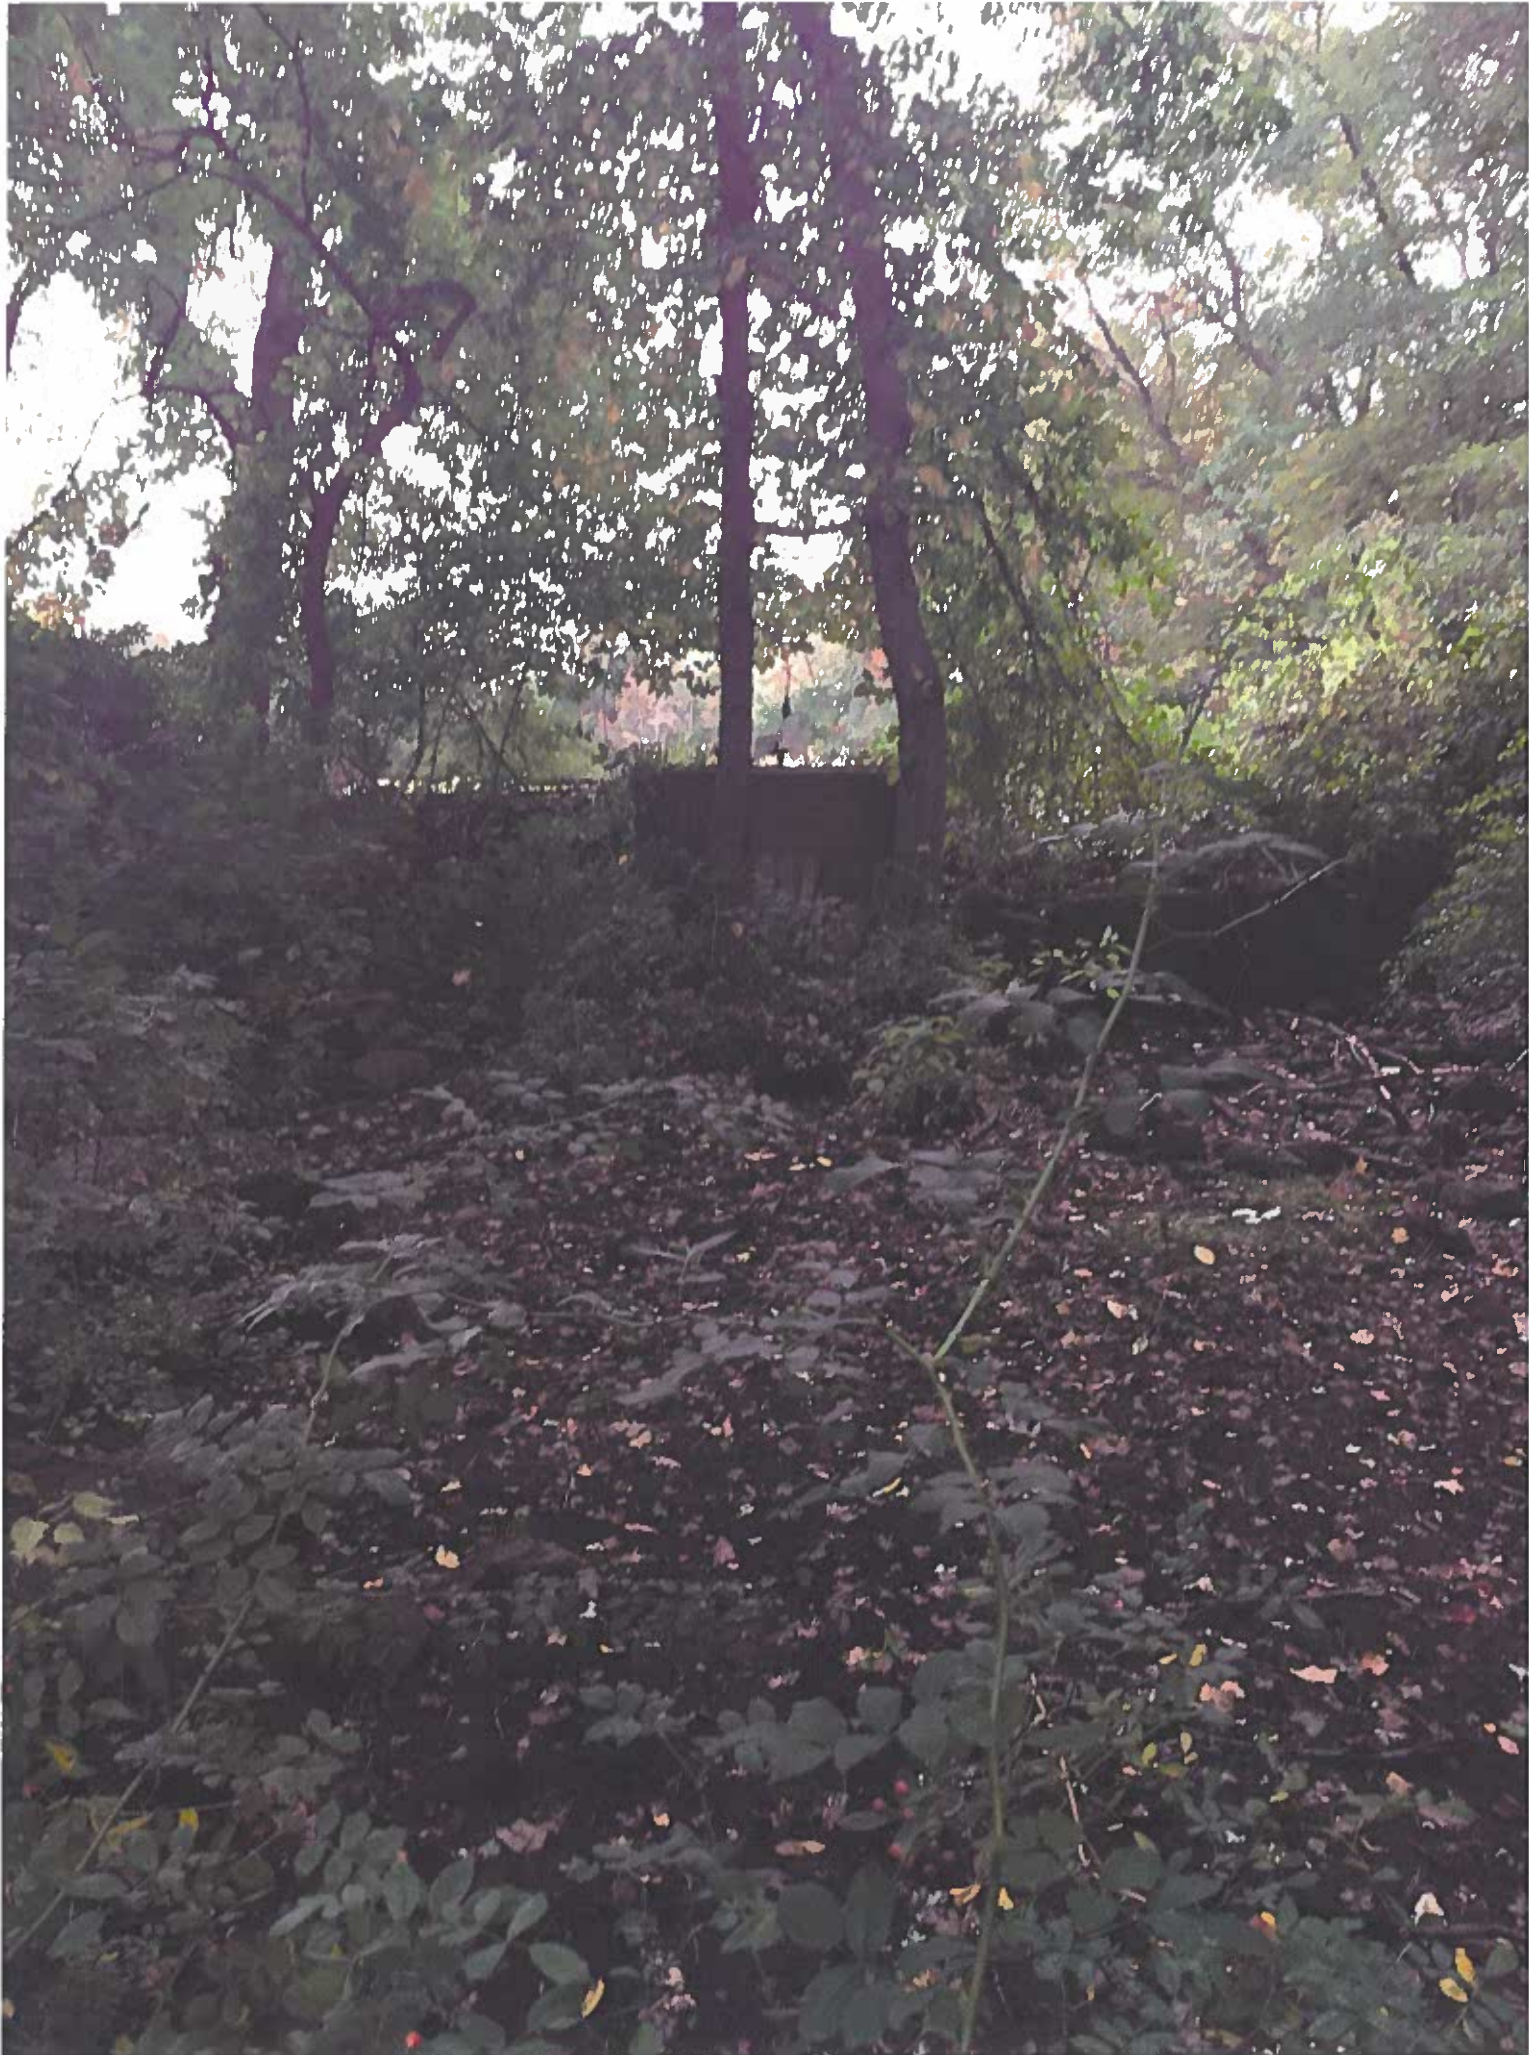
- B. Main concrete dam and channel October 2020 during drought. Note stream bed is 30 -40 feet wide not 5 feet wide.
- C. Spillway channel in earthen dam flowing during drought on same day as main channel was dry.

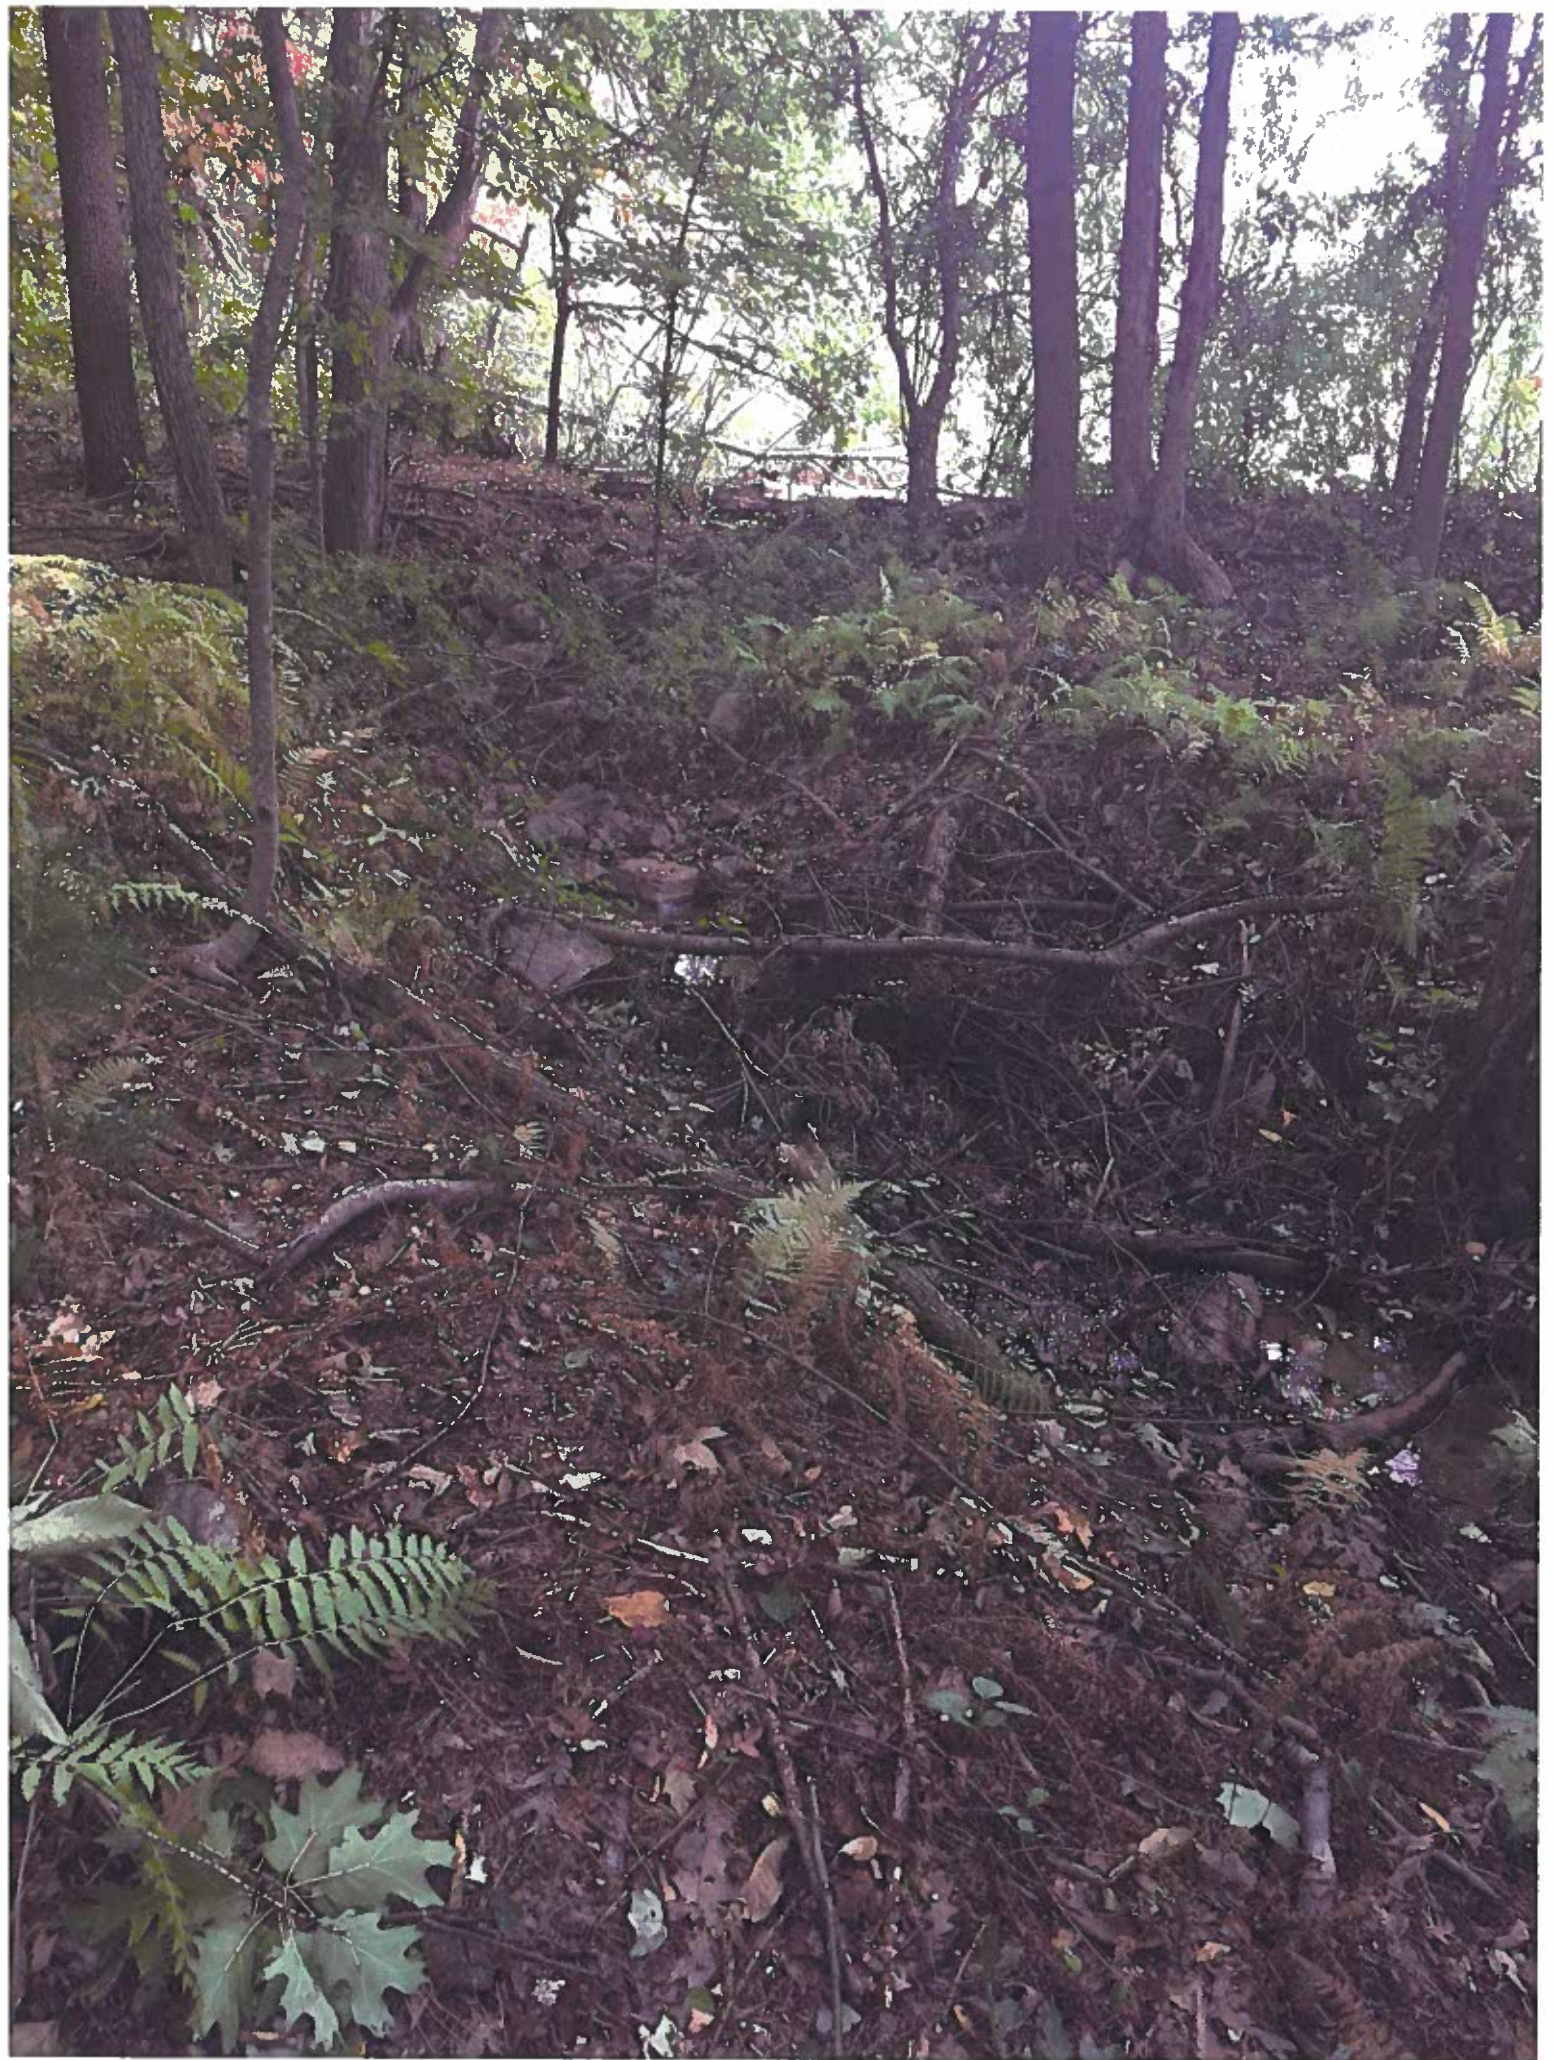
- D. Same spillway on 12/1 2020 after 2.6 inches of rain confirm that this is the main river and should be treated as such in association with ~~number 10~~ below  
Letter E

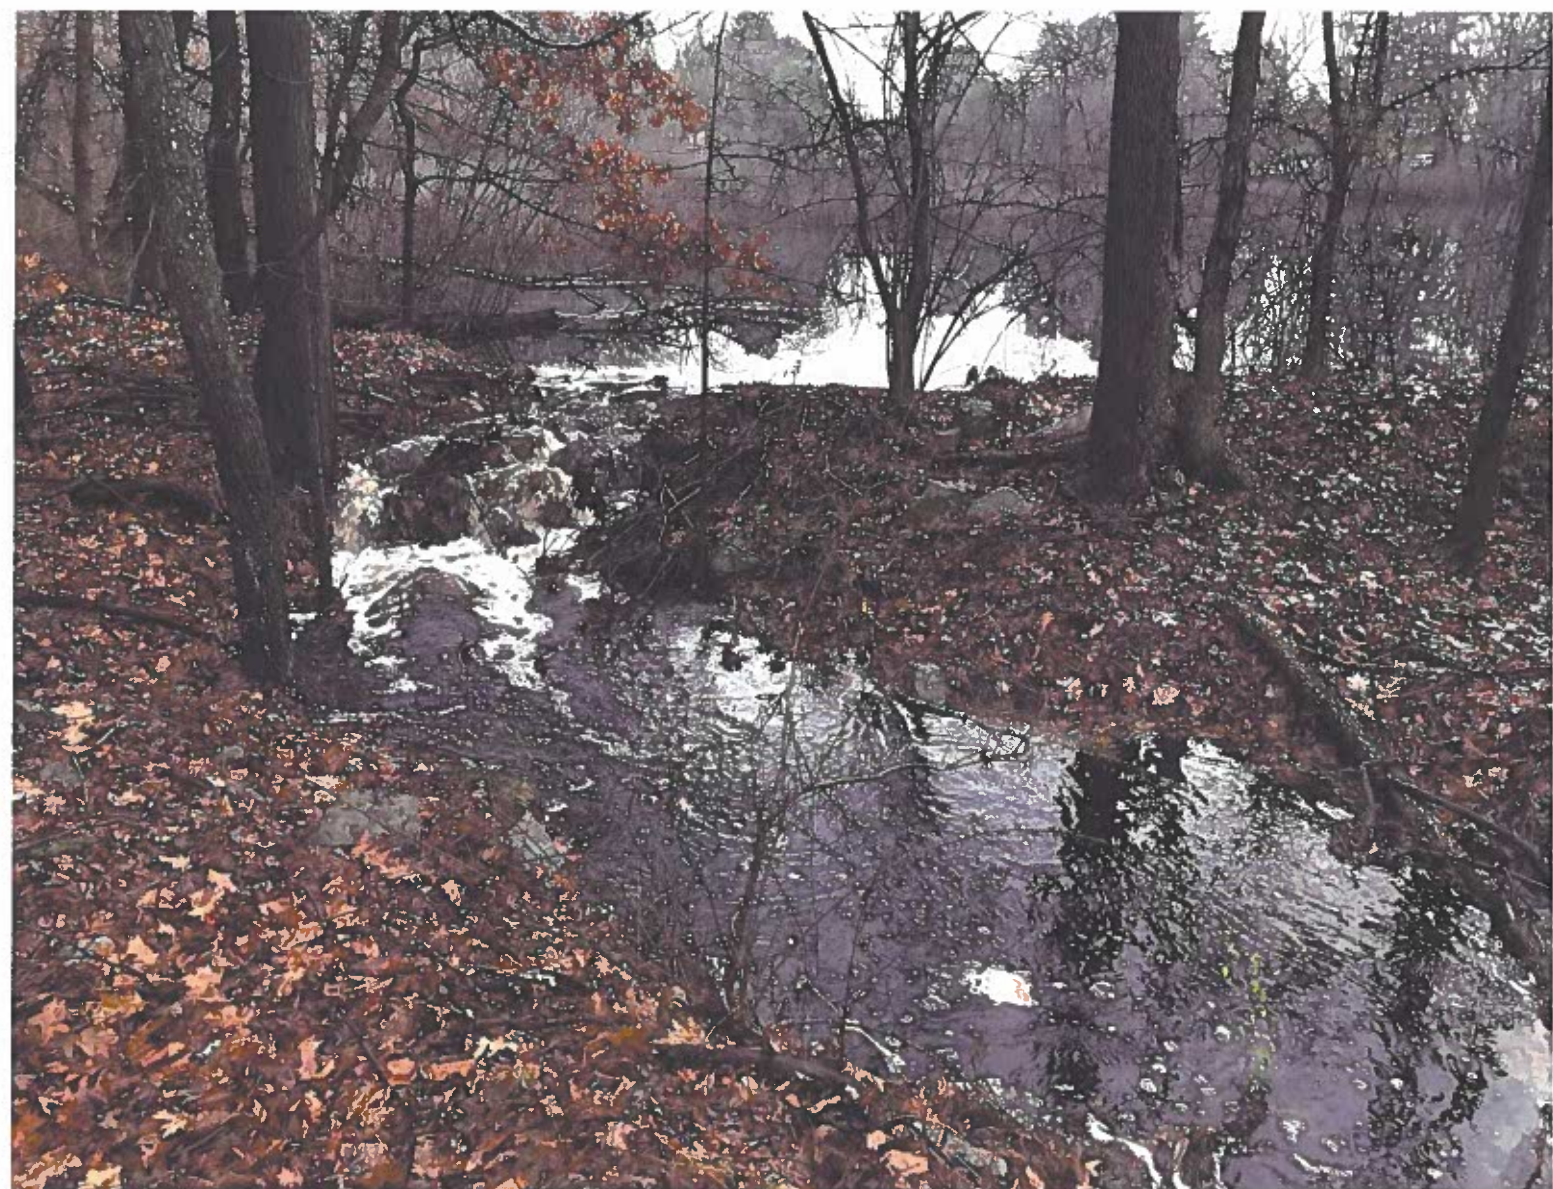
- E. Looking downstream of channel indicating annual high water level of 1888 feet not 184 feet per regulations 10.58 2 (2)
- F. Current 100- and 500-year floodplain per FEMA FIRM from Mass GIS - entire site is in floodplain

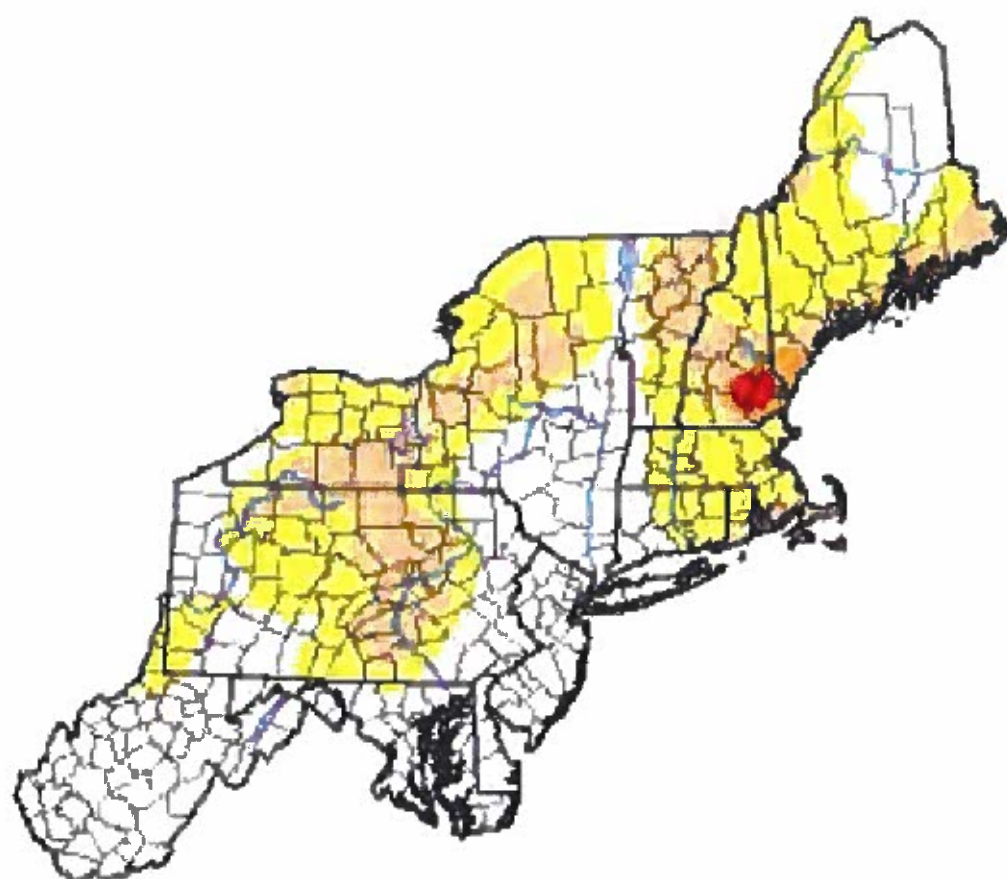
# U.S. Drought Monitor Northeast

- G. Fall 2020 Drought monitor plan indicating extensive drought condition
- H. Plan of land submitted with application indicating the proposed access location is not from the Right of way but within abutter’s property

**December 1, 2020**  
(Released Thursday, Dec. 3, 2020)  
Valid 7 a.m. EST

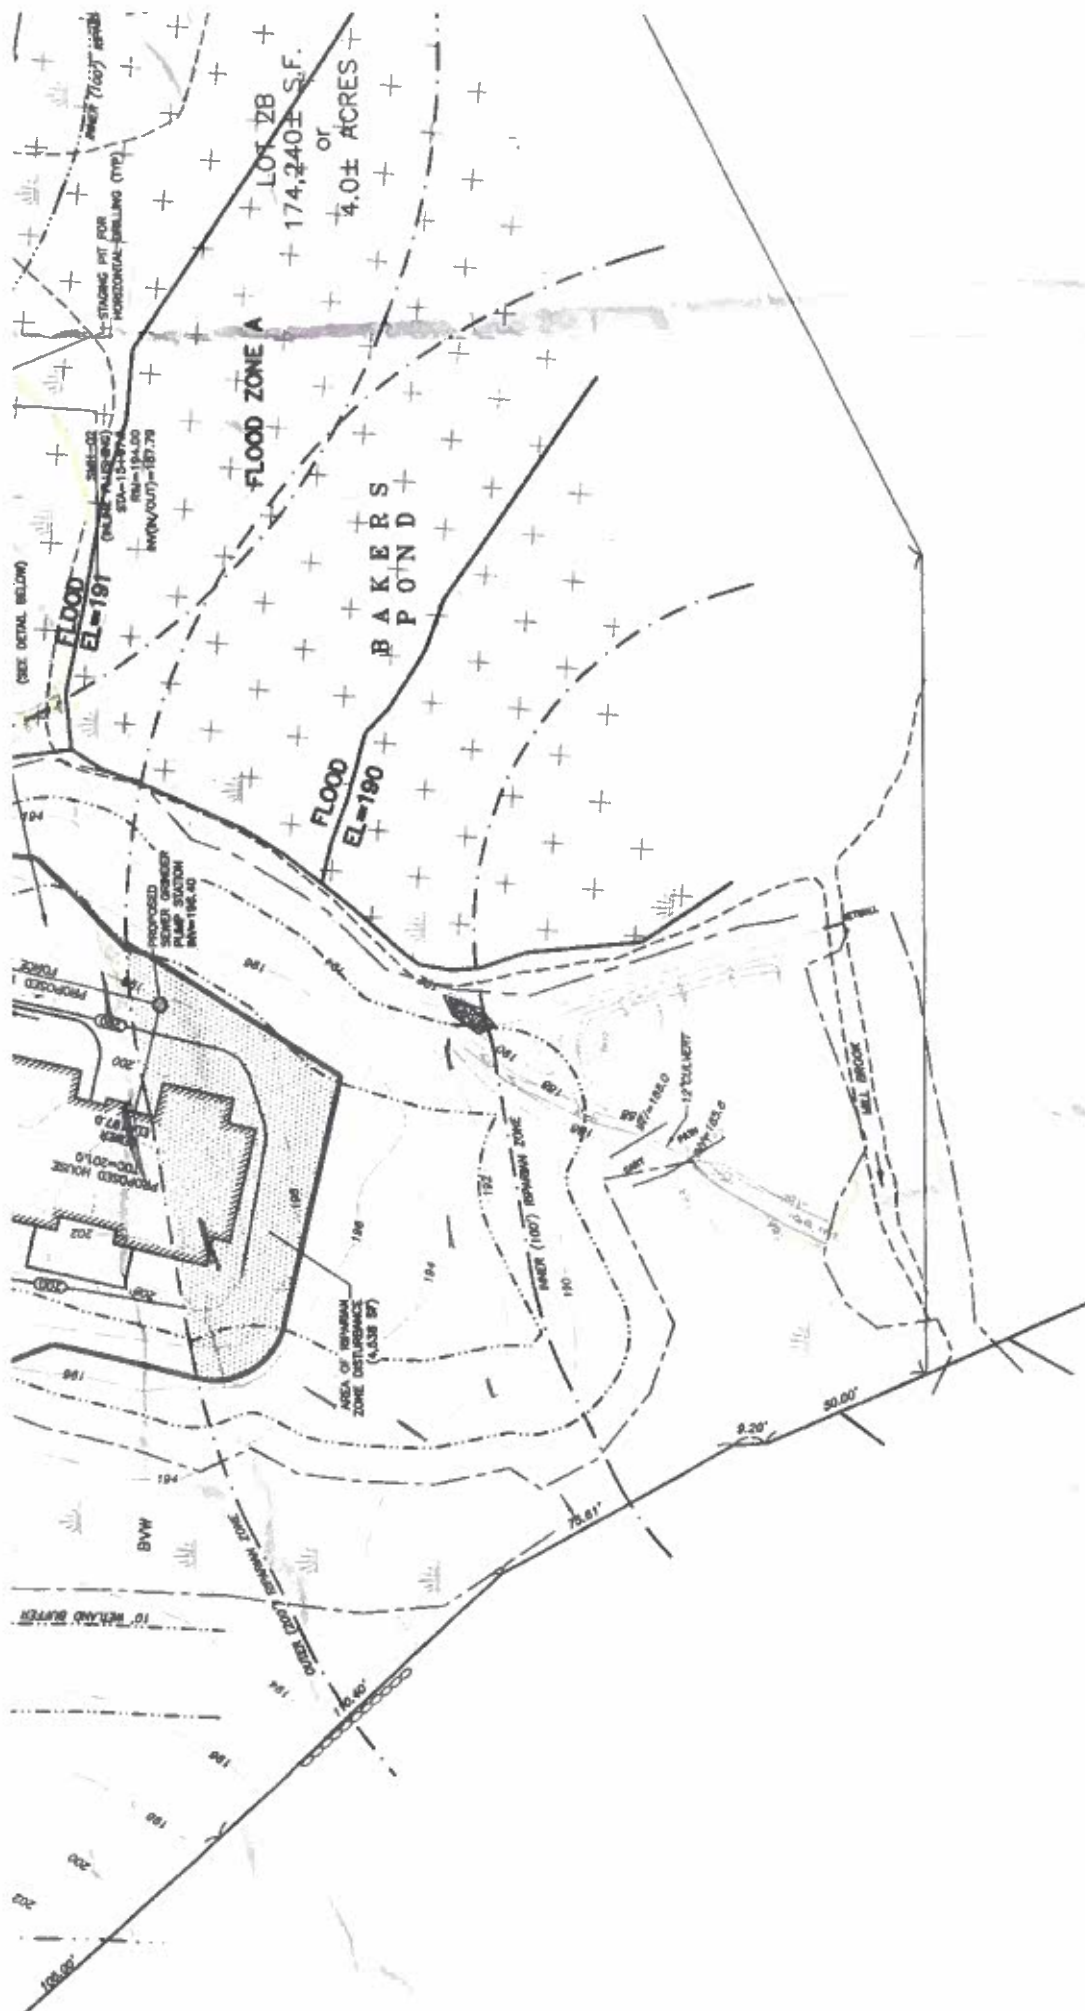
- I. Plan of land indicating the stream channel width (5 feet) used to establish riverfront setback rather than the channel shown on the plan adjusted per the annual high water elevation of 188 feet.
