EXPLORING POROUS PAVEMENT MAINTENANCE STRATEGIES

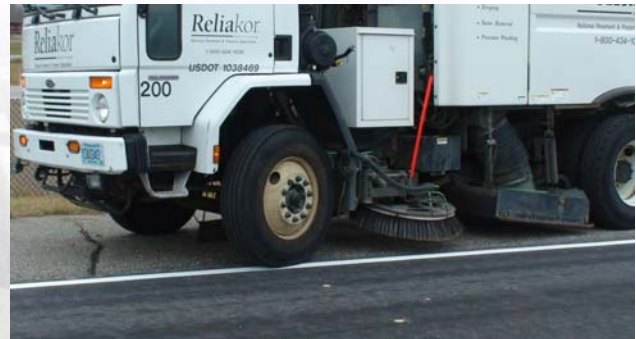
Reliakor Vacuum at MnROAD.

Mn/DOT demonstrated a porous pavement vacuuming process using equipment owned and operated by Reliakor, a Minnesota based Company at MnROAD on November 4, 2009. Pervious concrete test cells 85 and 89 and porous asphalt cells 86 and 88 were vacuumed. Representatives from Mn/DOT Metro District, Mn/DOT Research, Mn/DOT Tech Support, Mn/DOT Maintenance Research, the City of Minneapolis, DNR, and Reliakor Services Inc were in attendance.

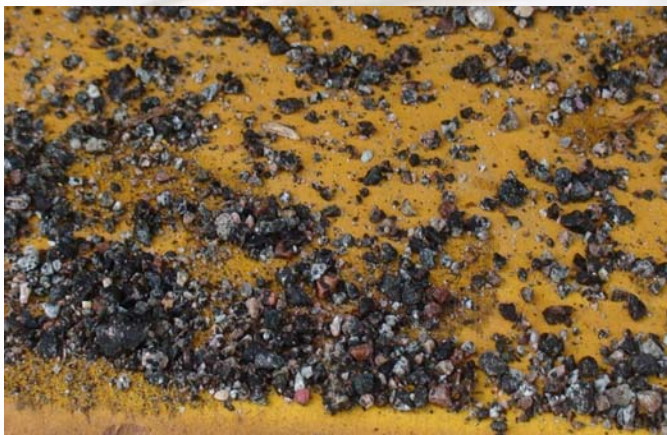
Debris removed by Reliakor Vacuum.

The contents of the vacuum were emptied after vacuuming each test cell. While the test sections did not have visible debris in the voids, there was some surface material, likely from the shoulders and neighboring test cells. In the porous asphalt test cells 86 and 88 there were some areas of surface raveling where loose aggregate was removed by the vacuum.

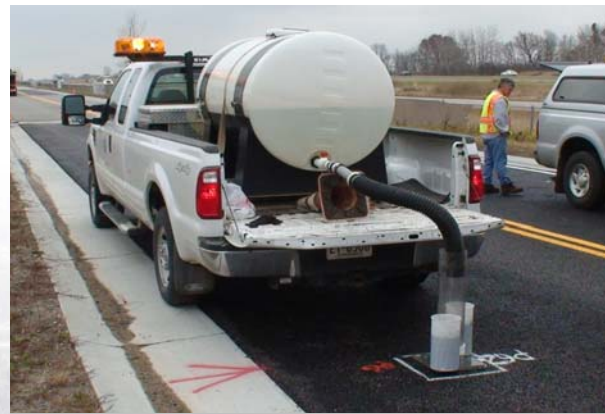
Flow measurements were made the day before and immediately after vacuuming. The change in permeability was measured using a falling head permeability device. This device consisted of a 90 centimeter long clear vertical six inch diameter tube that was sealed to the pavement surface using duct seal compound. A water tank and hose was then used to fill the tube with water. The water was then allowed to calm down and drain smoothly before timing began. The time that it took the water to drain from 37 cm to 11 cm was recorded at each test spot.

Mn/DOT Permeability Device.

One spot was tested in each test cell at the wheel path. Since the pervious concrete test cells (85 and 89) were very clean with no surface distress there was very little change in flow time. In the porous asphalt test cells, there was a 30% and 23% decrease in flow time in cells 86 and 88 respectively. This greater improvement is likely due to the removal of the raveled surface aggregate.
