We are pleased to report the dismantling, cleaning, and reassembly of the roughing and foreline valves in the vacuum system, as well as a functional check of the roughing pump. We removed the four Allen-head screws from each valve faceplate, scrubbed the valve assemblies in ethanol, and air dried them at room temperature. After a lapse of some days, we lubricated the rubber components with Dow vacuum grease, inserted the valves into the guide sleeves, and then fixed the screws in place. One item that we had not anticipated was that there are two miniature polymer semi-lunate parts within each valve that guide the stem as it is turned by the operator. Reassembling these proved to be a bit of a challenge until one of us (JH) suggested holding them in place with vacuum grease. That worked well. The valves themselves are of a standard accordion type, where the travel of the stem screw serves to displace the far end of a cylinder that then occludes a flow. The stem of the foreline valve bends as it exits the faceplate: the aperture is misaligned. An exploded side view of a valve follows; the lunate parts are within the accordion body; the bellows are slightly dented.

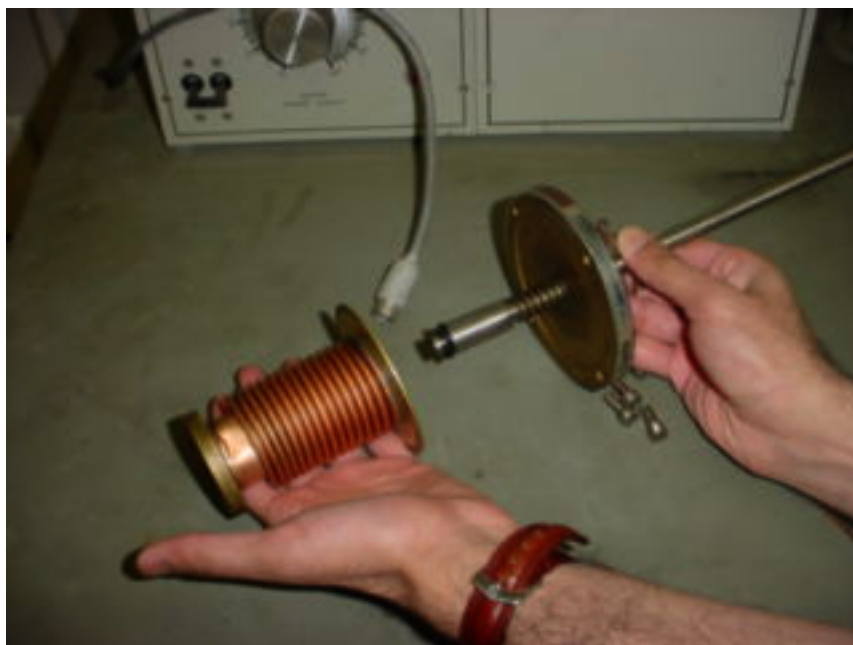
Figure 1. Expanded side view of a valve.

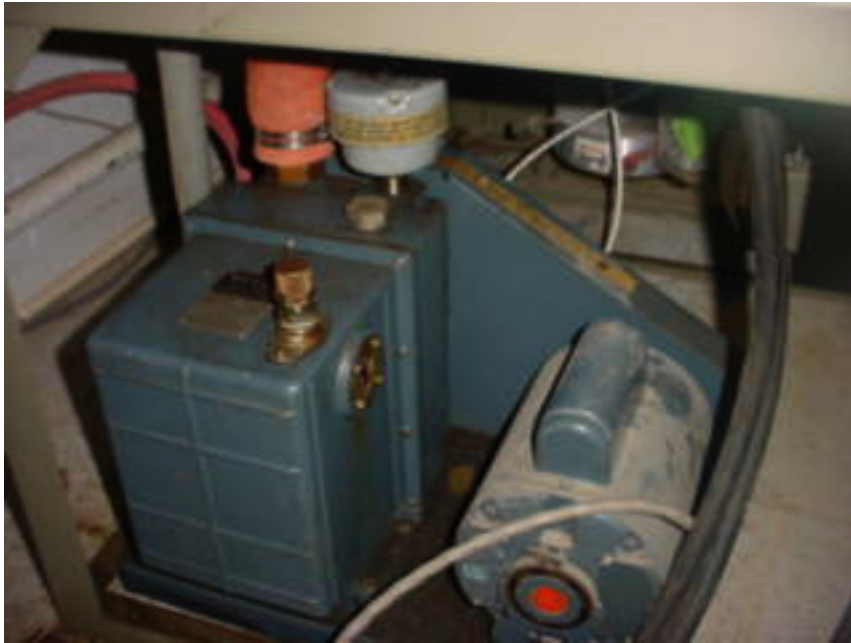
The roughing pump oil was checked and filled, and pressure-checked to 10 Torr. We used a cork and a vacuum gauge to limit the flow and measure the pressure in absolute units. The pump made the anticipated gurgling sound as it drew down the atmosphere, and there was no untoward noise in the machinery. The pump, pictured below, is a standard belt-driven Welch pump of the 1300 series, having a fractional horsepower motor driven by 120V single-phase current. We anticipate no difficulties with this unit, nor with any of the valves, and expect that they will be fully functional components of a refurbished evaporator system.

Figure 2. Welch roughing pump.
