Field Report for the Monitoring of Salmon Abundance, Water Level, and Water Chemistry in the Indian River within Sitka National Historical Park

Katlyn Haven^{1*}, Scott Gende^{2*} and Brinnen Carter^{3*}

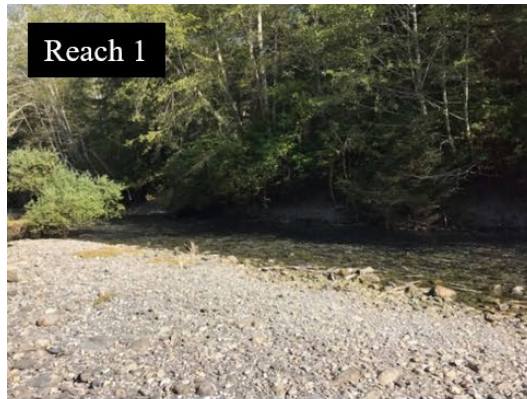
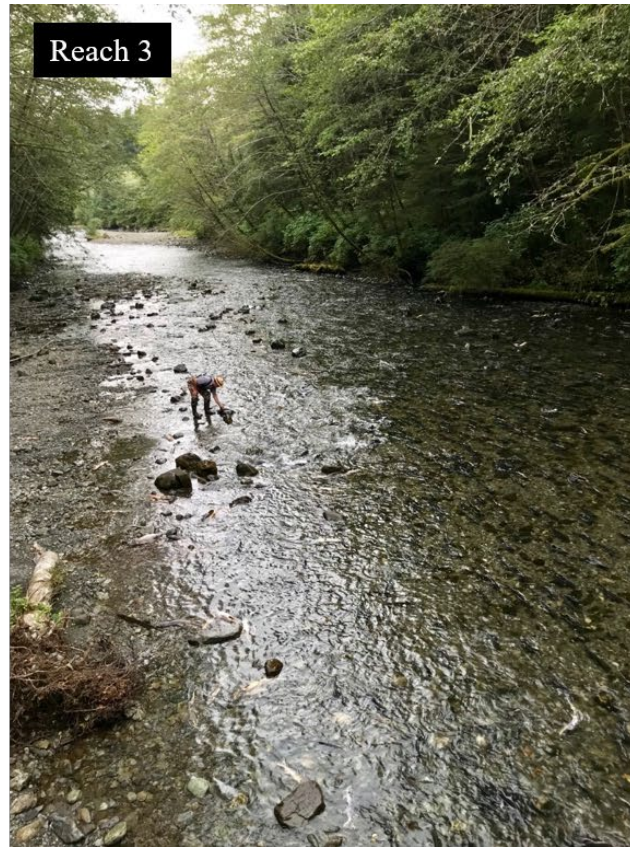
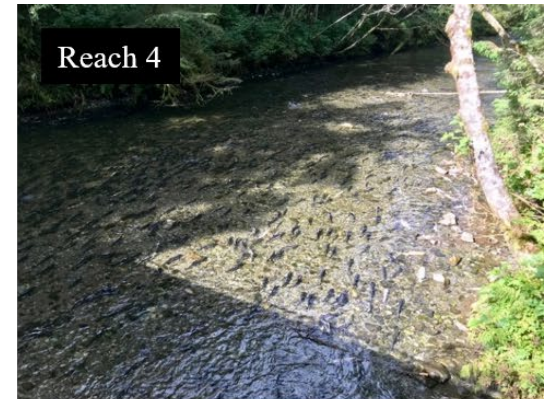
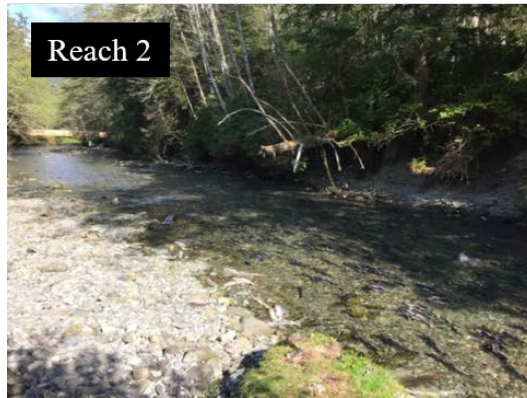
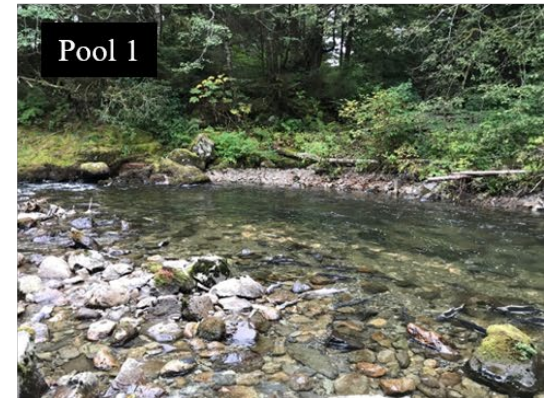
Figure 2. Study sites within Sitka National Historical Park. Each site is a 20-meter stretch of the Indian River. Reach 1 and Reach 2 are downstream and upstream, respectively, of a large piece of concrete debris. Reach 3 and Reach 4 are downstream and upstream, respectively, from the Sitka National Historical Park trail system's Pedestrian Bridge. Pool 1 is downstream of the Sawmill Creek Road bridge.

The authors estimated an index of salmon escapement by first establishing five 20-meter long river reaches within Sitka National Historical Park (Figure 1; Figure 2), then, two people counted live salmon within each reach to realize 3-6 total counts. Counts were conducted on both 31 August 2019, and on 6 September 2019. Videos were captured at each observation site.
