INDIAN RIVER WATERSHED COLLABORATIVE MANAGEMENT STRATEGY

A Blueprint for Sustainable Management of Indian River, Sitka Alaska

June 2018

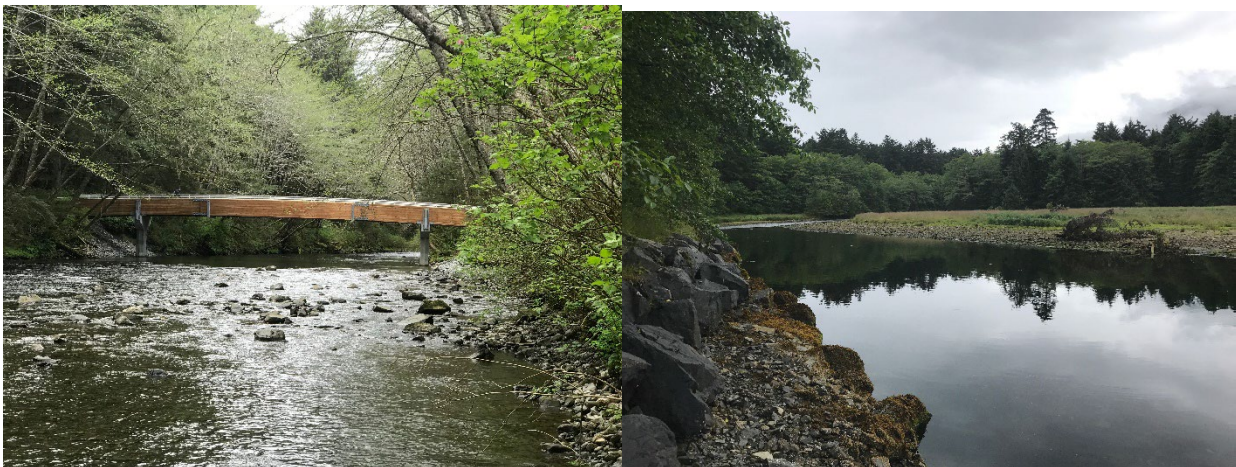
Figure 3 SNHP Pedestrian Bridge (left); Fort Site rock rip-rap (right)

Within the lower two miles of Indian River, several hydraulic structures in the river and floodplain affect natural processes and aquatic ecosystems to varying degrees (fig 4). The National Park Service (NPS) constructed a 500 ft. rock channel revetment along the west bank of the estuary to protect the historic Tlingit fort site within Sitka National Historic Park (SNHP, fig 3). The NPS recently rebuilt a concrete pier pedestrian footbridge use by visitors for trail access and wildlife viewing (fig 3). The main highway bridge crossing for Sawmill Creek Road is located at the northern boundary of the park. Just upstream from the bridge, NPS in cooperation with the US Geological Survey (USGS) maintains a stream gauging and water quality monitoring station (figs 4-5). At river mile 0.8, the SJH rubble dam diverts river water to a pipeline and open flume through the Sitka Fine Arts Campus (formerly Sheldon Jackson College) to the Sitka Sound Science Center (SSSC) SJH facility a Crescent Harbor (fig 4). An abandoned log stringer bridge at mile 1.0 has collapsed into the channel (fig 4). Two tributary streams enter the main stem channel adjacent to the Indian River BIHA subdivision. These streams are connected to storm water drainage and water detention structures within the developments. These channels along with a constructed pond (Kaelke pond) provide important salmonid rearing habitat. The last developed site is the City of Sitka (CBS) municipal water supply and treatment facility at river mile 1.4 (fig 4). This is a secondary or backup water supply for the CBS and is not currently in operation.

The SNHP pedestrian bridge intersects the primary pink salmon spawning beds in lower Indian River (fig 3). Monitoring results comparing channel cross-section, longitudinal gradient and bed substrate size distribution in 1995 and 2017 show only minor changes in channel condition. Localized bank erosion associated with foot trafficking was observed immediate downstream of the bridge on the east bank.

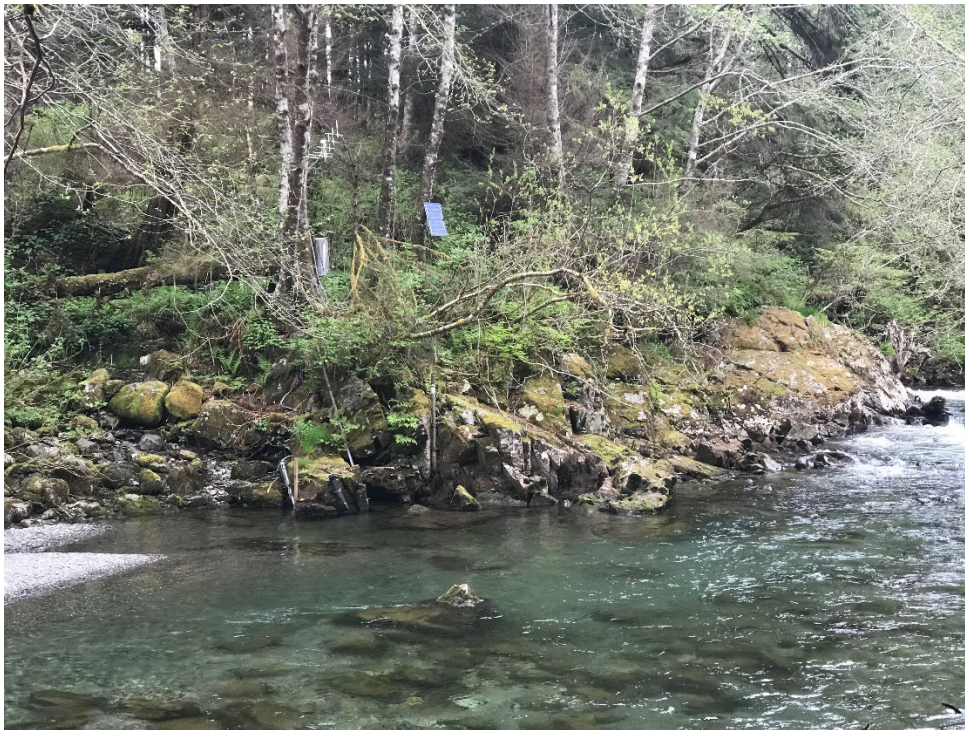
Figure 5. Stream Gauge and Water Quality Monitoring Site near Sawmill Creek Bridge.

NPS maintains water quality instrumentation at the Indian River gauge site for continuous monitoring of temperature, dissolved oxygen, pH and specific conductivity (fig 5). Measurements show rare instances of low dissolved oxygen that are potentially harmful to aquatic organisms. This phenomenon has occurred naturally in Southeast Alaska watersheds in conjunction with warm water temperature, low stream flow and large numbers of spawning adult salmon (Sergeant 2014). An

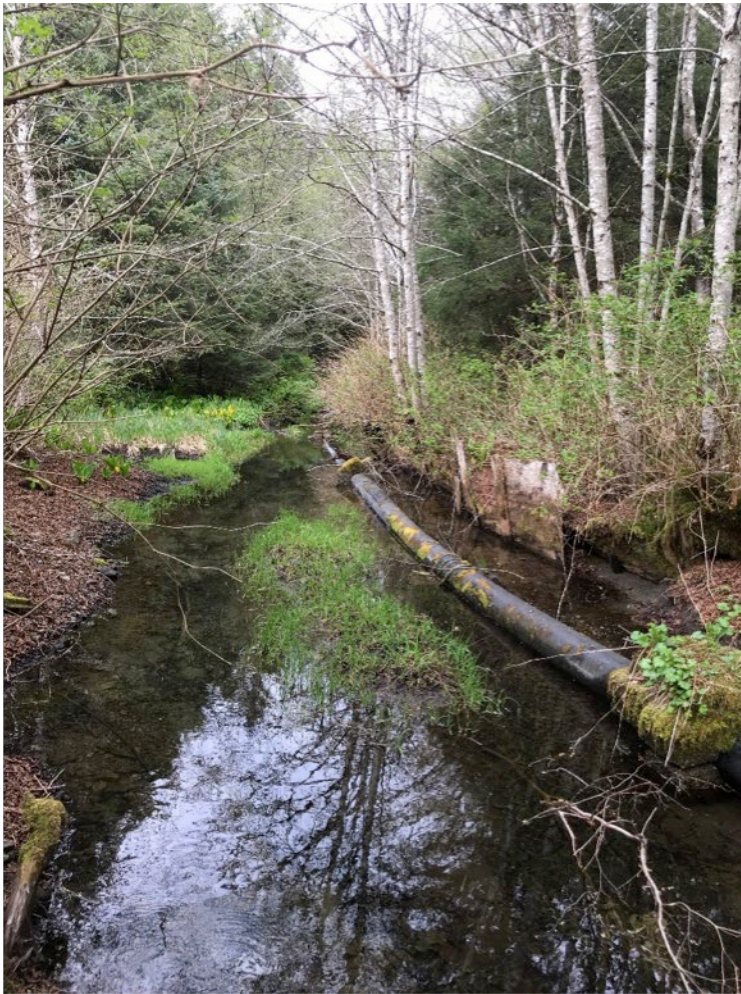
Figure 6. SJH flume and water supply pipeline near the Sitka Fine Arts Campus

Four Indian River Working Group members have designated water rights (by the Alaska Department of Natural Resources, ADNRR) in the river. CBS holds the oldest (1914) priority water right of 4 cubic feet per second (cfs) to withdraw water for its municipal water supply. CBS also applied for an additional 5.4 cfs to meet additional water demands of the current population. Sheldon Jackson College had a 1934 water right of 30 cfs that was transferred to the SSSC for operation of SJH. The original water right was designated for hydropower generation and hatchery operations (fig 6). The hydropower facility was decommissioned in 1988 therefore, SJH generally uses less than the current 30 cfs allocation.

- Sitka Fine Arts Camp is concerned about the integrity of the historic hatchery flume and underground penstock. Seepage from the flume ditch and underground wood stave penstock affect foundations of campus structures.

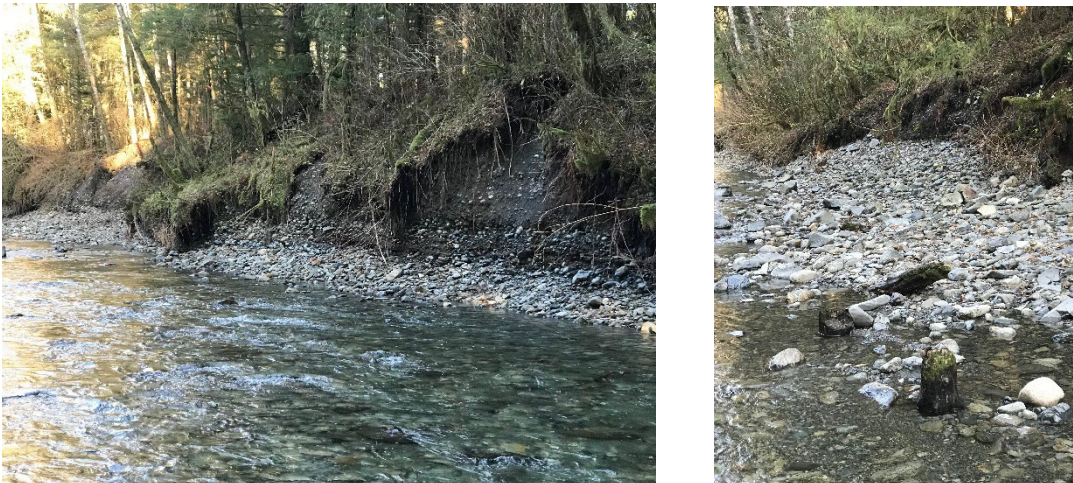
Figure 8. Evidence of recent stream bank erosion and channel entrenchment along the SNHP reach.

The channel segment from 100 m above the pedestrian bridge to the Sawmill Creek Road show signs of vertical instability and accelerated erosion along the east bank (fig 8). This area was not included in the 1995 river morphology study therefore, the rate of change in this reach is difficult to quantify. Numerous bedrock outcrops along the opposite (west) bank of this reach maintain a very stable streambank configuration. The east streambank is composed of easily eroded gravel and sand. Significant bank sluffing is evident along the entire reach (fig 8). Channel downcutting in this reach recently exposed remnants of a historic bridge pilings (fig 8). The specific cause of channel instability is unknown; however, a high frequency of large flood events 2014-2017 and disruptions to normal bedload sediment transport at upstream impoundments are the most likely causative factors.

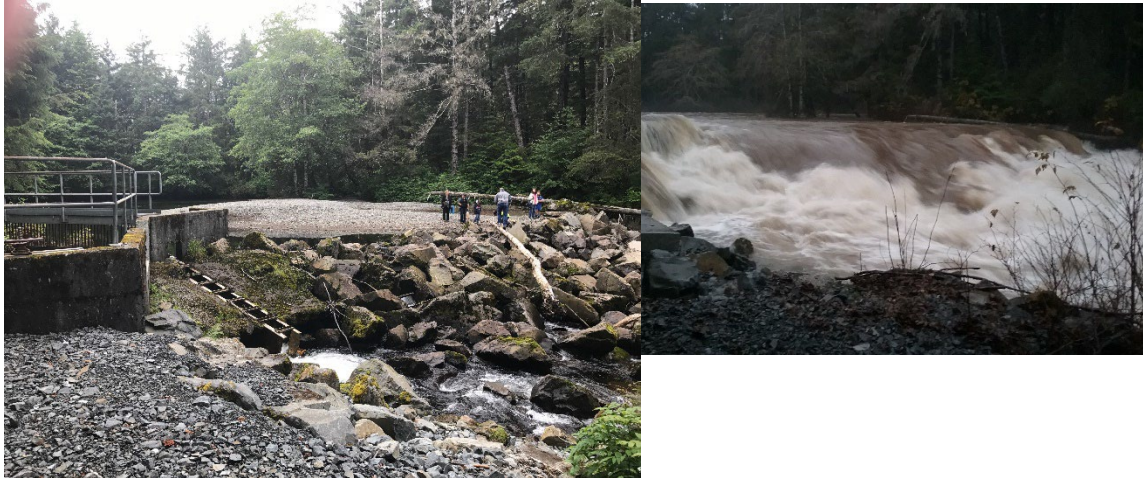
Figure 9 SJH diversion structure, fish pass and rubble dam at base flow (left) and flood flow (right)

Various dam and water intake installations for SJH have been in place since 1934. The current structure consists of a boulder-rubble dam, aluminum fish pass and a concrete water intake gallery feeding a 42" diameter metal pipeline flowing into the hatchery flume and raceway, and a 12" diameter pipe that serves as the hatchery freshwater supply (figs 6, 9). Large volumes of sediment are trapped behind the diversion dam and must be periodically dredged to maintain the functionality of the water intake and fish ladder. Stream bed aggradation above the dam also increases the risk of the river being diverted around the structure during a large flood event (fig 9). The 2004 Indian

River Master Plan recommended periodic dredging of sediment to maintain the integrity of diversion structures or alternatively installing weir structure that would allow bedload sediment to be flushed from the impoundment during higher flow events.

- The Sheldon Jackson Hatchery -Sitka Sound Science Center is concerned about the current state of the hatchery diversion structure. The diversion design requires frequent and sometimes costly repairs after flood events. The associated fish pass structure also needs frequent maintenance. The hatchery requires consistence flows for hatchery operations including higher water demand during salmon spawning season. Maintenance of the flume and penstock drainageway through the Sitka Fine Arts Campus is also integral to the hatchery operation.

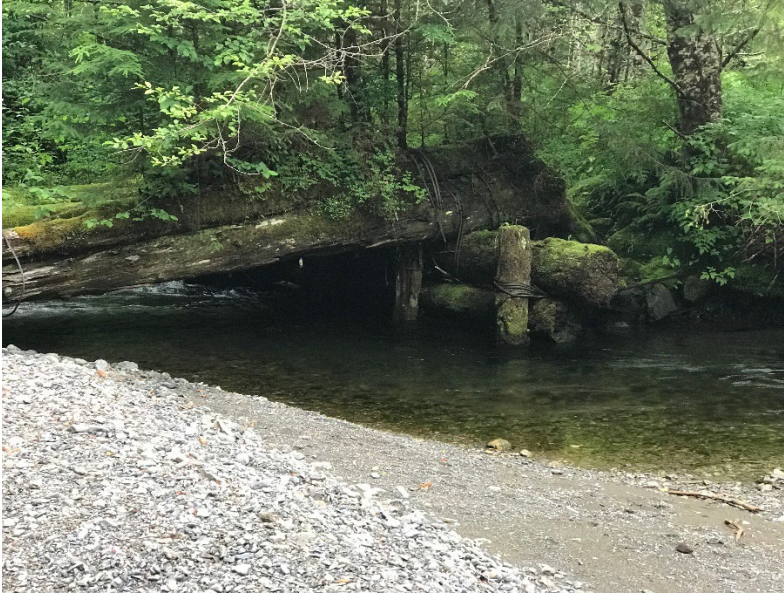
Figure 10 Remnants of abandoned log stringer bridge adjacent to the Indian River Subdivision

Similar problems of sediment aggradation and channel braiding were noted further upstream at an abandoned bridge crossing adjacent to the Indian River subdivision. Log stringers from the bridge have collapsed into the river diverting flow and trapping sediment (fig 10). This situation may reduce flood flow conveyance and potentially increase the flooding risk in the nearby residential development. The quality of fish habitat in this reach is also reduced by this structure.

7. Remove or reposition debris from the abandoned log stringer bridge (at river mile 1.0) to improve channel stability, flood water conveyance and fish habitat conditions.

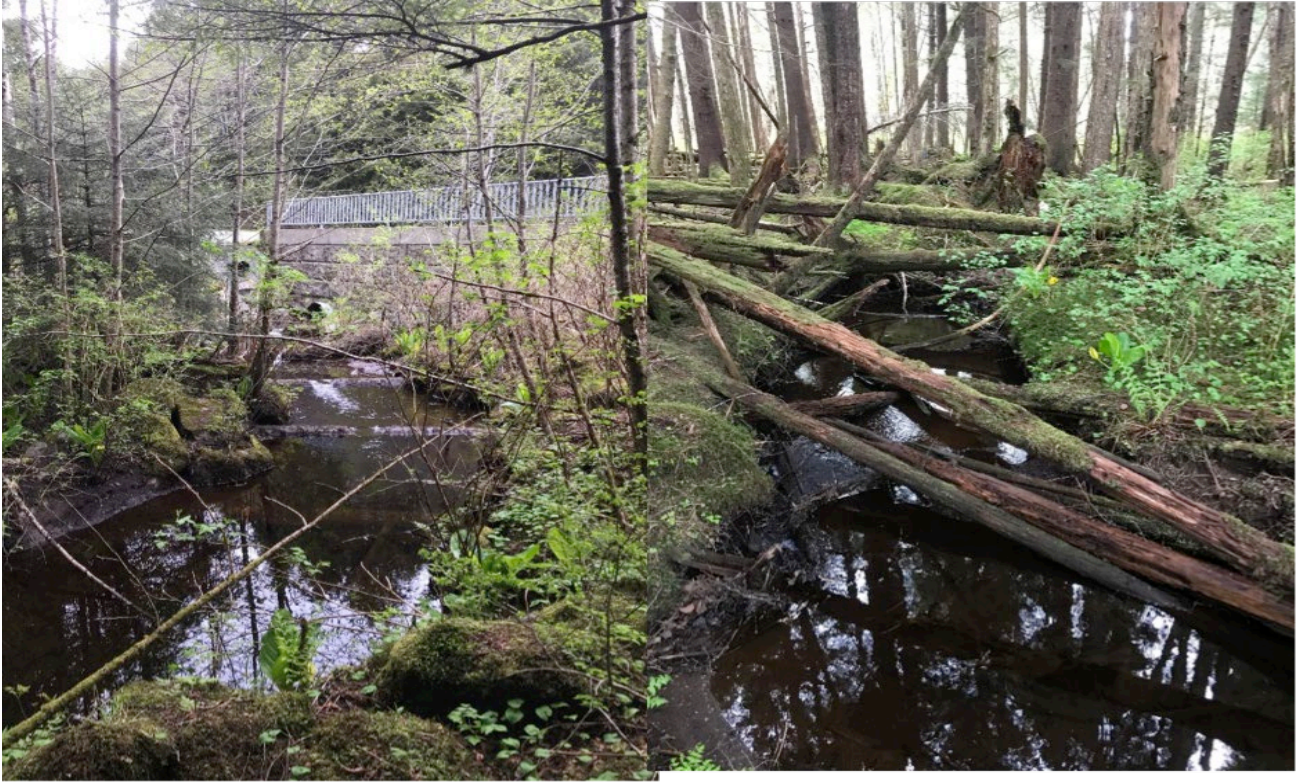
Figure 11 Proposed water quality monitoring sites Tributary 2 (left) and Tributary 3 (right)

4. Implement recommendations of the USGS Water Quality Monitoring Strategy (Neal 2007) for Indian River (estimated cost \$10,000 per cycle). This information is needed to validate water quality findings from 1995 and 2002 surveys for current conditions in the river. The strategy incorporates 3 new monitoring sites in small tributary streams (fig 11) located near developed areas of the watershed. Water quality monitoring stations would be sampled over a range of streamflow on a 5 to 10 yr. cycle. Monitoring will include a comprehensive suite of physical and chemical parameters in addition to benthic invertebrate water quality indicator taxa.

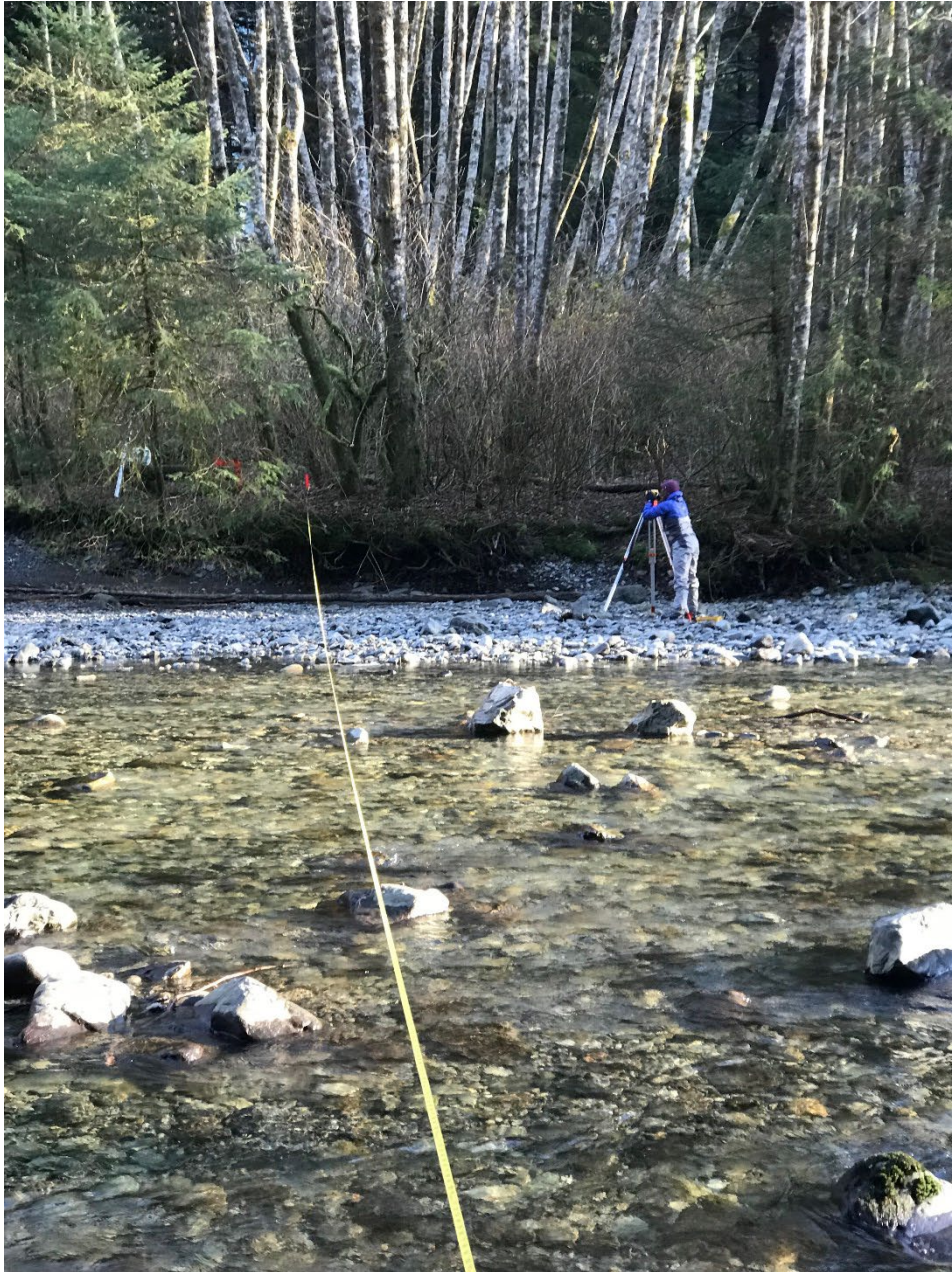
Figure 12 Channel morphology monitoring station SNHP reach.

2. Channel morphology monitoring within the SNHP reach of Indian River should be conducted at 5- to 10-year increments (estimated cost per cycle \$2,000). This information is needed to determine the trajectory of bank erosion, channel downcutting and bed substrate armoring in the reach (fig 12).
