Develop Door phone Automation Line with improvement to increase pass rate and reduce running cost

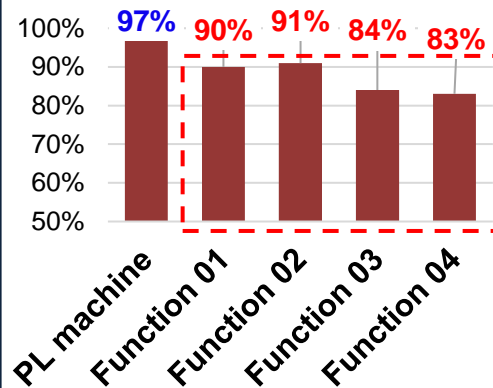
### PASS RATE OF MACHINES

Pass rate of function checkers are low

1. Connection is unstable
2. Signal is disturbed

Minimum pass rate achieve 94% (Function checker 02)

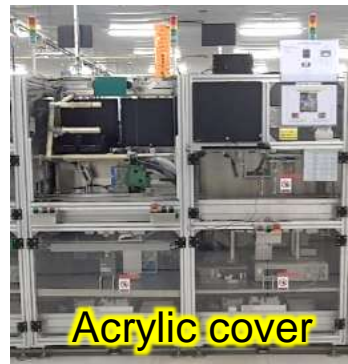
Most of transparent covers at PSNV are made by acrylic plastic

- Hard, nice appearance
- Easy to clean, process

- Broken by impact
- Poor anti-vibration

Door, cover are broken by impact and vibration
