# Phased Array Ultrasonic Testing for Post-Weld and OnLine Detection of Friction Stir Welding Defects

D. J. Huggett, M. W. Dewan, M. A. Wahab, A. Okeil & T. W. Liao

<sup>a</sup>Department of Mechanical and Industrial Engineering, Louisiana State University, Baton Rouge, Louisiana, USA; <sup>b</sup>Department of Civil and Environmental Engineering, Louisiana State University, Baton Rouge, Louisiana, USA

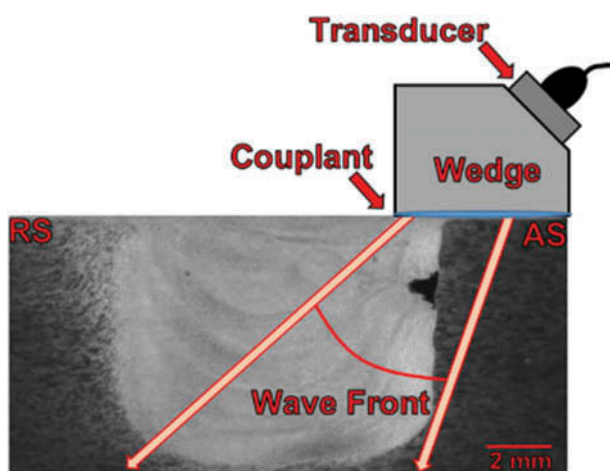
**Figure 1.** A typical probe and wedge configuration with illustration of wave propagation inside a FS welded specimen.

In FSW, there are two sides of a welded specimen, which are distinctively different from one another, called Advancing and Retreating. Each side of a FS weld has specific properties based upon material flow due to the rotation of the pin. Through this study, scanning of FS welded panels was conducted by placing the PAUT probe/wedge unit on the advancing side (AS) of the FS weld, as seen in Fig. 1. As defects in FSW typically form on the AS, the wedge/transducer unit was thereby placed on that side. This allows defect signals to be closer to the wedge causing less divergence of the sound waves, and thus more accurate data. Furthermore, during welding material expulsion out of the weld seam (considered flash) can occur. The expulsion of material typically occurs on the retreating side (RS), and to avoid flash contact with the wedge, the AS was deemed more suitable for placement. As the project aims to scan FS welds online, index offset is particularly important. As the FSW process generates ripple patterns on the surface of the welded area, PAUT cannot scan on top or near the weld center line without post-processing. By utilizing correct index offset processes, scanning may be accomplished without post-processing of the welded seam. Through the course of the work, the PAUT system was calibrated to be 20 mm away from the weld center line.

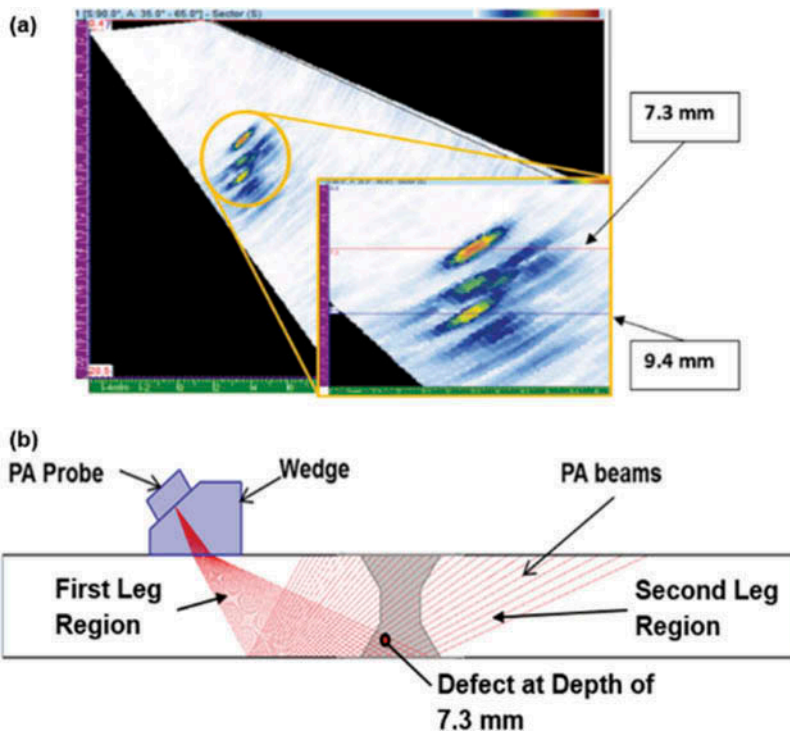
**Figure 2.** (a) PAUT S-scan image displaying the effect of side drilled hole (SDH) at larger depth, with associated schematic of first and second legs with SDH defect (b).

farther than the initial thickness of the workpiece. With two legs, waves travel twice the thickness of the material. This feature is very important as index offset is utilized in this study. An illustration of the inverting (mirror) image technique in the data acquisition unit with first and second leg sound waves can be seen in Fig. 2.

It can be seen that the initial defect image is at a depth of 7.3 mm in Fig. 2(a). An apparent second defect at a distance of 9.4 mm is also observed. The second defect image is located at a distance that exceeds the thickness of the workpiece (8.32 mm thickness for this experiment). The defect's actual depth is evaluated by the operator taking the difference of the depth given from the image and workpiece thickness. The resulting value is then subtracted from the workpiece thickness, which is the location similar to the first leg defect depth. In summary, due to the many elements in a PAUT transducer, signals emitted from certain elements may not be influenced by a defect; consequently, the first leg signals from those elements have not been redirected. These signals are then reflected off the bottom surface of the specimen which redirects the signal that results in reflecting off the defect. This is illustrated in Fig. 2(b) for the defect at the larger depth.

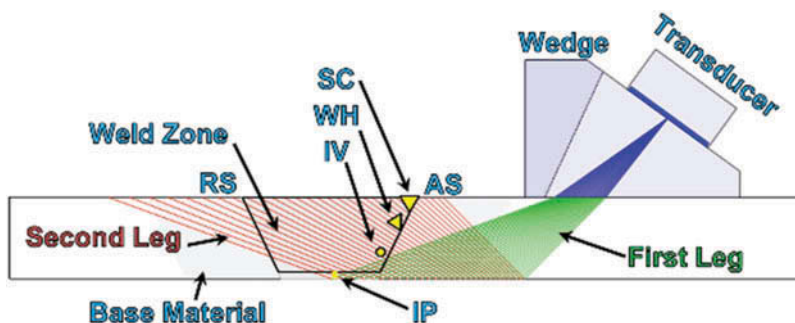
**Figure 3.** Illustration of the PAUT system with various legs indicating where FSW defects may occur.

A comparison of the abilities of PAUT and X-ray radiography to detect various forms and sizes of defects in weldments has been carried out in this study. The FS-welded plates were analyzed employing PAUT and compared with X-ray radiography to illustrate sizing capabilities when utilizing a calibrated PAUT system (note the X-ray images below are inverted for better quality). These FS welds were executed utilizing varying weld schedule parameters (plunge or forge force, travel speed, and spindle speed). Weld schedules were designed in a way to purposely produce defects. Four defect types are presented below. Defects presented in this study include surface cavities (SC), wormhole (WH), internal voids (IV), and incomplete penetration (IP). SCs are surface defects whereas WH and IV are internal defects. IP is a defect located at the root of a weld caused by unconsolidated material on the seam line. Each defect type has a different formation mechanism and is directly related to the process parameters utilized during welding. First, a SC formed by lack of material in the weld seam during the plunge stage of FSW is presented. Secondly, a WH defect is presented, followed by another SC, often considered a trenching (TR) defect. Following these defects, an IV is presented. Lastly, IP defects are described. General defect locations of a FS weld can be observed in Fig. 3, with anticipated ultrasonic wave front, or leg, which will identify the defect.

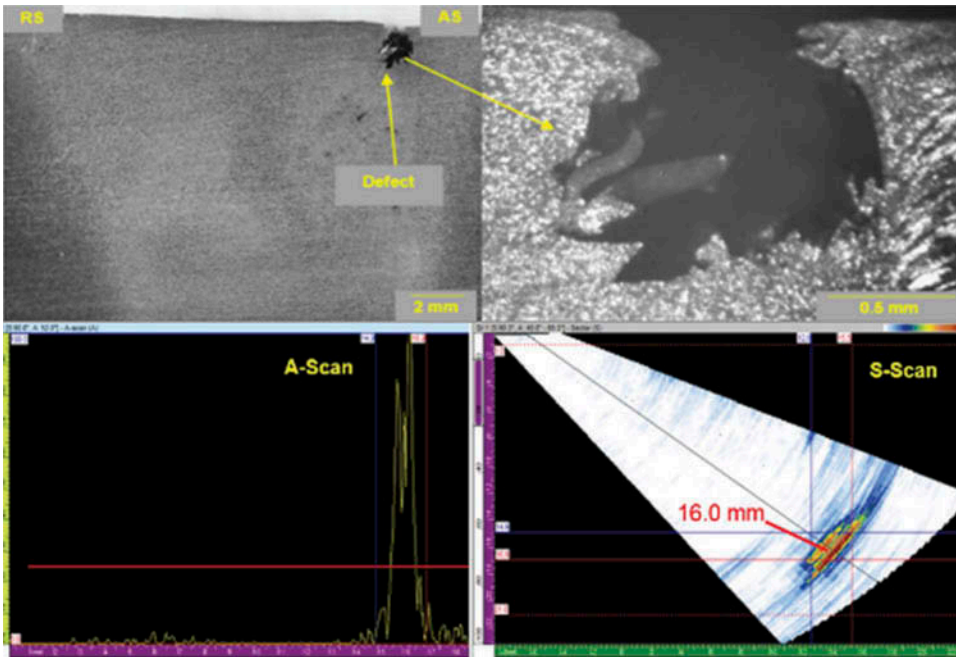
**Figure 4.** Optical image of cross-section, enlarged defect image, PAUT A-scan, and S-scan image (second leg) of an FS-welded panel with surface cavity (observed by second leg).

Figure 4 illustrates an FS weld that has incurred a large defect located on the AS of the weld. An A-scan image can be seen with the associated S-scan image. The S-scan image depicts a snapshot of the defect with accurate estimates of its size and location. It is observed that the defect is found by second leg signals, as the depth of the defect is greater than the workpiece's thickness, i.e., 8.32 mm, and less than doubled thickness, i.e., 16.64 mm. Figure 5 illustrates a representation of the X-ray image compared with a B-scan and a C-scan of the PAUT system. Furthermore, in Figs. 6 and 7, a WH defect is shown. In a similar fashion, a SC defect is

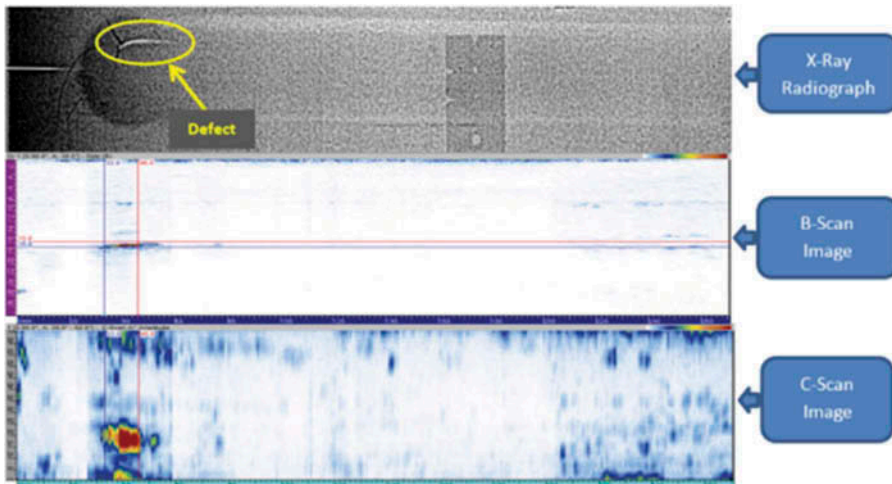
**Figure 5.** Radiographic, PAUT B-scan, and PAUT C-scan images of an FS-welded panel with surface defect.

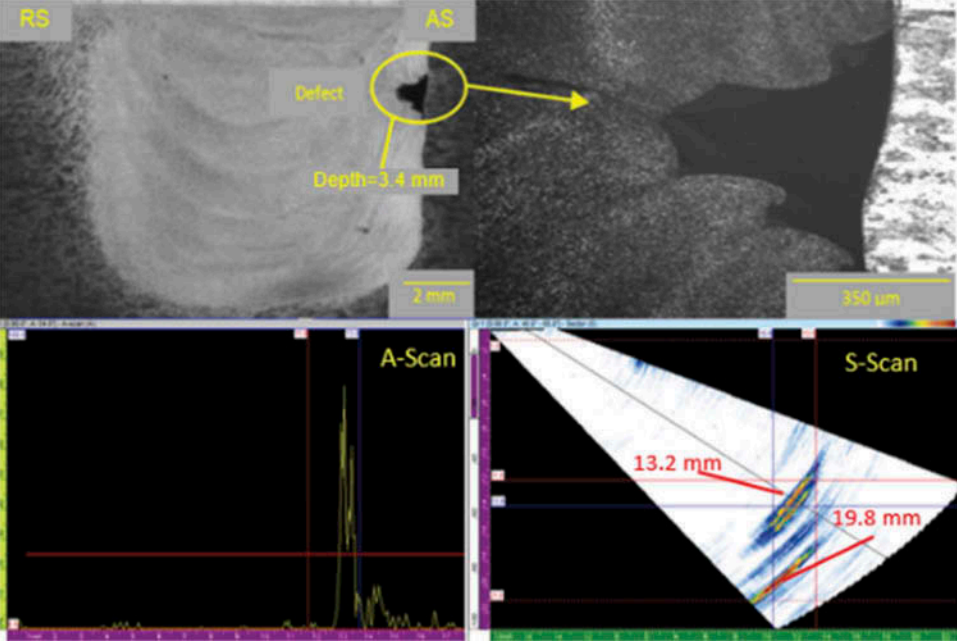
**Figure 6.** Optical image of cross-section, enlarged defect image, PAUT A-scan, and S-scan image of an FS-welded panel with wormhole defect (observed by second and third leg).

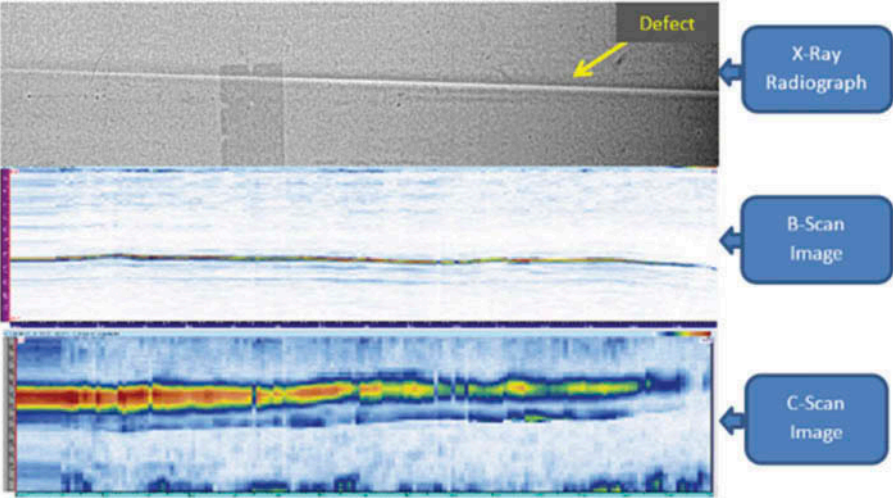
**Figure 7.** Radiographic, PAUT B-scan, and PAUT C-scan images of an FS-welded panel with wormhole defect.

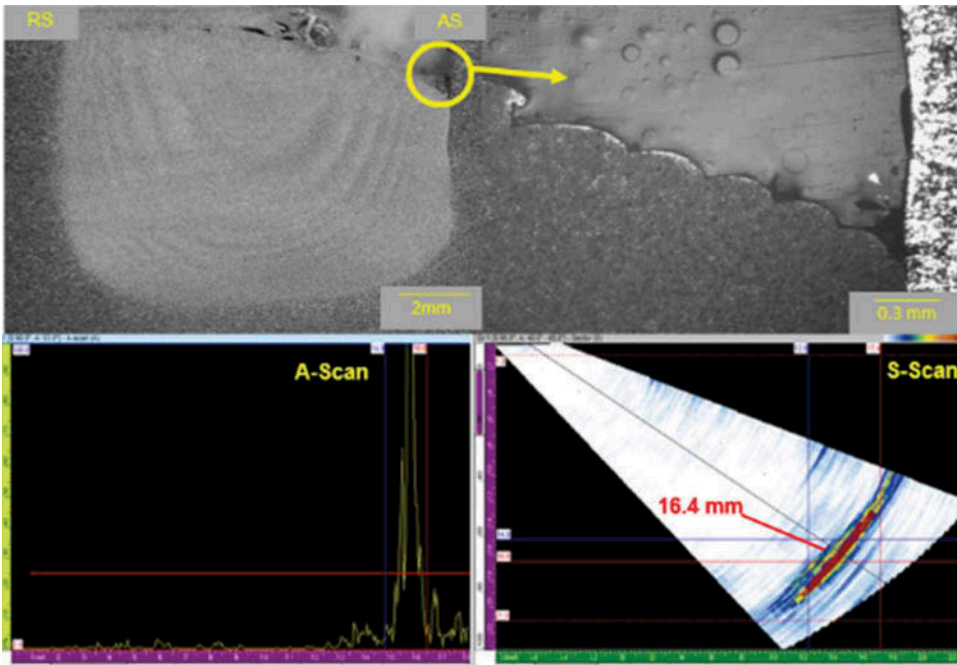
**Figure 8.** Optical image of cross-section, enlarged defect image, PAUT A-scan, and S-scan image of an FS-welded panel with SC defect (observed by second leg).

presented in Figs. 8 and 9. These defects were as well detected by the second leg signals, as the wedge/transducer system is not scanning near or on top of the defect. In Fig. 6, it is noted that the WH was also found by third leg signals, as the defect's depth is greater than 16.64 and less than

24.96 mm. It can be seen that, as the signal propagates further through the specimen, the defect depth has larger error. These defects were found accurately with X-ray radiography and PAUT. Note that there was no post-processing of the panels for these tests. The X-ray image compares

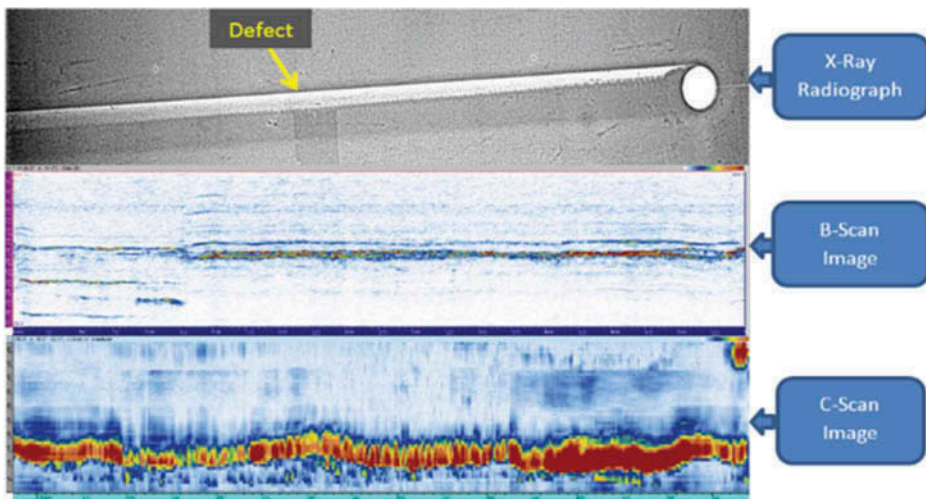
**Figure 9.** Radiographic, PAUT B-scan, and PAUT C-scan images of an FS-welded panel with SC defect.

very well with PAUT scans and shows that the two NDE techniques correlate very well for large defects, which is expected; however, it can be said that defects of this size and shape will most likely not occur in the production line.

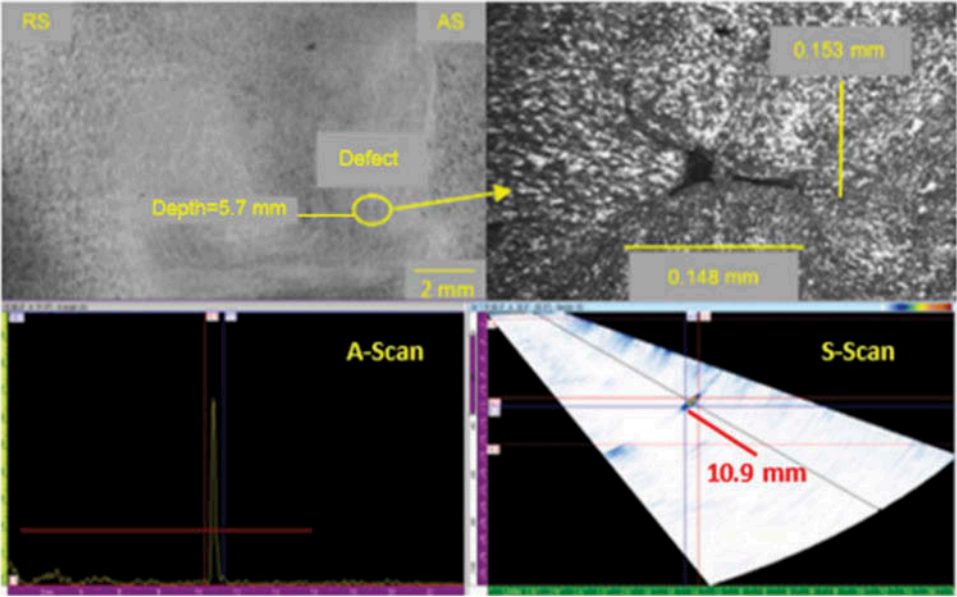
**Figure 10.** Optical image of cross-section, enlarged defect image, PAUT A-scan, and S-scan image of an FS-welded panel with internal void (observed by second leg).

An internal void defect is shown in Figs. 10 and 11. In this FS weld, two defects were found by the PAUT system; however, both defects were not found by X-ray radiography. The smaller defect on the right in Fig. 11 is analyzed here. The defect was measured to be in the range of 0.15 mm in both length and height. It is seen that the A-scan amplitude does not reach 80% due to calibrating the system with a larger defect size. The intensity of the reflected sound wave decreased giving maximum amplitude of 68%. It is observed that the X-ray image does not detect the small defect.

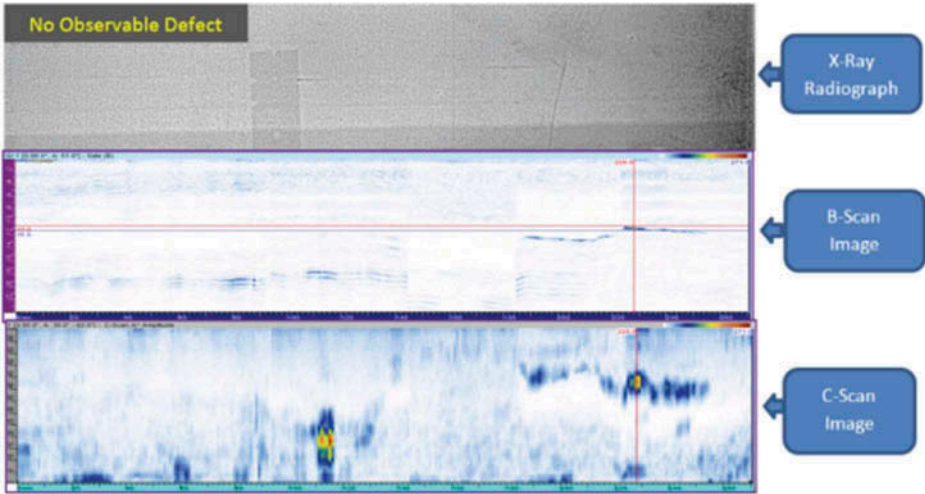
**Figure 11.** Radiographic image, PAUT B-scan image, and C-scan image of an FS-welded panel with internal void.

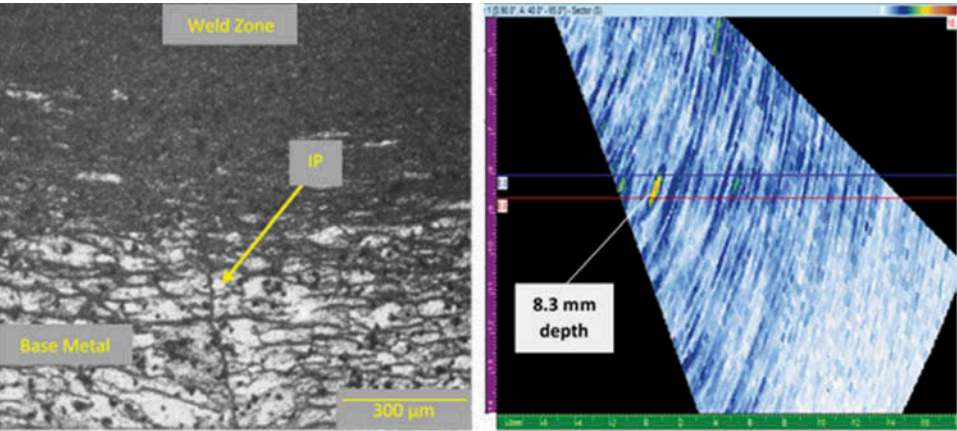
**Figure 12.** Optical image (left) of IP defect of length 480  $\mu\text{m}$  and associated S-scan image (right) of IP defect.

To indicate the performance of the PAUT system, a comparison of an S-scan IP image with associated optical micrograph can be observed in Fig. 12. The defect size of this specimen is 480  $\mu\text{m}$  and was found by the PAUT system to have a defect height of 500  $\mu\text{m}$ . PAUT defect height overestimates the actual defect height in most cases due to high gain values implemented in calibration. IP defects were thereafter verified with tensile tests, which were conducted on all specimens welded in this study with an MTS 810 Material Testing System. Figure 13 illustrates an IP defect with associated fracture origination from tensile test, and scanning electron microscopy (SEM) image of the fracture surface. In the SEM image, it is evident an unbonded surface is present by observing a lack of fracture dimples associated with a bonded surface.

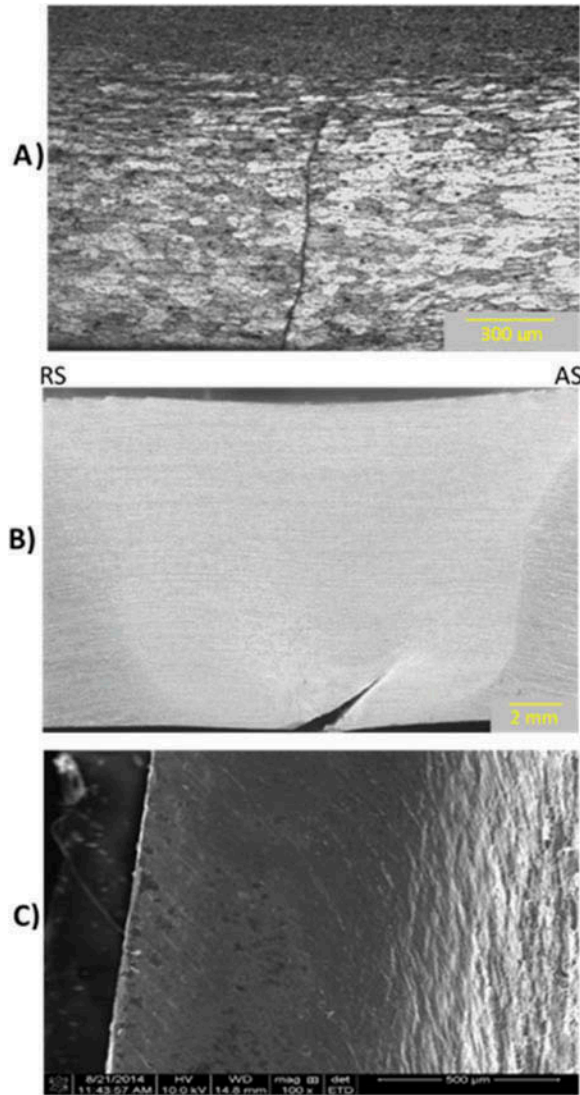
**Figure 13.** A) Optical micrograph of IP defect. B) Optical image of tensile tested specimen indicating fracture origination. C) SEM image indicating unbonded area.

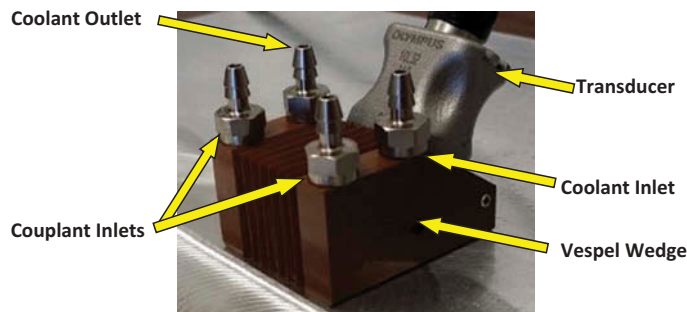
**Figure 14.** Custom PAUT HT wedge/transducer unit.

for the FSW application. The wedge was further designed with a water inlet and outlet for cooling around the transducer casing to ensure piezo-electric element safety. Furthermore, inlets were inserted to allow a steady flow of couplant to the workpiece during scanning, see [Fig. 14](#).

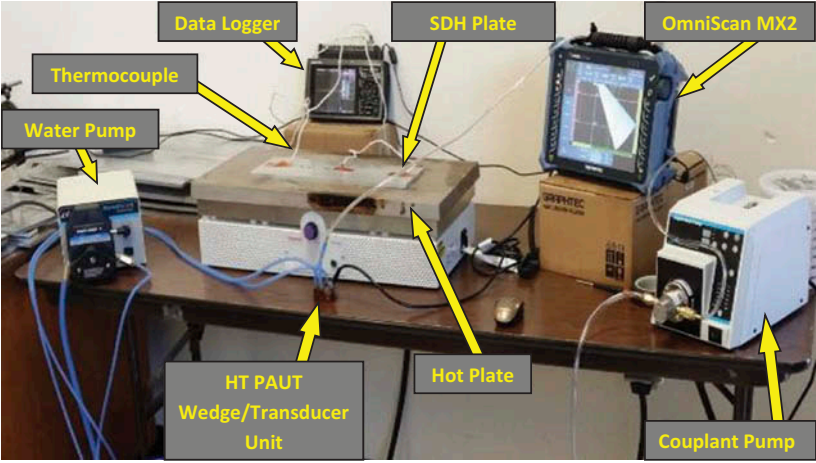
**Figure 15.** Illustration of HT PAUT for SDH AA-2219 specimen of 8.13 mm thickness.

The effectiveness of the newly designed and fabricated wedge was first tested in a laboratory setting for a simulated controlled environment at ambient and elevated temperatures (25.0°C, 100°C, 200°C, and 300°C). The experiments entailed three trials per temperature, and utilized a different calibration file for each trial. Temperature readings were taken with K-type thermocouples and Midi Logger GL820 acquisition system with a sampling rate of 200 ms. A Thermo-Scientific 2200 Hot Plate was employed to heat the AA-2219-T87 material used for calibration. In order to pump coolant and couplant through the wedge by the inlets and outlet channel, two Master-Flex pumps were employed. Couplant is required to induce transmission of ultrasonic waves from wedge to workpiece, and the coolant is required to maintain a safe operating temperature for the piezoelectric elements in the transducer. [Figure 15](#) illustrates the experimental setup. [Table 2](#) summarizes results at ambient conditions. It is observed that with appropriate calibration procedures accurate defect sizing and location were obtained, similar to conventional PAUT wedges. The effects at elevated temperatures can be seen in [Table 3](#). [Figure 16](#) illustrates two S-scan images of a similar defect at varying temperatures (ambient and 300°C). It was observed that the location of the defect increased in distance as the temperature increased, due to the change in ultrasonic velocity as the material heats. It is observed that at 300°C the maximum depth change was found to be 1.2 mm. This value appears small and indicates that at 300°C there is minimal change for our PAUT configuration. One reason for this small change is due to the unconventional wedge material that is utilized. According to ASME standard [44], high-temperature materials up to 540°C can be measured with appropriate HT instruments. For steel, it is claimed the rule of thumb for apparent

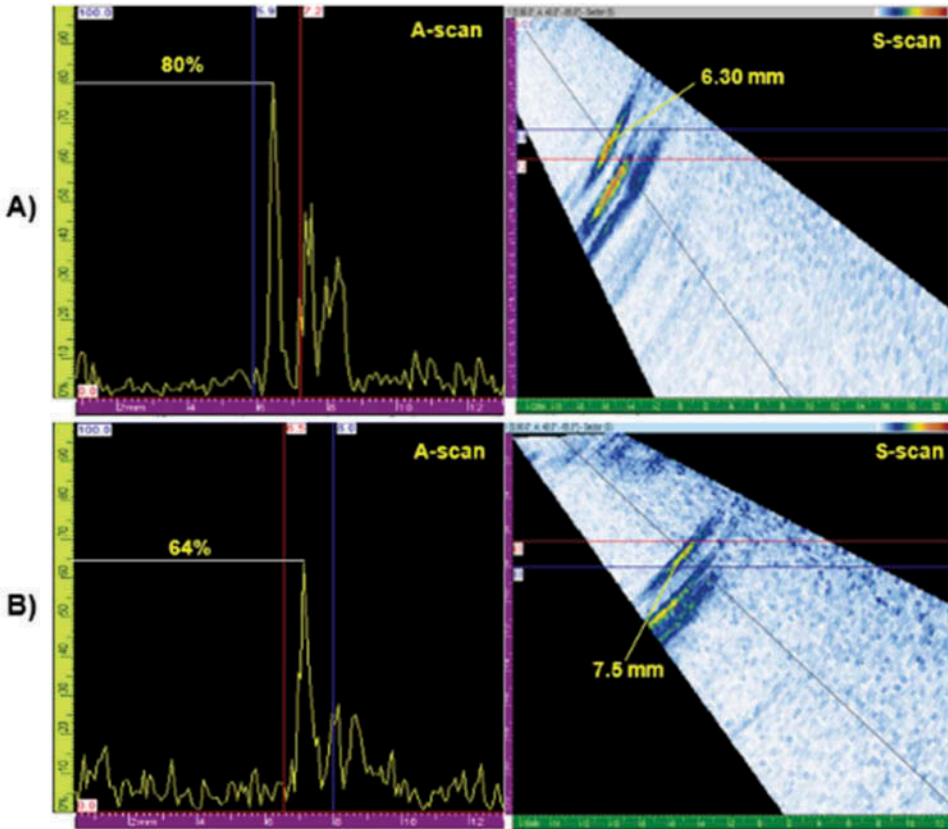
**Figure 16.** Comparison of A- and S-scan images of 1.19 mm diameter SDH at a depth of 6.3 mm. Case A) was conducted at room temperature, and case B) was conducted at 300°C. A change in depth of 1.2 mm occurred with an increase in temperature to 300°C with an increase in attenuation (80% down to 64% A-scan peak amplitude).

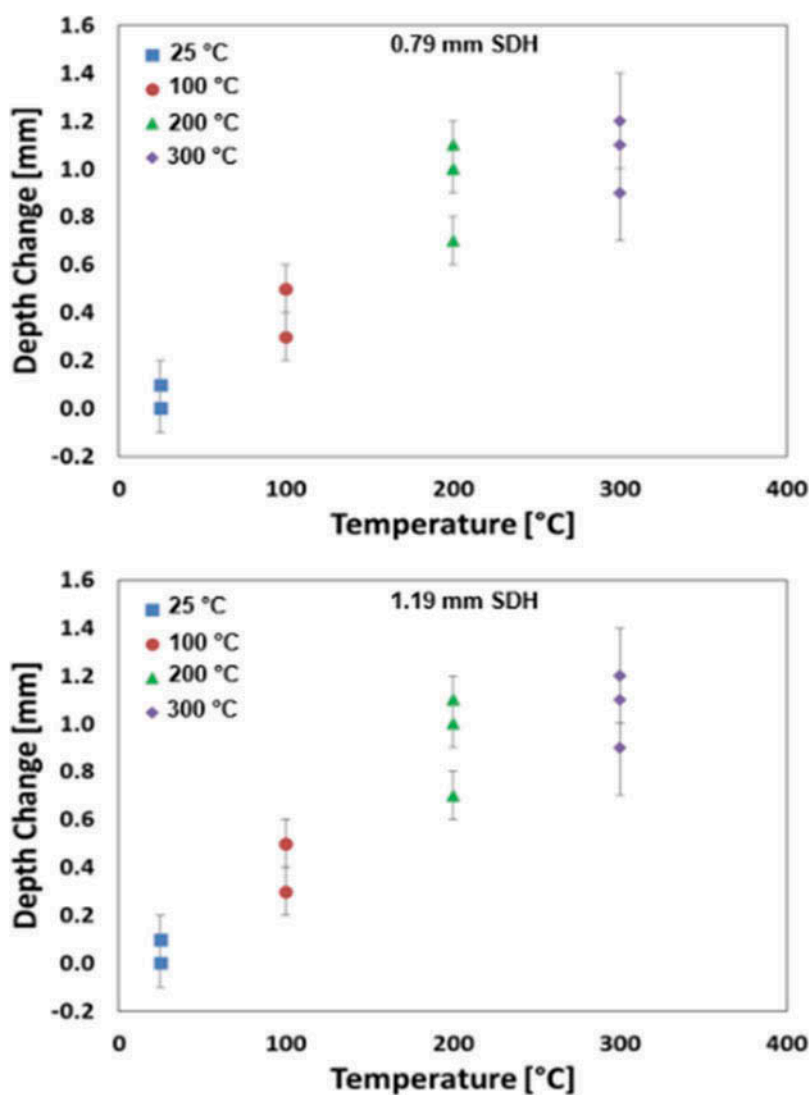
**Figure 17.** Effect of temperature on defect measurement for HT PAUT system for SDH of diameter 0.79 mm (top) and 1.19 mm (bottom).

thickness measurements with elevated temperatures increases by a factor of 1% per 55°C. A comparison of defect depth variation with temperature can be seen in Fig. 17. At room temperature, error in depth measurement is small compared to when an increase in temperature occurs. With an increase in temperature, defect depth increases. Defect depth measurement variation also increases when the temperature and defect location increases. Furthermore, the attenuation has increased at higher temperatures, which can be observed by the reduction in A-scan peak amplitude. At room temperature, 80% A-scan peak amplitude (as calibrated) is obtained, whereas at 300°C, a decrease in A-scan peak amplitude is obtained; consequently, the gain value should be increased to compensate for the loss in signal intensity. When a material's temperature increases, the atoms inside are in an elevated energy state which increases interatomic spacing which impedes transmission. Consequently, at these temperatures a calibration of the software must take place in order to

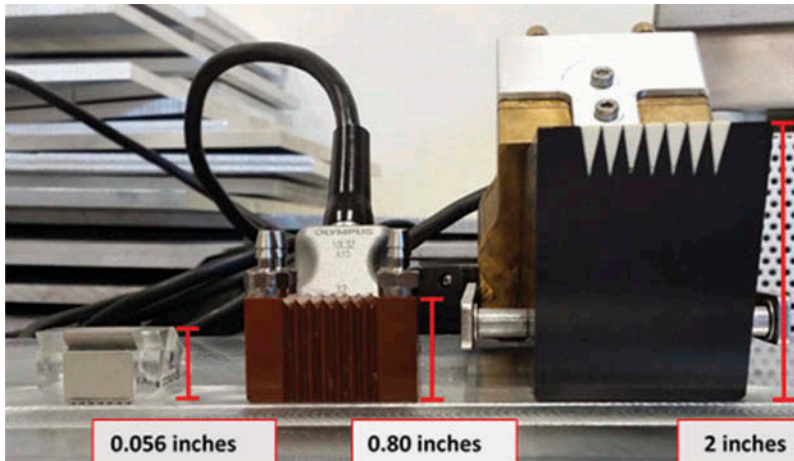
**Figure 18.** PAUT ambient temperature wedge (left), custom HT wedge, and commercial HT wedge.

and pin tool. An issue arises in many welding cases as the chill bar is typically placed very close to the weld seam which would not allow typical HT transducers found in the market available to be employed in this application (see Fig. 18 for a comparison of a typical industrial HT wedge, room temperature wedge, and newly developed HT wedge). This study is, to the author's knowledge, the first of its kind in that the HT/transducer unit was designed in consideration of the fixture geometries utilized in the aforementioned extensive AA-2219-T87 study (see Fig. 19). In later developments, depending on the geometry of the fixture and pin tool, the dimensions of the wedge/transducer setup can be adapted.

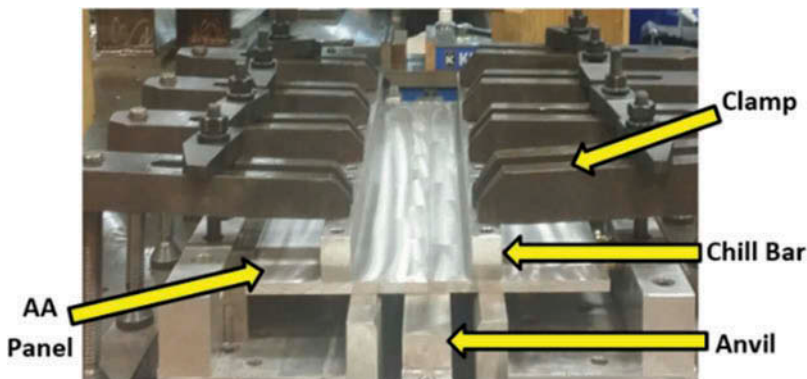
**Figure 19.** Image of FSW fixture employed in this study.

A FSW fixture is a key factor in determining weld quality. The fixture rigidly holds the material to be welded in place and also acts as a heat sink. In order for the development of an online system, the HT wedge/transducer unit must fit between a bar which is used to clamp down the material (namely, chill bar)

In order to utilize the current HT wedge/transducer setup, the chill bar on the AS was shifted from the nominal position of 1 inch from the weld seam to 3 inches to compensate for length of the HT wedge. This distance was considered safe to ensure that the wedge would not come into contact with

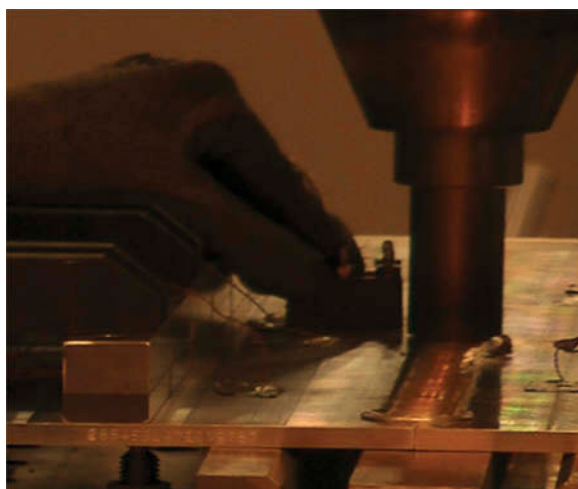
**Figure 20.** Custom PAUT HT wedge/transducer unit scanning during FSW.

During welding experimentation, an I-Stir Process Development System (PDS) FS welder was employed to test the PAUT system. The experiment entailed placing the HT wedge/transducer unit roughly 25 mm away from the weld seam on the AS. This distance allowed enough clearance for the pin tool during welding, as can be seen in [Fig. 20](#). The wedge/transducer unit was placed by hand to scan the workpiece before, during, and after the FSW fixed pin tool traversed the weld seam. A high-temperature couplant, called Pyrogel, which has an operating range of 315°C, was employed for HT tests. In a similar fashion, this method was conducted multiple times during each weld experiment. Four weld schedules were analyzed and can be observed in [Table 4](#). The weld schedules chosen were conducted to obtain two nominal welds and two defect welds to observe the performance of the online PAUT system.

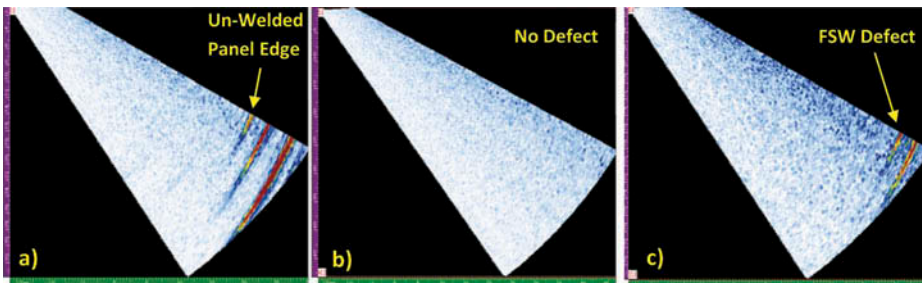
**Figure 21.** PAUT S-scan images of HT wedge/transducer unit signals: a) unwelded seam, b) nominal welded seam, and c) TR defect welded seam.

free experiments, once the pin tool traversed the weld seam, material was consolidated providing no defect signals. However, when defects are welded into the workpiece, the PAUT system is able to capture them. Figure 21 illustrates the S-scan images of the unwelded seam, nominal weld without defect, and weld with defect. As discussed previously, multiple legs are employed to scan the entire welded area. Consequently, care must be applied in interpreting the results as the distance for scanning in these experiments employed three legs, which can have adverse effects on correctly interpreting defect signals.

In image (c) of Fig. 21, only signals generated at large angles could determine the defect due to the distance the probe was placed from the weld seam, as indicated by Fig. 22. Here the first defect image was found by the second leg, and thereafter the second defect image was found by the third leg. The back-wall was not found in the image shown in Fig. 21 (b) due to the filter that was applied for scanning; moreover, as attenuation increased, the back-wall signal could not to be found. In Figs. 21(a) and (c), the back-wall is located at the same location of the defect, and hence it is hard to distinguish.

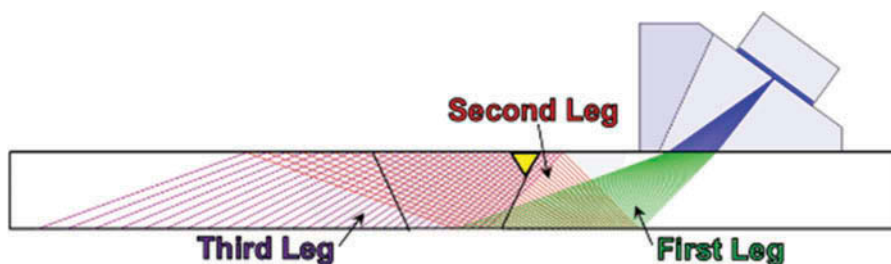
**Figure 22.** PAUT illustration of multiple legs scanning an FS welded with a TR defect on AS.
