Report No. SES 2009-004  
Deschutes County (+)  
T15S R10E Sections 13, 14, 21, 22, 23, 24

**Three Sisters Irrigation District Main Canal Pipeline and Watson Reservoir Hydroelectric Power  
Project: Phase I Field Survey and Section 106 Evaluation, Deschutes County, Oregon**

Report prepared for the Three Sisters Irrigation District  
and  
The Deschutes River Conservancy

Report Number SES 2009-004

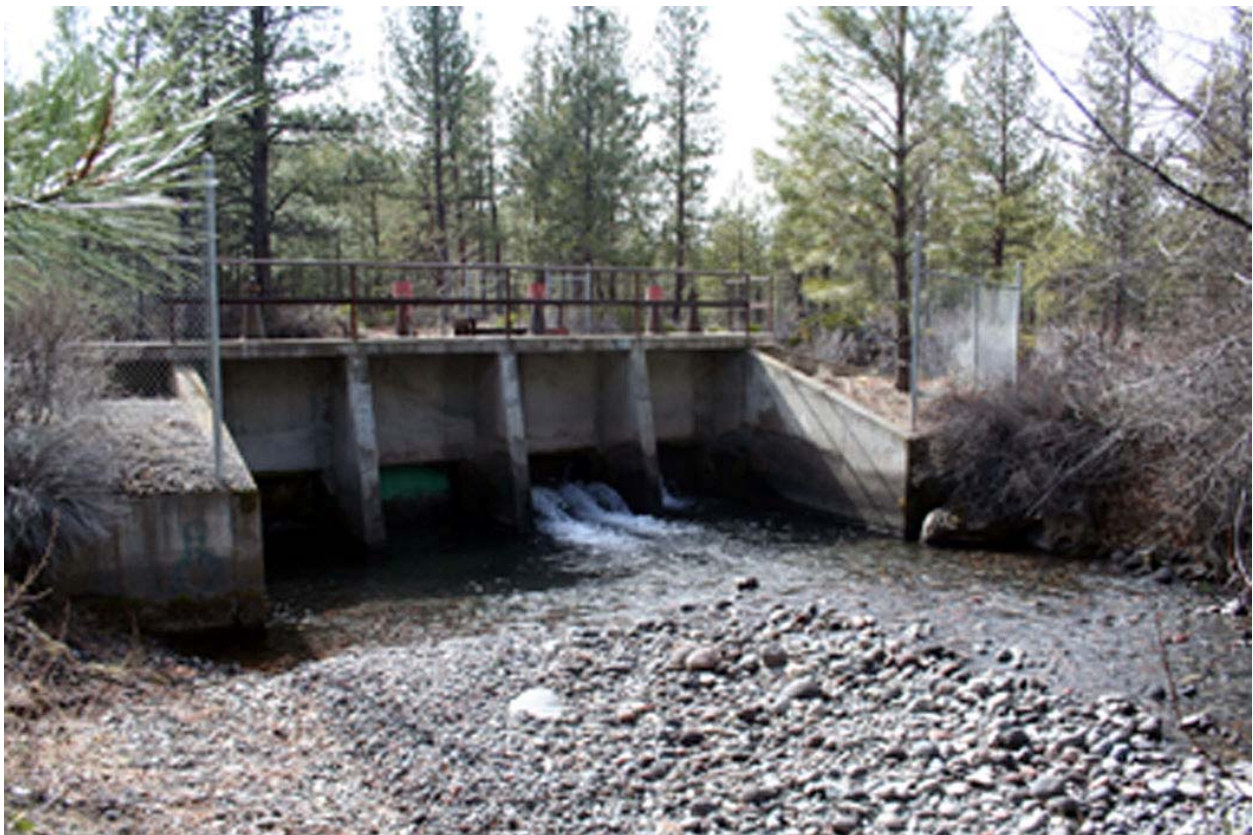
The Three Sisters Irrigation District (TSID) is proposing to replace their Main Canal from the headworks (Figure 1) with two 54-inch high density polyethylene pipelines (HPDP) approximately 4 mile in length. The project will begin at the canal's headworks on Whychus Creek to Watson Reservoir. Two 750-kilowatt turbines will be installed at the terminus below the Watson Reservoir.

Figure 1. Three Sisters Irrigation District Headworks

The existing head works was built in 1970. Four laterals or turnouts exist along the main canal. These include the Uncle John Turnout, Cloverdale Turnout, Fryrear Turnout and the Patterson Turnout. An inflow weir is located at the southeast end of an earthen dam that creates Watson Reservoir.

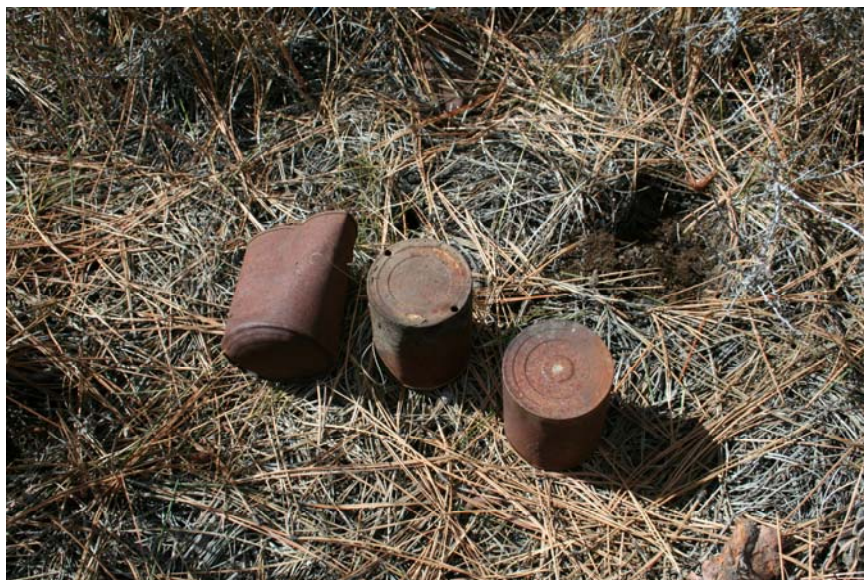
One historic refuse scatter of 10 vent hole evaporated milk cans and a crimped seal sanitary can (a 303 can) post-dating 1963 was identified during the pedestrian survey (Figure 3 and 4). This resource given the lack of additional physical evidence and the age, the resource does not meet the criteria for eligibility to the NRHP.

Figure 3. Representative Sample of Cans from TSID 001-09.

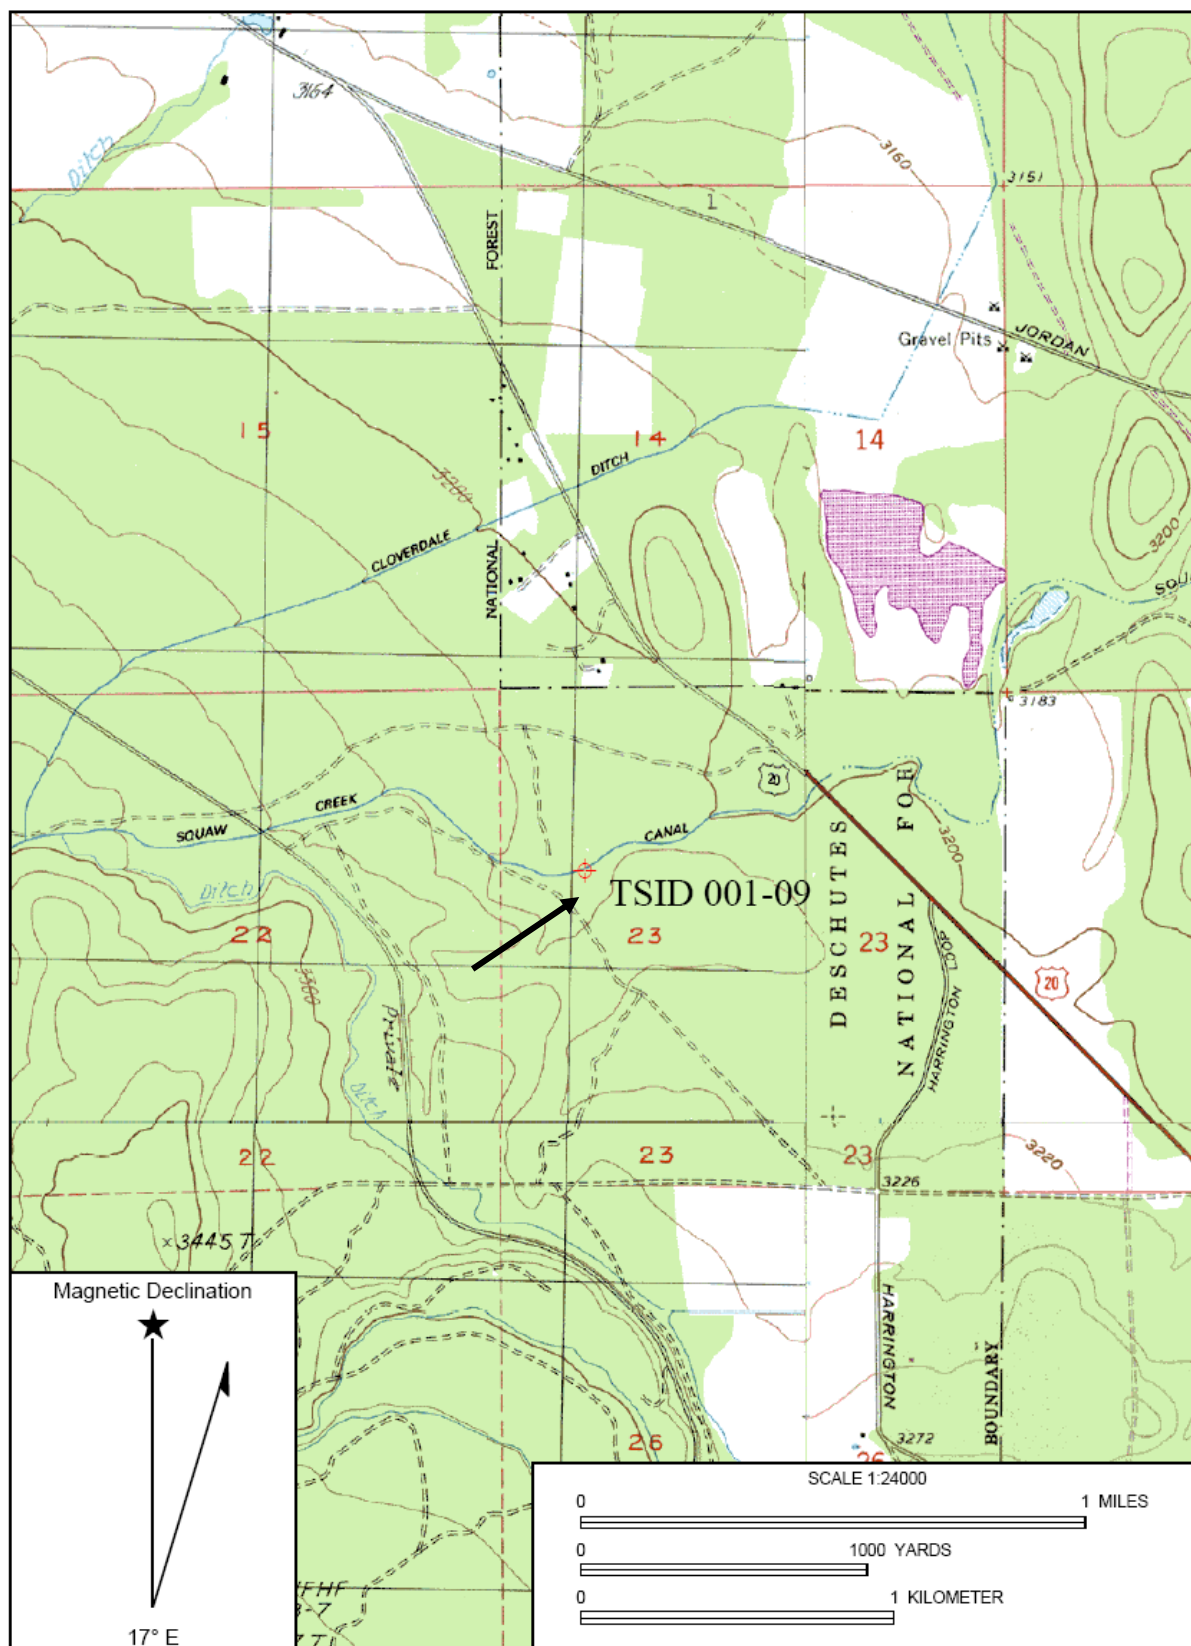
Figure 4. Isolate Find TSID 001-09 T15S R10E Section 23 NE/SW/NW
