Kuttampokuna

Twin Ponds| Architectural landscape

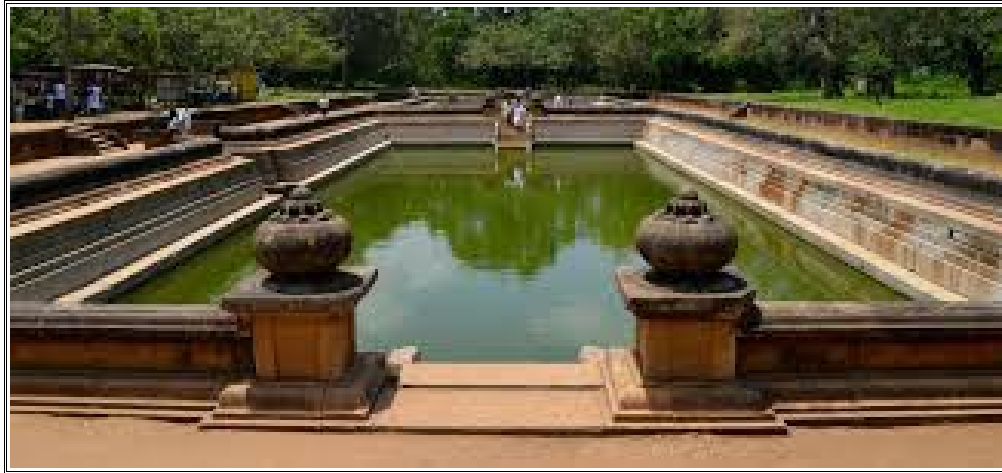
The smaller pond (the northern) one has been constructed first and the larger one at a later stage. They are connected through a pipeline at the bottom. The northern pond is 91 feet (28 meters) long and the other 132 feet (40 meters) .

Water to these ponds have been supplied through underground pipelines and the water is sent through several filtering chambers before it falls on the northern pond through a mouth of a dragon. The water from both ponds is drained from a small outlet in the smaller northern pond.

Though the underground pipelines are no more, you can see 4 levels of filtering of the water before it enters the ponds.

A garden was landscaped which separates the two ponds which long is 18½ ft. The larger pool of the two is 132 ft by 51 ft, while the smaller pool is 91 ft by 51 ft. The depths of the two pools is 14 ft and 18 ft for the smaller pool and the larger pool respectively.

The faces of the pools were cut granite slabs which includes the bottom and the sides of the pool. A wall was also built around the pool which encloses the compound. Flights of steps are seen on both ends of the pool decorated with punkalas, or pots of abundance and scroll design. Embankments were constructed to enable monks to bathe using pots or other utensils. Water to the pools were transferred through underground ducts and filtered before flowing to the pool and in a similar fashion the water was emptied.

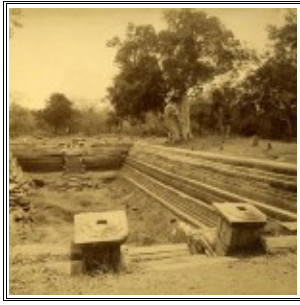
Kuttam Pokuna before restoration – photo taken on late 1800's or early 1900's

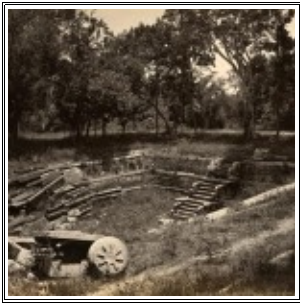
Kuttam Pokuna before restoration – photo taken on late 1800's or early 1900's
