## LIGHTNING PROTECTION SYSTEM (LPS)

The Lightning Protection System (LPS) is a passive lightning protection, ensuring that lightning strikes hitting the blade are transferred to the grounding.

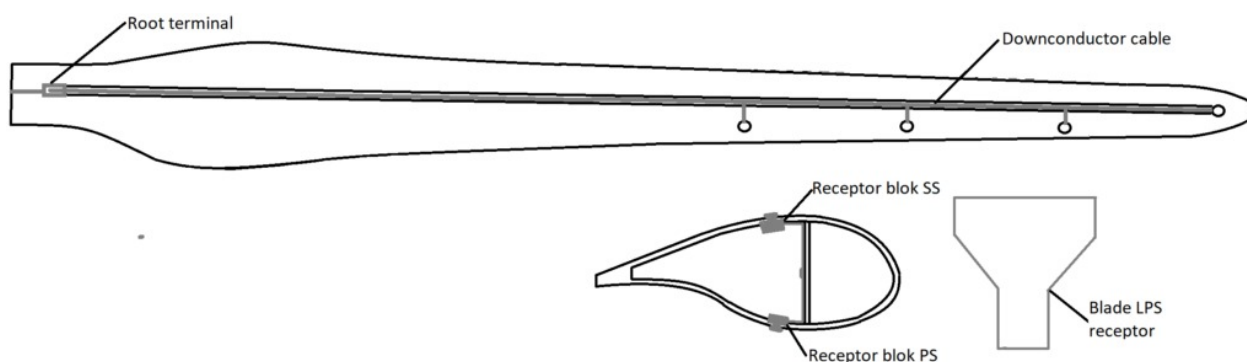
The systems are tested in accordance to the IEC 61400-24 standard.

Dependent on the test tier the system is designed to handle 100–200kA, without significant system wear.

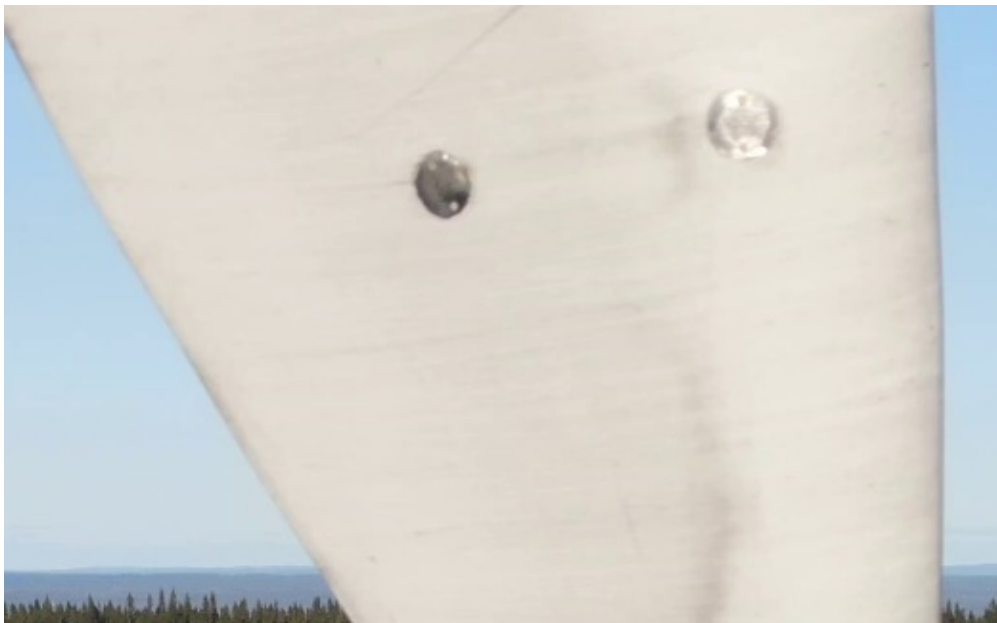
The receptor is a component made from metal like copper or equivalent current transferring metal alloy. It is designed to attract lightning and transfer the load to the receptor block. The receptor has a conic screw below the base that ensures contact to the receptor block. The receptor is a replaceable component that is mounted post blade production. On older blades the tip receptor can be a massive copper piece taking up the outer 20cm of the blade tip.

Risks of failure are worn receptor base or missing connection to the receptor block. The wear mechanisms include arching of the receptor base from lightning attachments and corrosion from water ingress between the receptor and receptor block. Visual inspection can be used to determine the condition of a receptor. Scorching and deformation are the most common signs of wear from lightning on the receptor base. Lightnings will also remove some material of the receptor base over time. If material removal proceeds below the blade surface, the receptor will have a reduced attractiveness to lightning.

Missing sealant allows water ingress between the receptor and the receptor block, which can cause corrosion and damage to receptor block over time.

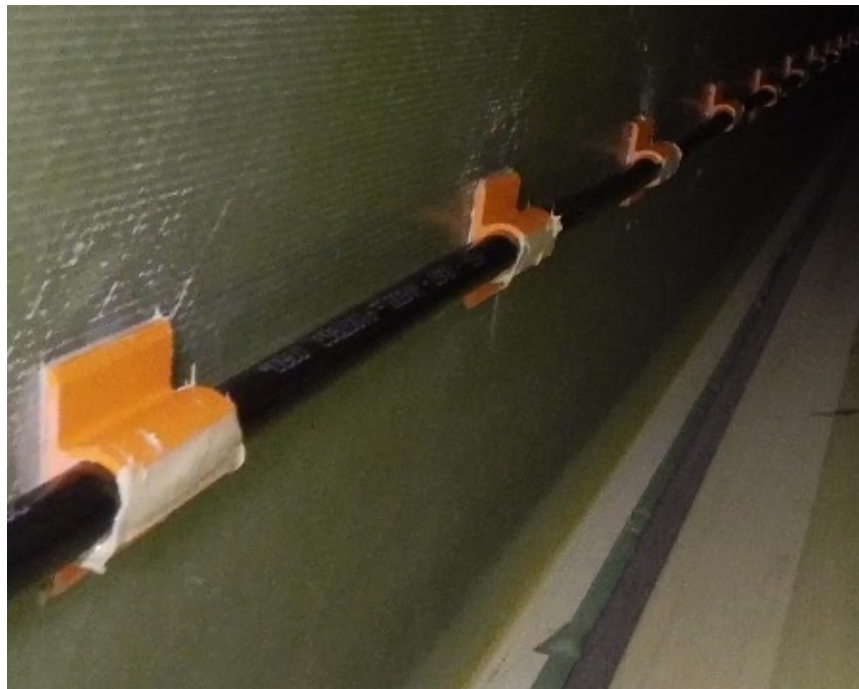
The design of the cable varies between the different OEM's, including copper mesh, solid copper cable, linked aluminum plates and solid cable.

The cable is centered on the web of the blade, it can be located on both LE or TE side dependent on the OEM design. The cable is cast into the blade during production. Repair is possible but very complex and due to a clamping device changing shape of the cable the blade has additional risks of wrong lightning attachments post repair.

Failure types include missing connection to root terminal, or receptor block and cable separation due to fatigue. Connection to the root terminal can be checked with an internal visual inspection, which can be performed without entering the blade. Detecting separation of the down conductor cable is possible with a dedicated internal inspection. A skilled technician or internal drone can reach 1/3 into the blade, while a sewer crawler can inspect until a few meters from the tip. The most detailed inspection is achieved by a technician or drone inspection.

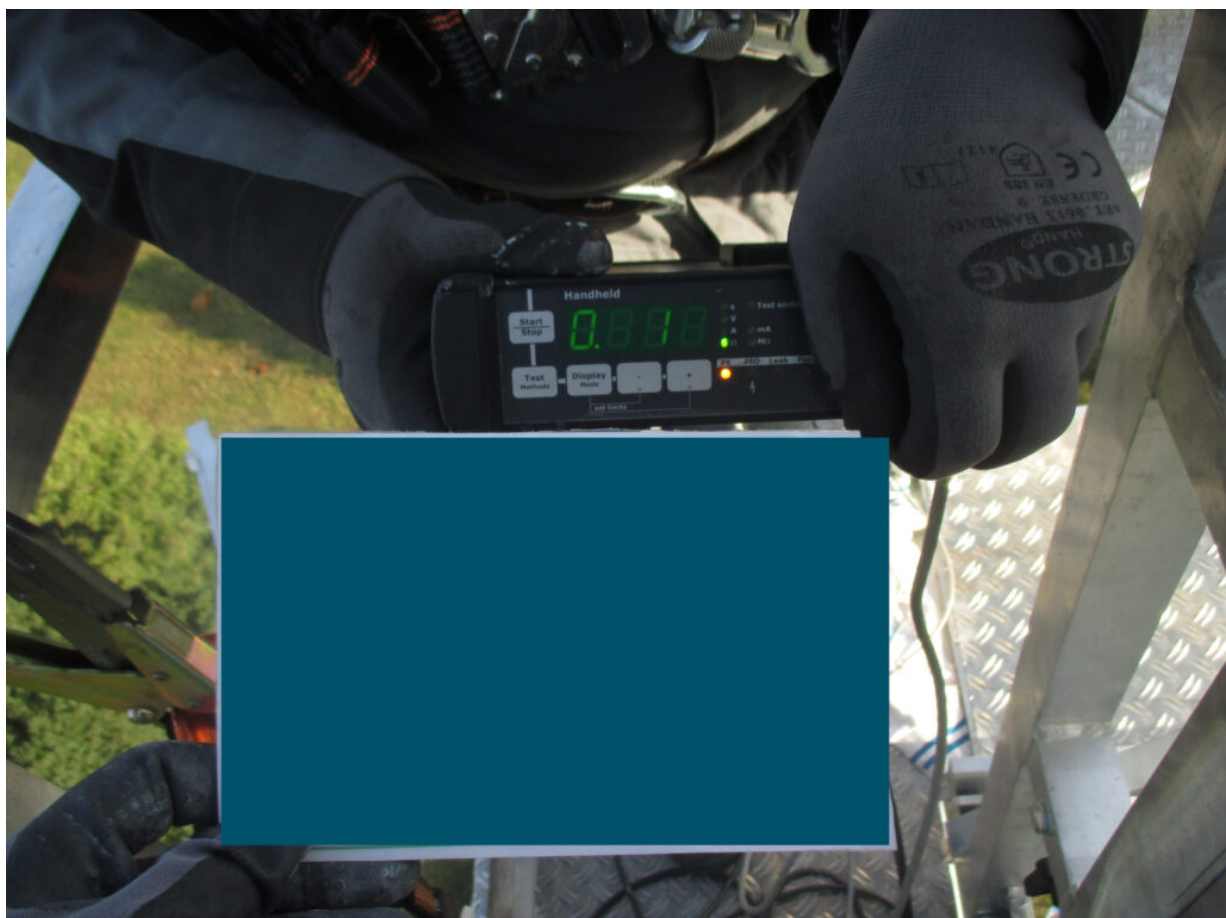
The currently used method of determining whether an LPS is functional is by conducting a resistance measurement. It is performed by connecting multi-meter probes to the two ends of an LPS, essentially creating a closed circuit. To check the functionality of the system within a blade, you must connect one probe to the tip receptor and one probe to the root connection. To check the functionality on turbine level, you must connect one probe to the

tip receptor and one probe to the earthing system at the tower base. Performing the measurements between different components of the LPS can help localising the damaged part. For example, if no connection is established during a resistance measurement on blade level from the tip receptor on the SS to the root connection, and a  $25\text{m}\Omega$  are measured from tip receptor on PS to the root connection, it can be deduced that the damaged part of the LPS is between the tip receptor on the SS and the tip receptor block.

The resistance measurement will determine if a connection between the receptor and root connection is present. A common measurement for a 40–45m blade is in the region of  $25\text{m}\Omega$ , and a full measurement of the grounding system should not exceed  $1\Omega$ .
