Document 522

Post-Assessment Report

Chapter: [Worcester Polytechnic Institute](#)
Country: [Guatemala](#)
Community: [Guachtuq](#)
Project: [Rainwater Harvesting](#)

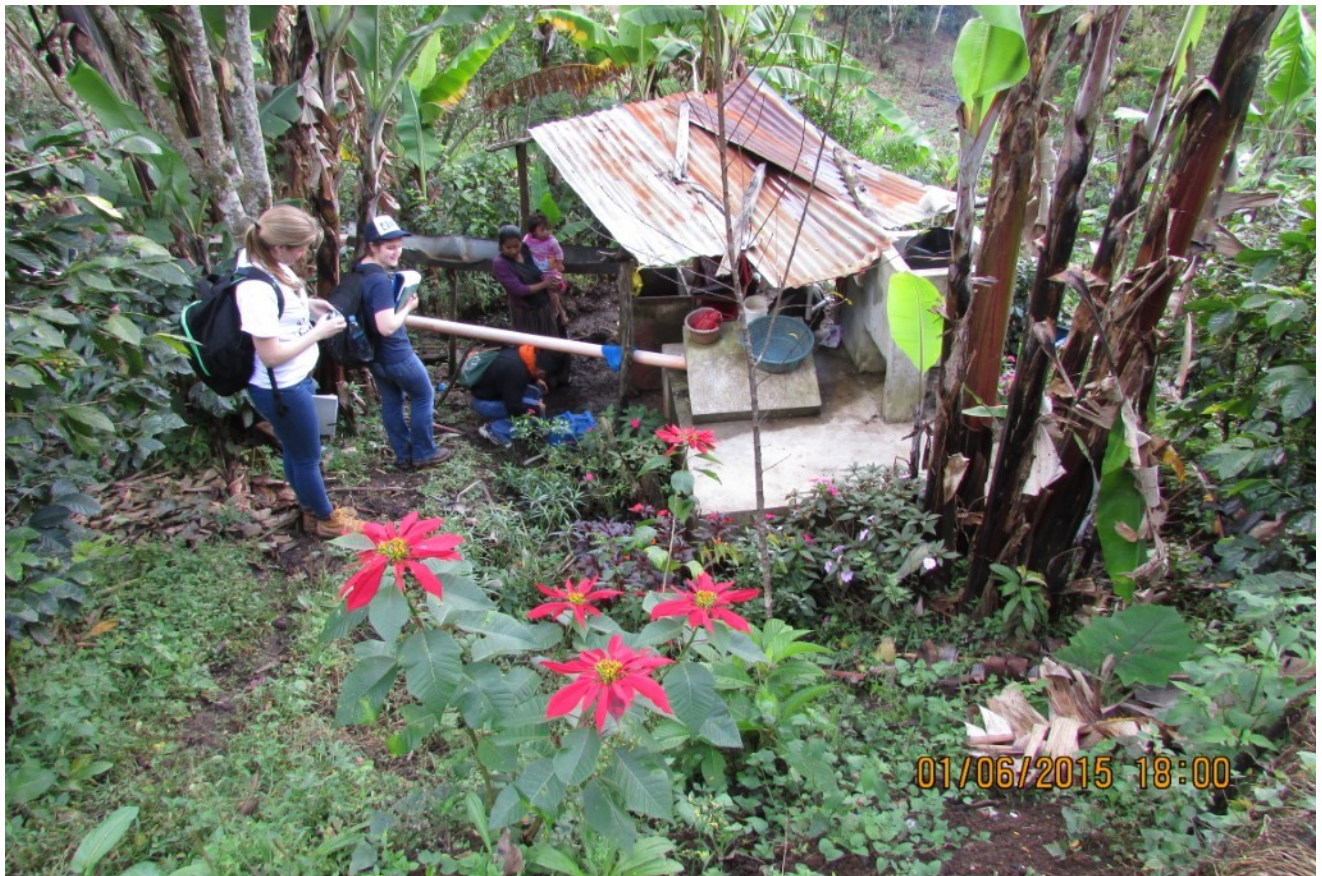
Figure 3: This picture is of a team of travelers assessing House 24, one of the homes that will be implemented on this coming May 2015. Travelers in this photo are Amanda Gatz and Katie Picchione.

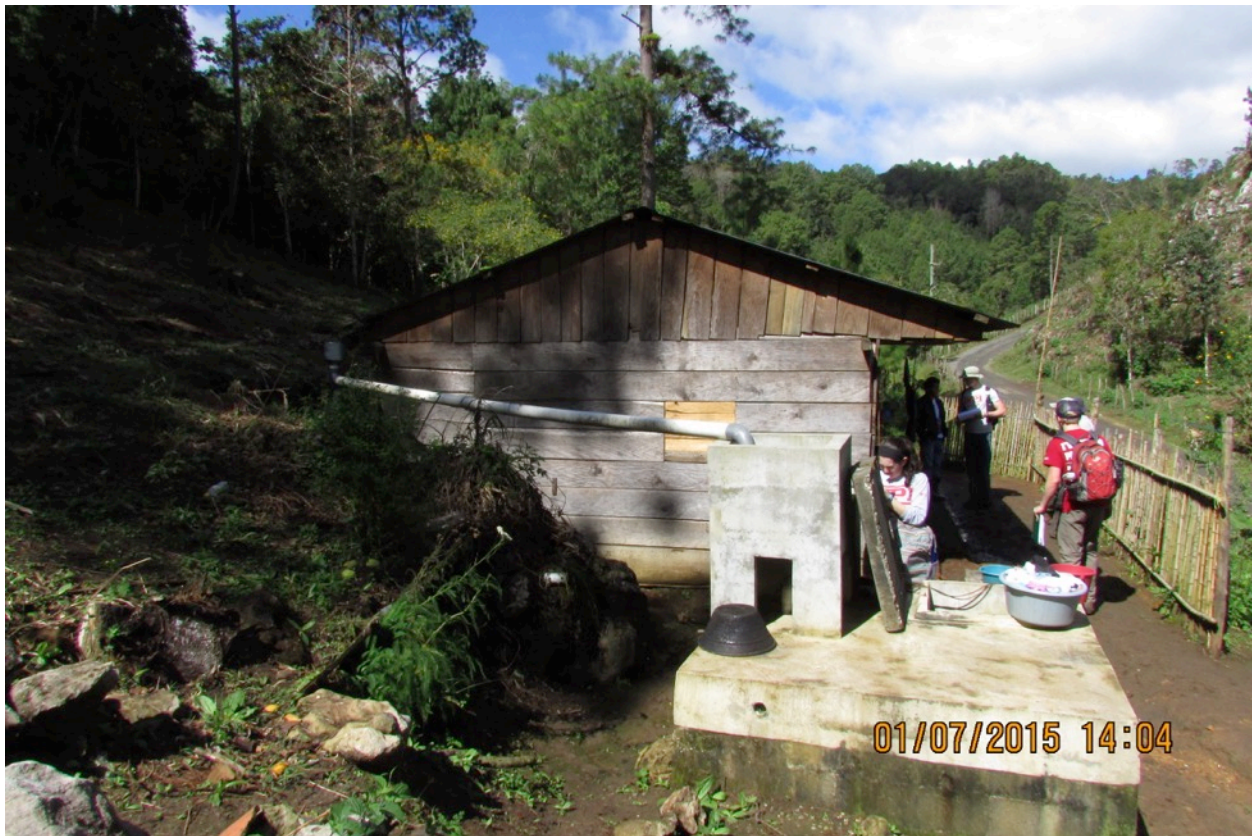
Figure 4: This is a picture of House 12, one of the homes that will be implemented on in the coming May 2015 trip. At this home the concrete tank was also assessed for possible improvements to be implemented in the coming trip.
