Results for GRAPPA implementation:

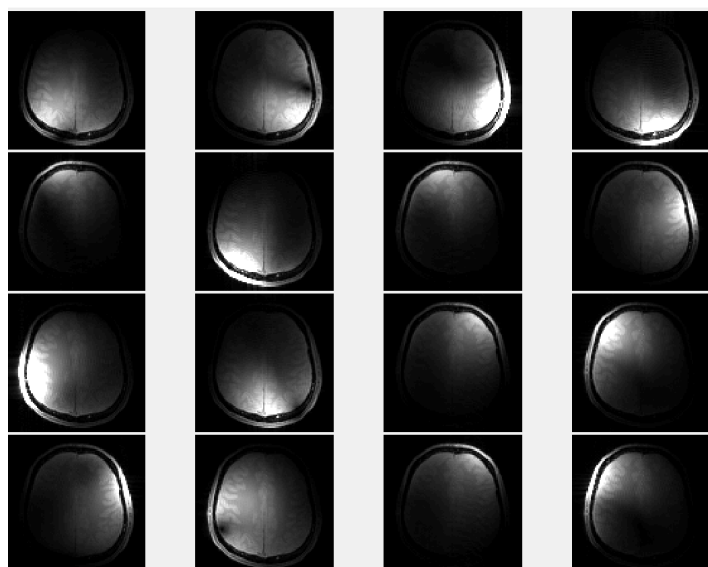
Ground Truth Coil Images

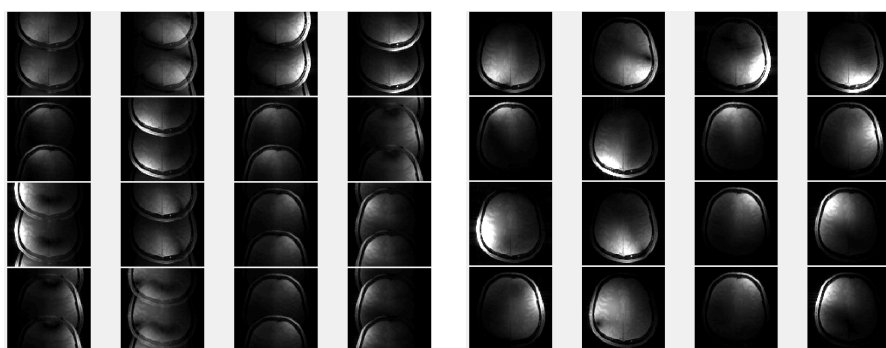
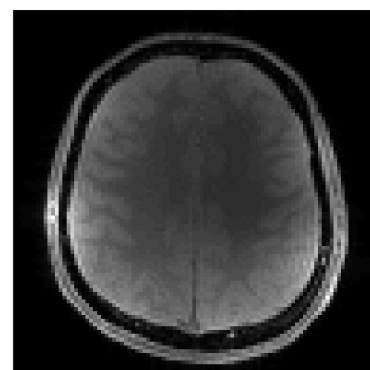
R= 2:

Before Reconstruction

After

After, Coil Combined

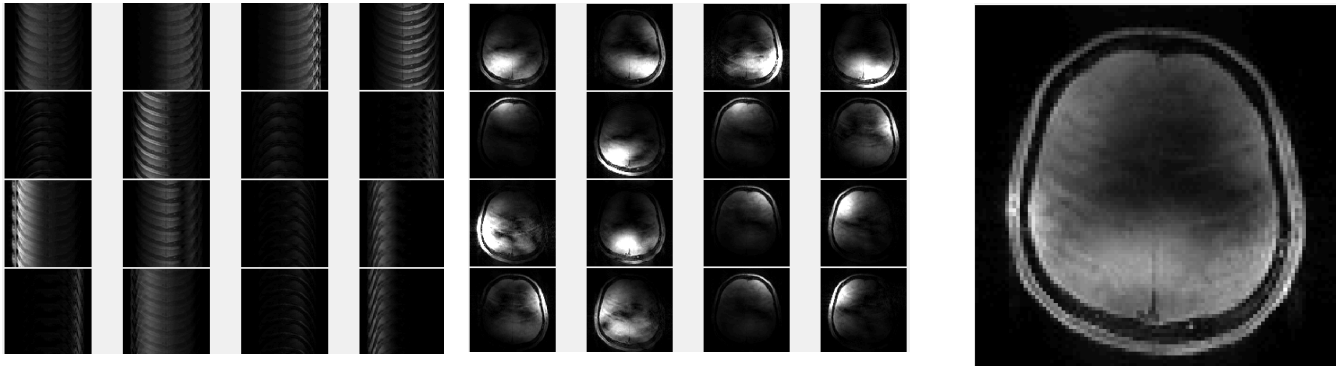
R = 6:

Artifacts begin to become noticeable at R = 6
R = 6 with additional lines of calibration space:
